**Arborist Report
Butte Fire Incident
15-CA-AEU-0024918**

prepared by Michael T Mahoney, RCA #353
32759 Greene Drive · Springville, CA 93265 · 949/283-6439
michael@michaeltmahoney.com

February 15, 2016

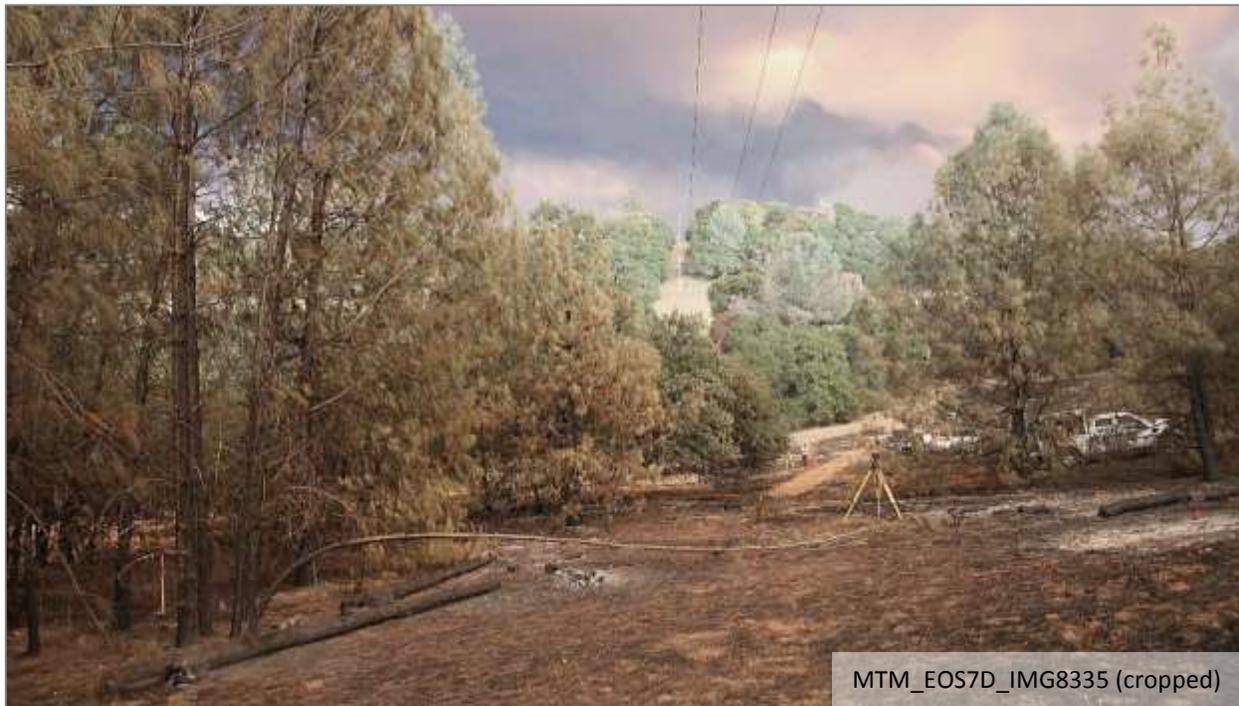
MTM_EOS7D_IMG8335 (cropped)

Attention was directed to the ongoing inspection of a Gray pine (*Pinus sabiniana*) observed with the length of its slender stem lying horizontal, just above the ground with the base of the tree still firmly upright and rooted (previous page - image 8335). The tree was one of several Gray pines growing along the north flank of an east-west powerline corridor; several pines and other trees and shrubs had been cut earlier in the season and stems and shrubbery were left lying alongside their stumps. The sight of the recumbent tree was compelling. My first inclination was to document the immediate scene and begin to establish an arboricultural context.

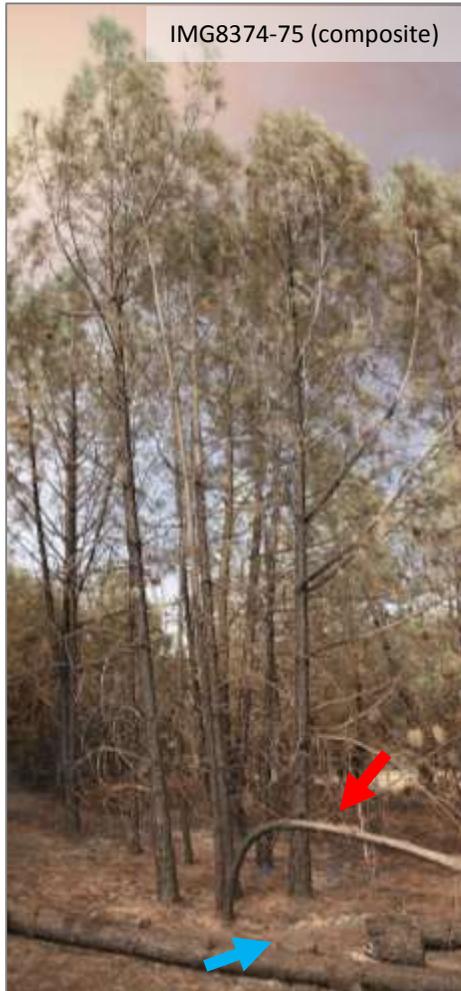
The surface grade is sloping in this locale, descending from the proximity of a power pole situated at the top of a rise. The 3-phase conductor span extends easterly over tree canopy and open-space to power poles in the distance. Images of the scene are shown on pages 2 and 3; a stand of Gray pines encompass the subject tree (seen here, left) with a red arrow indicating the subject tree extending out of the image, bottom right. A stand is a group of forest trees sufficiently similar in age, size and type to be considered a unit. Trees that are captured, and that develop within a closed stand, have narrow growth rings and poor stem taper. When the stand is altered and captured interior trees are exposed to open spaces, whether for right-of-way clearance or other reasons, they are prone to failure.

Two larger pines were situated on the south side at the edge of the stand; one of the remaining stumps is also visible here (shorter blue arrow). It is apparent that the act of cutting larger pines that previously contained the stand exposed interior trees.

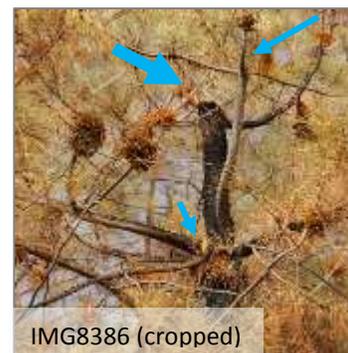
The sketch of the subject tree (right) focuses on inter-nodal dimensions; that is, the distance between lateral branching at nodes and corresponding loosely to annual growth increments. Of interest here is the over-all length of the stem, also representing the height of the tree. The subject tree sketch points to the proximity of charring – an indication of contact with an energized conductor, and its location in relation to the tree’s overall height.

The top elevation of the subject tree is 43'7^{10th} and charring is found just two feet below at 41'5^{10th}. The burned section is the second increment beneath the top or tip of growth. These burn marks are characteristic of contact with energized electrical equipment. The image, right, shows a top view of the limb and clearly demonstrates an inter-node.

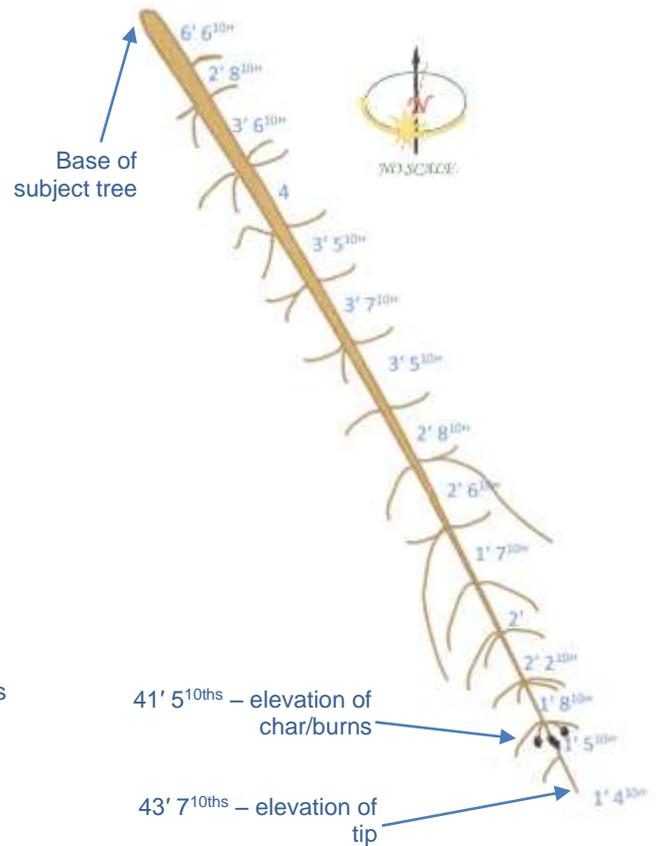
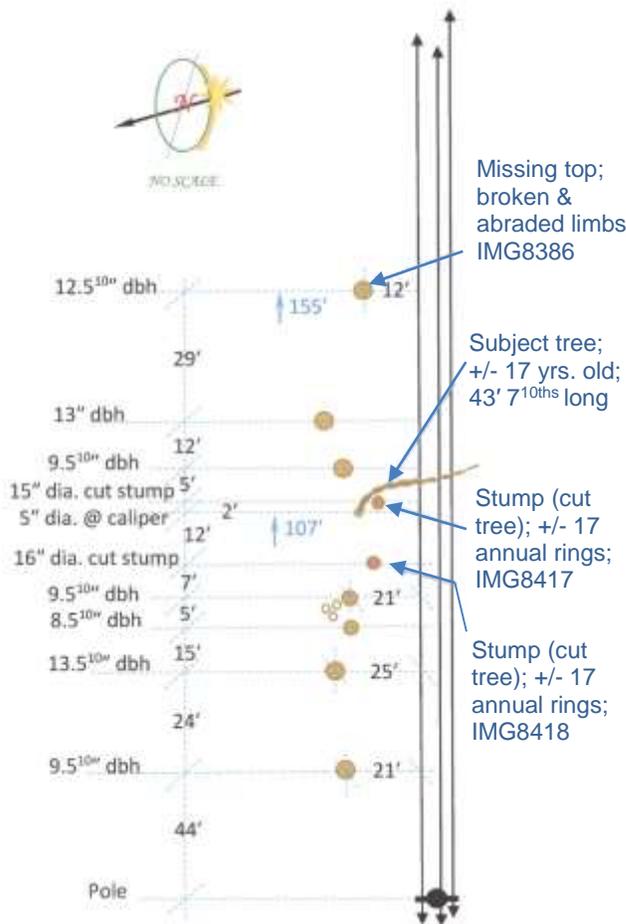
The site sketch (left) focuses on certain trees in the stand along the edge of the utility right-of-way; the subject tree and adjacent stumps; and a proximity with the tri-phase conductors south of the stand. Additional trees can be found beyond specific locations documented here.

Both the site sketch and the sketch of the subject tree are referenced with a compass rose and an indication of the path of the sun. It is well understood that trees and other green plants have a physical orientation toward the path of the sun and this can have significant consequences for maintaining safety.

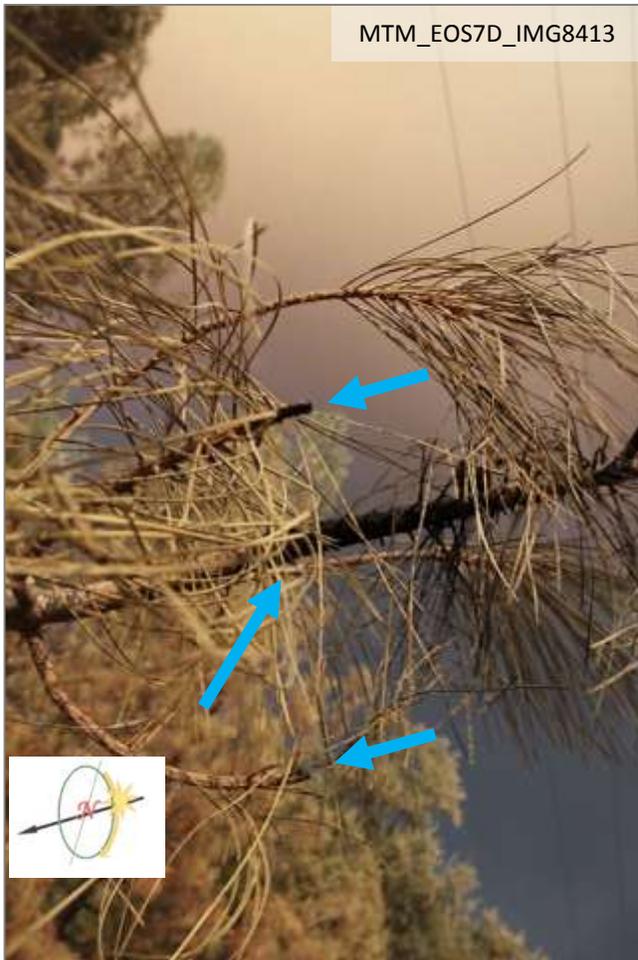
Viewed to the left is the side of the stem that came to rest on the energized conductor.

Blue arrows indicate the main stem - intact even though it was severely charred, and two lateral limbs whose tips caught fire, were burned-off, and fell onto the easement below. The top view shows less charring on the two lateral branches, an indication that the lateral limbs rested on the conductor very briefly, whereas the larger main stem is charred on top and bottom.

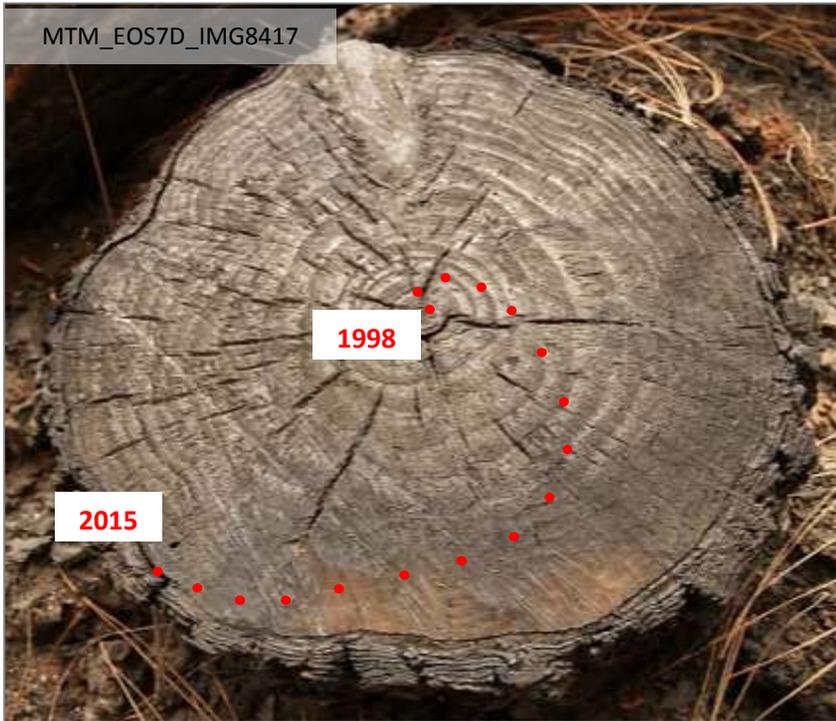
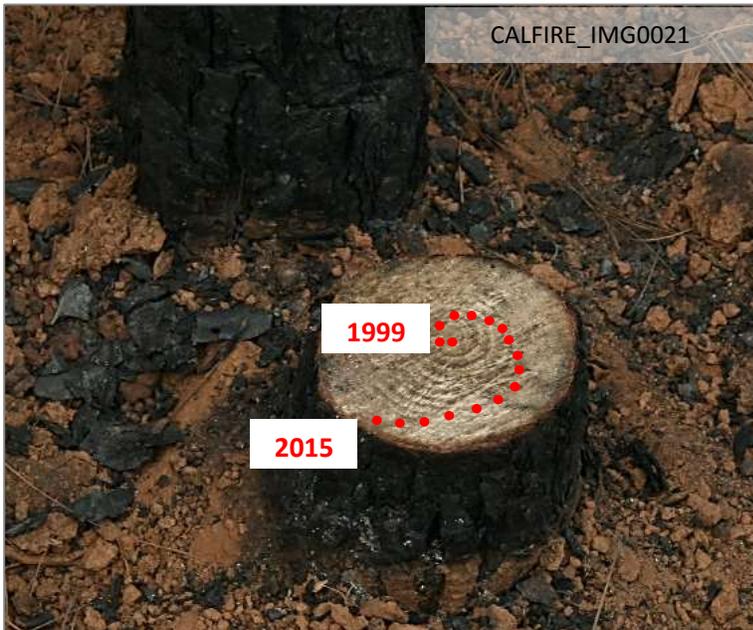
A 'ring count' focusing on cut surfaces of stumps provides specific historic information.

Slash and other pieces of wood cut prior to the fire suggest the trees were alive when cut, so the outer growth ring can demonstrate a specific point in time. Further, the stage of ring development also suggests a particular time in relation to the growing season. Latewood is abrupt and laid down at the end of a growing season; earlywood is expanding and corresponds to the time when the tree begins to grow and is actively growing thru summer. Other ring characteristics are apparent, but a comparison of the annual increment number and the last growing stage before the stump was cut is revealing.

It is apparent from this tree ring study that the larger trees cut in line clearance activities occurred prior to the onset of the 2015 growing season, whereas the subject tree (cut in September 2015) occurred near the end of the growing season. A great discrepancy exists in the character of these trees. Furthermore, annual growth rings indicate they are close to the same age.
