IMG_0001 - Cover sheet indicating beginning of photographs.

IMG_0002 - Front of house located at 8015 High Valley Road, Cobb, CA.

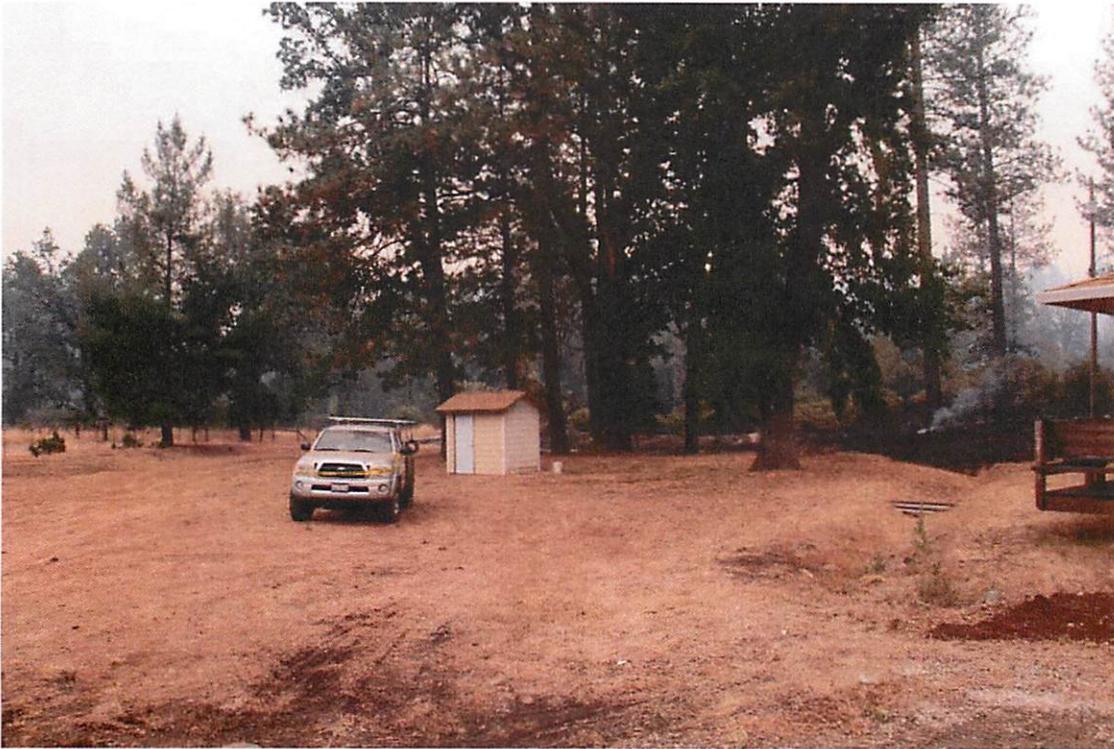
IMG_0006 - Looking southeasterly from driveway toward burnt tool shed and destroyed wood shed.

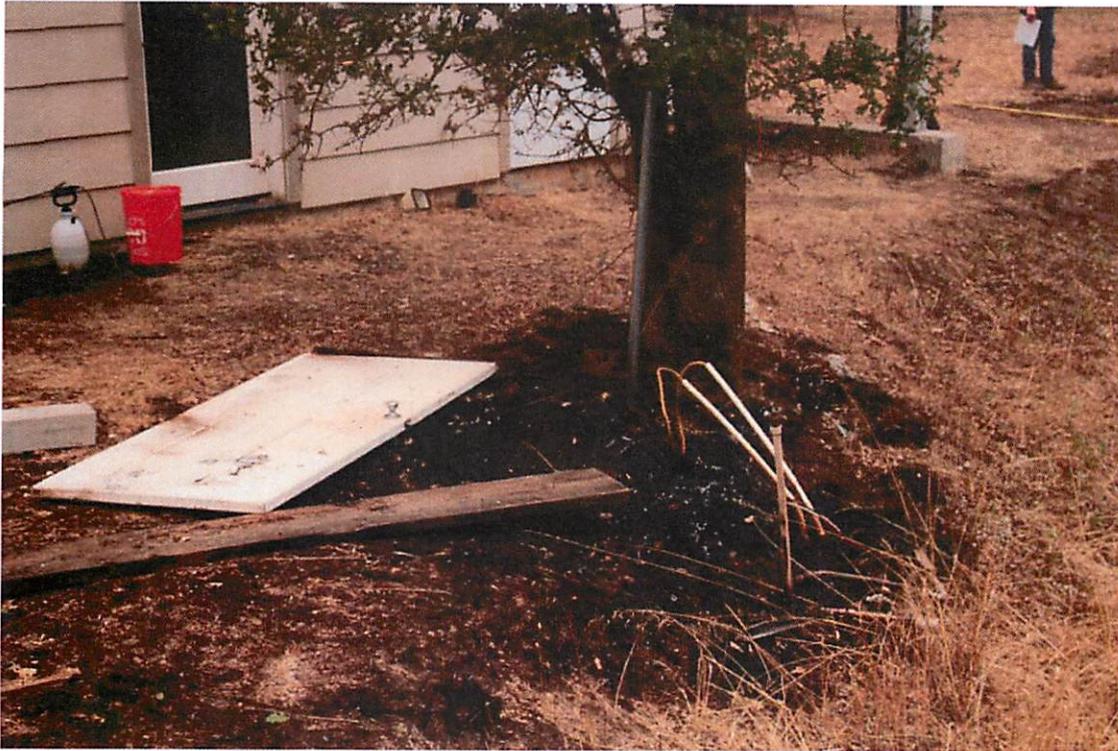
IMG_042 - Looking westerly toward destroyed wood shed and damaged tool shed, from adjacent to the southeast corner of house.

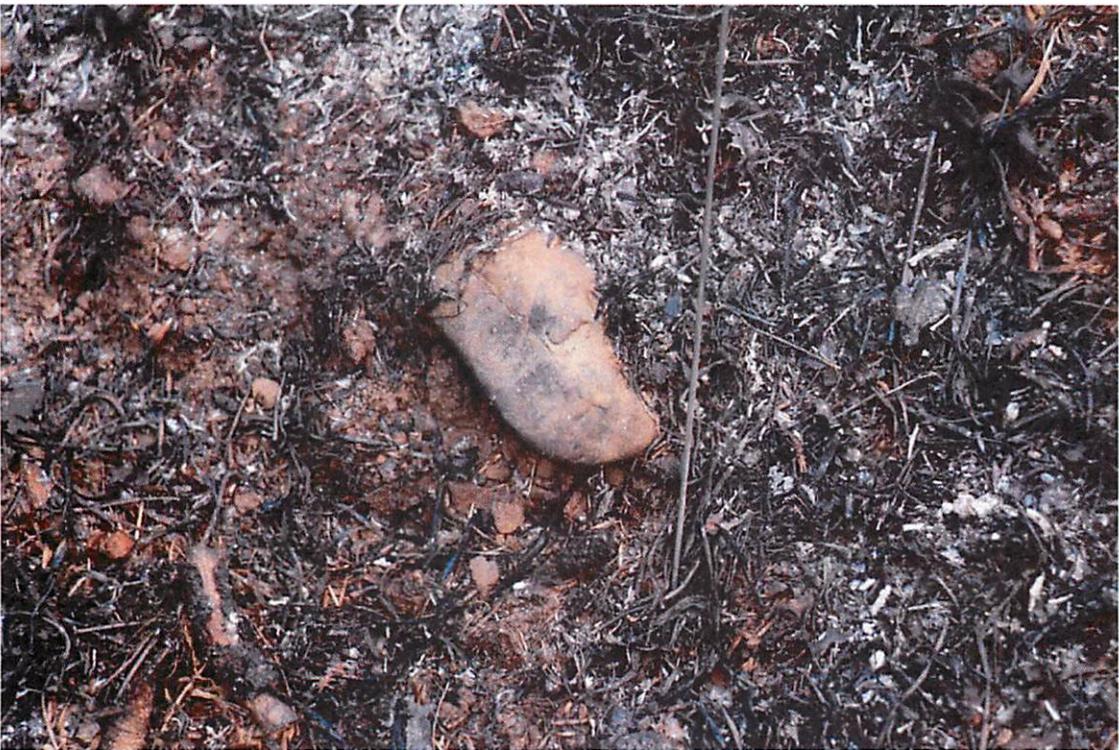
IMG_081 - Zoomed advancing indicator from #78 showing protection sooting and staining.

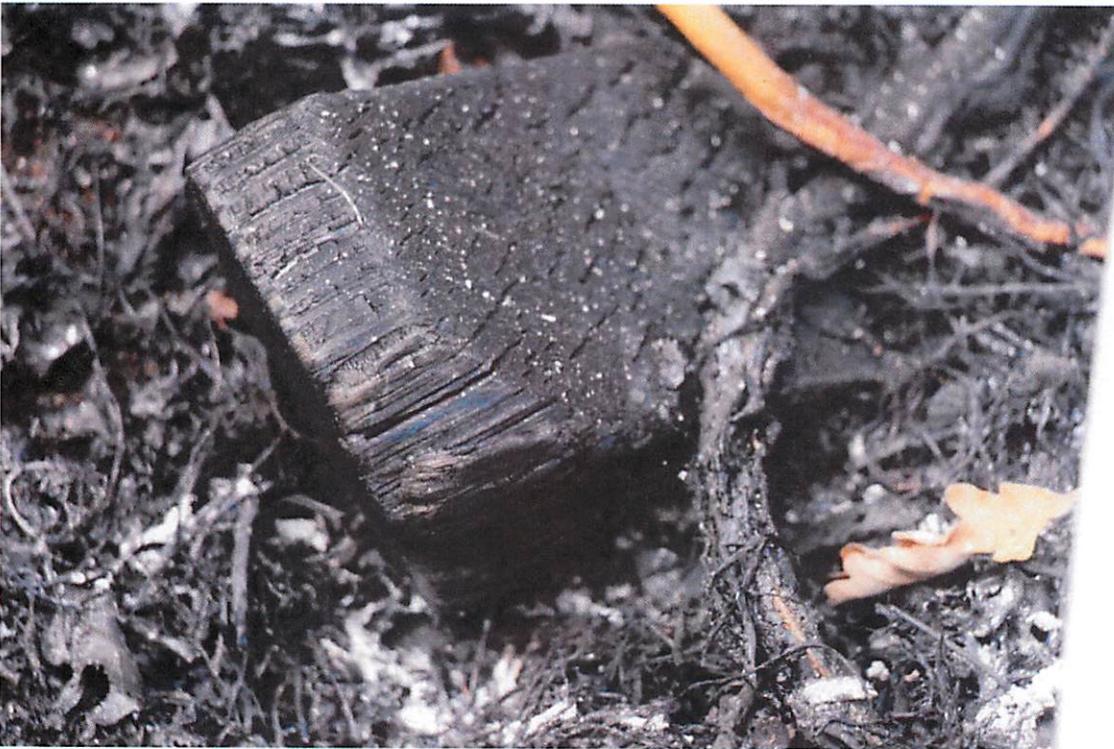
IMG_091 - Zoomed advancing indicator from #87, including degree of damage, depth of char, and protection. Also Romex and wires on ground.

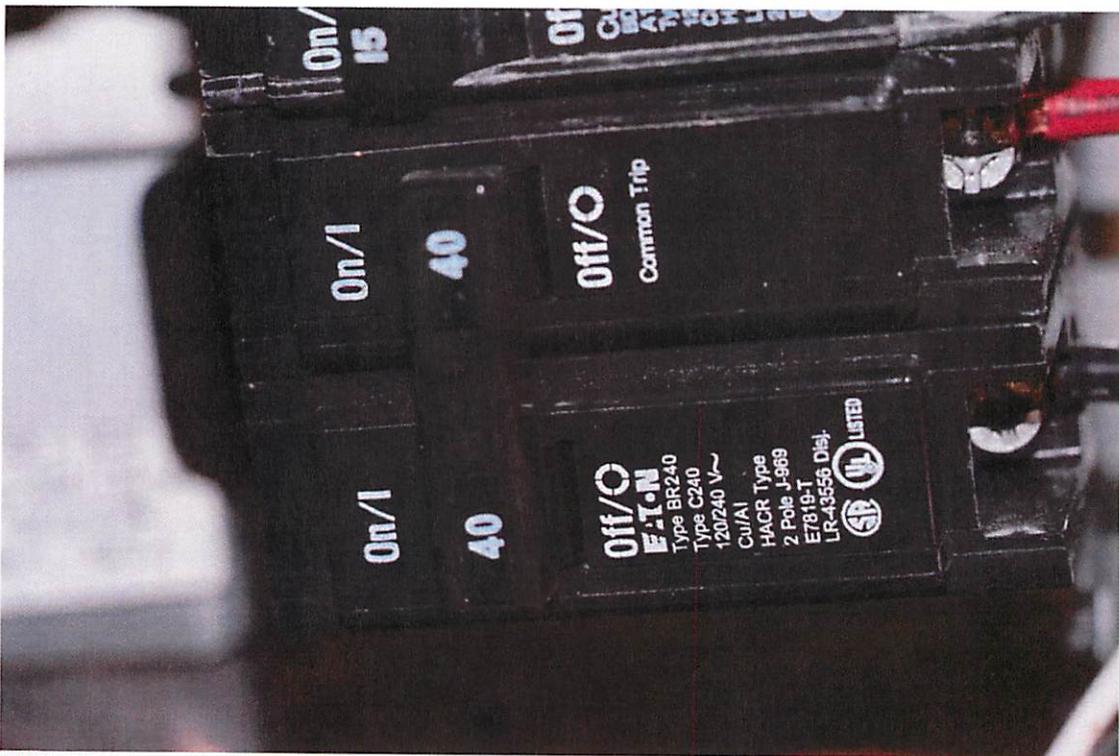
IMG_121 - Detail of lowest most tied breakers tripped and not in the "on" position.

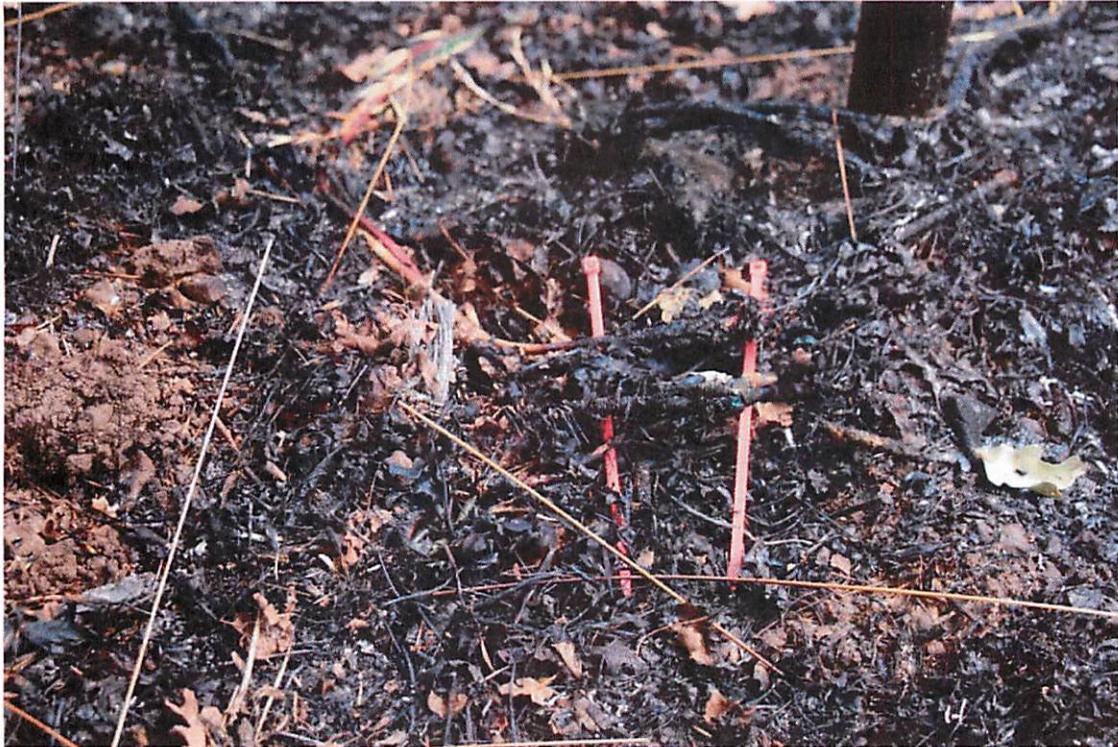
IMG_124 - Wire splice located within the SOA. This splice shows the green, black, white and red wires were connected with wire nuts.

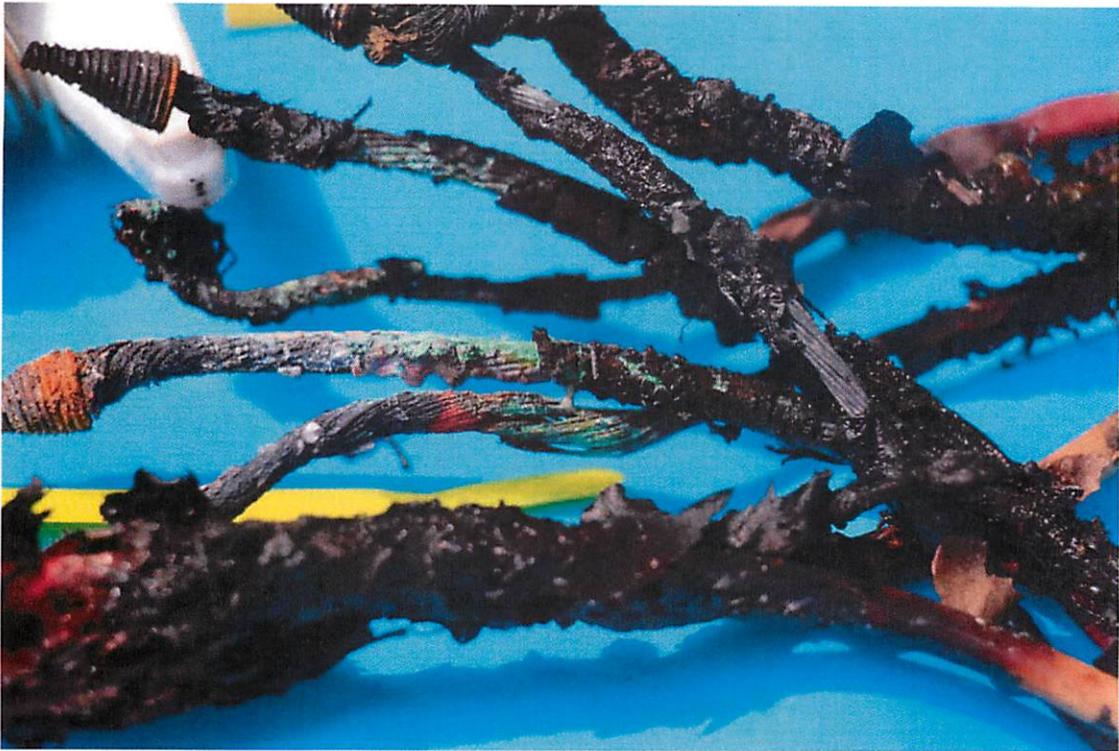
IMG_158 - Detail photo of splice with scaled blue paper beneath for contrast. Yellow wire tie pointed to location where wires were welded.

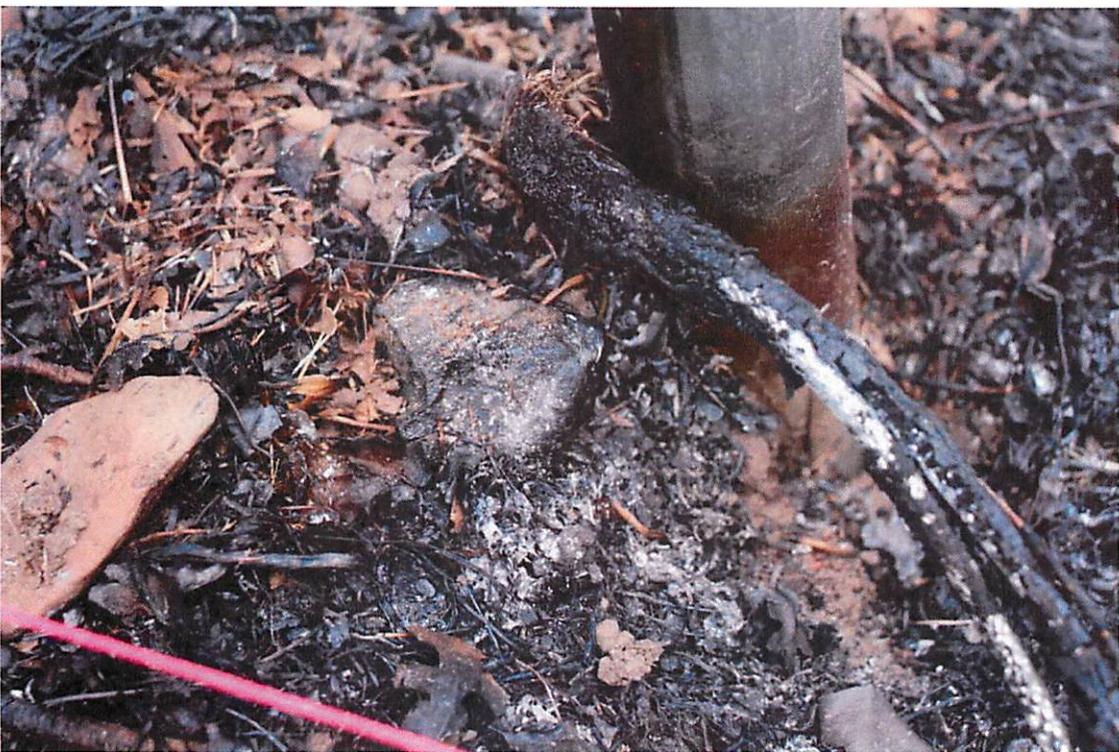
IMG_191 - Burnt vegetation with the first grid, indicating low intensity burning with unburnt vegetation present under the ash.

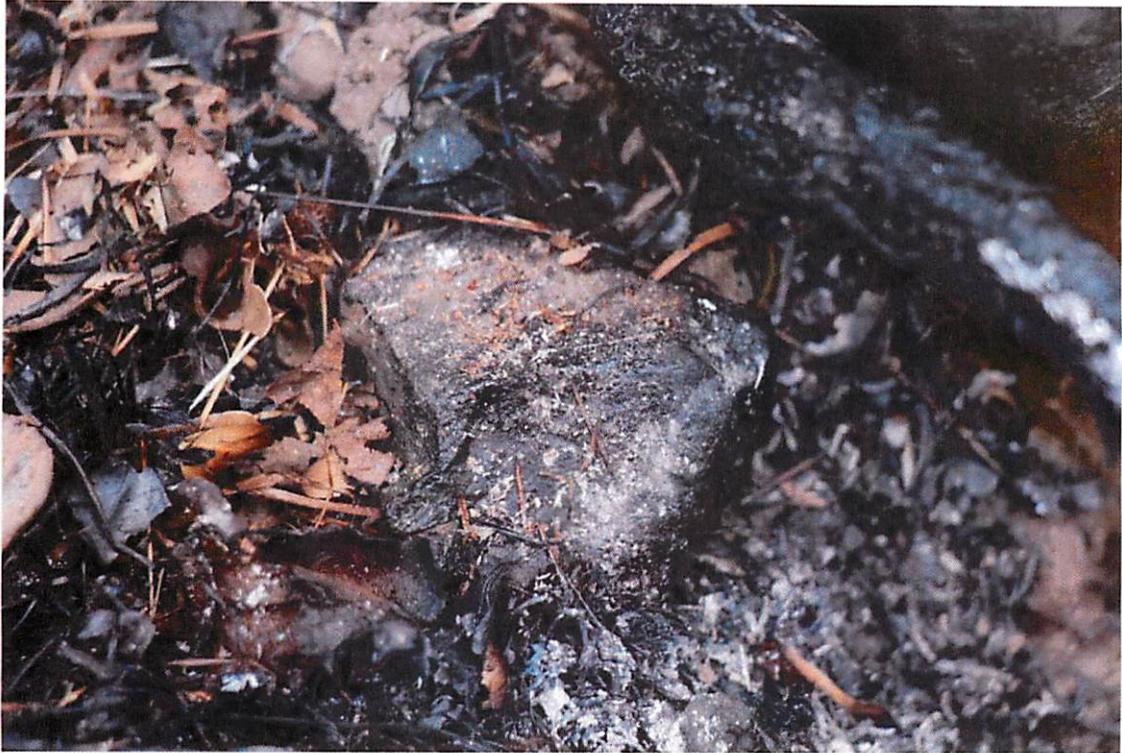
IMG_192 - Burnt coaxial cable within first grid with staining and sooting on rock and base of metal pipe.

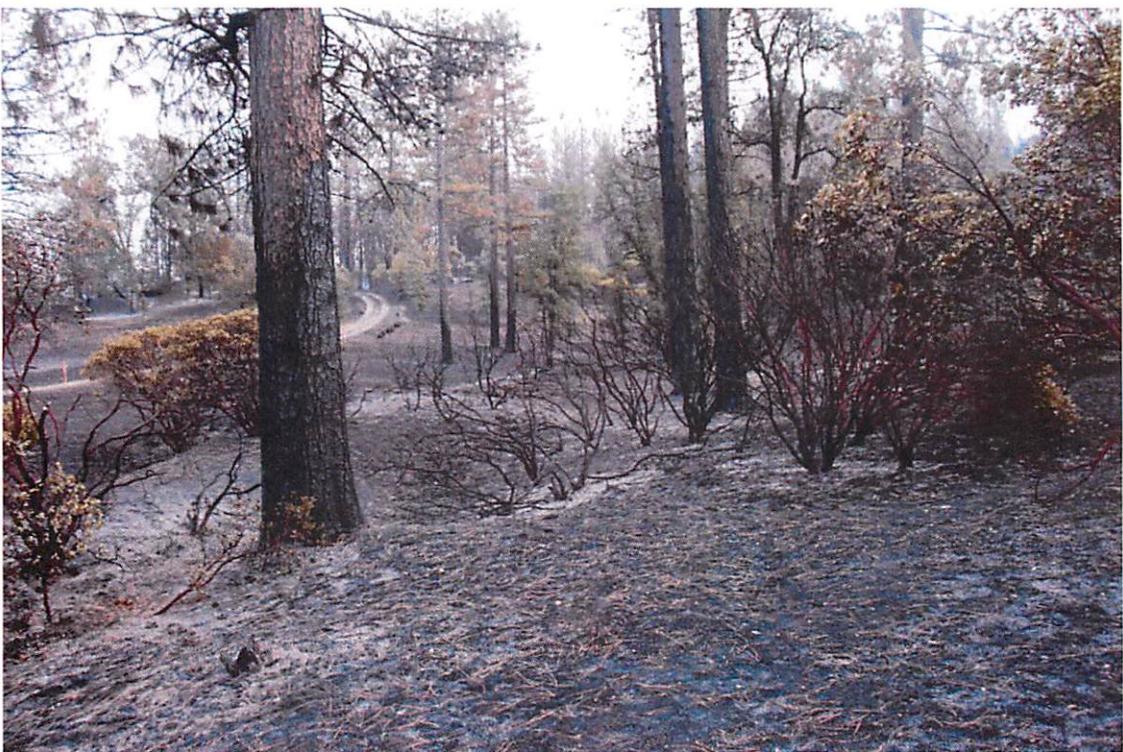
IMG_197 - Unburned vegetation, under ash indicating low intensity burning within second grid.
