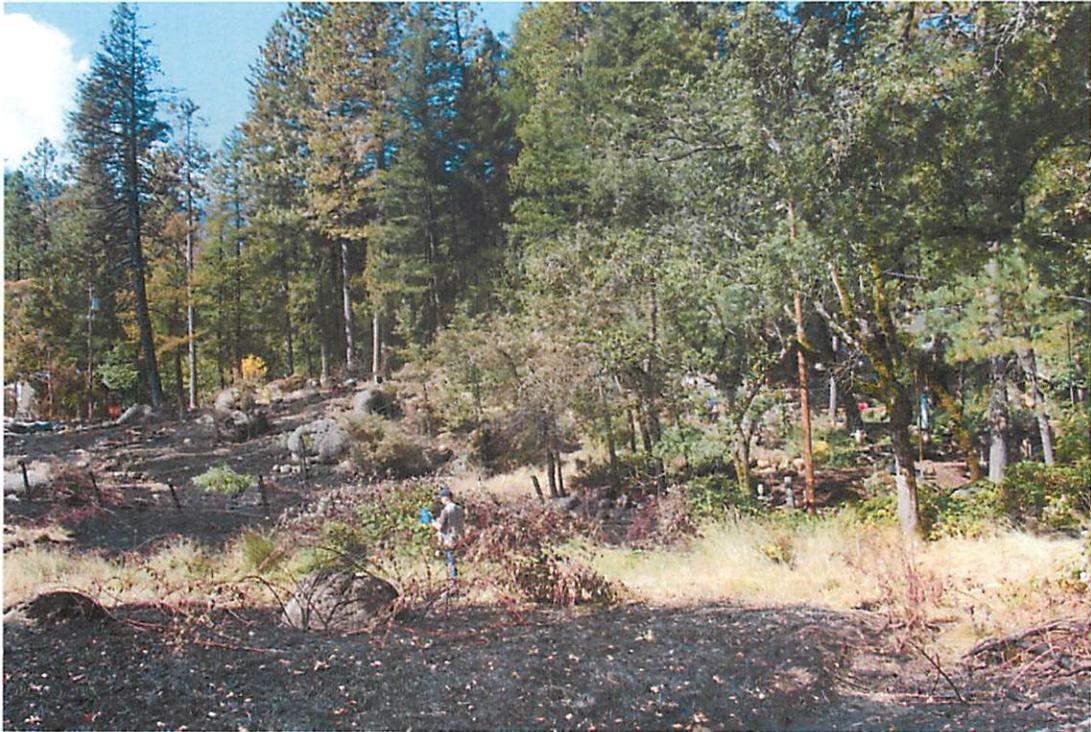
IMG\_0001 - Heel of fire, looking westerly.

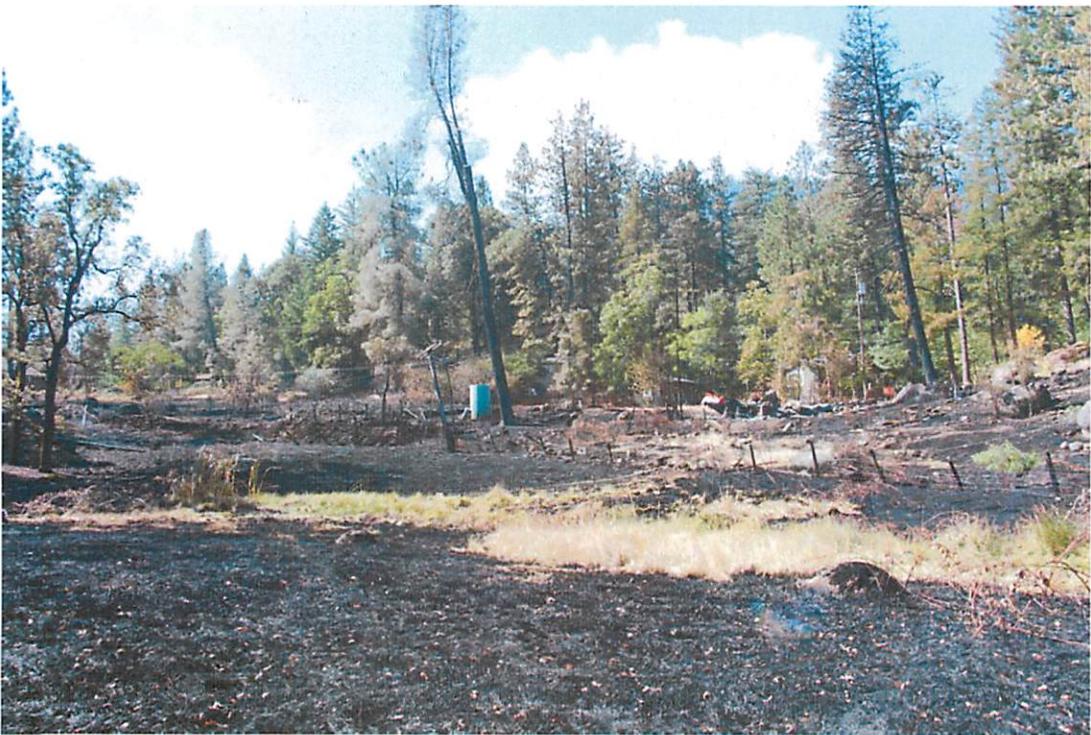
IMG\_0002 - Heel of fire, looking southwesterly.

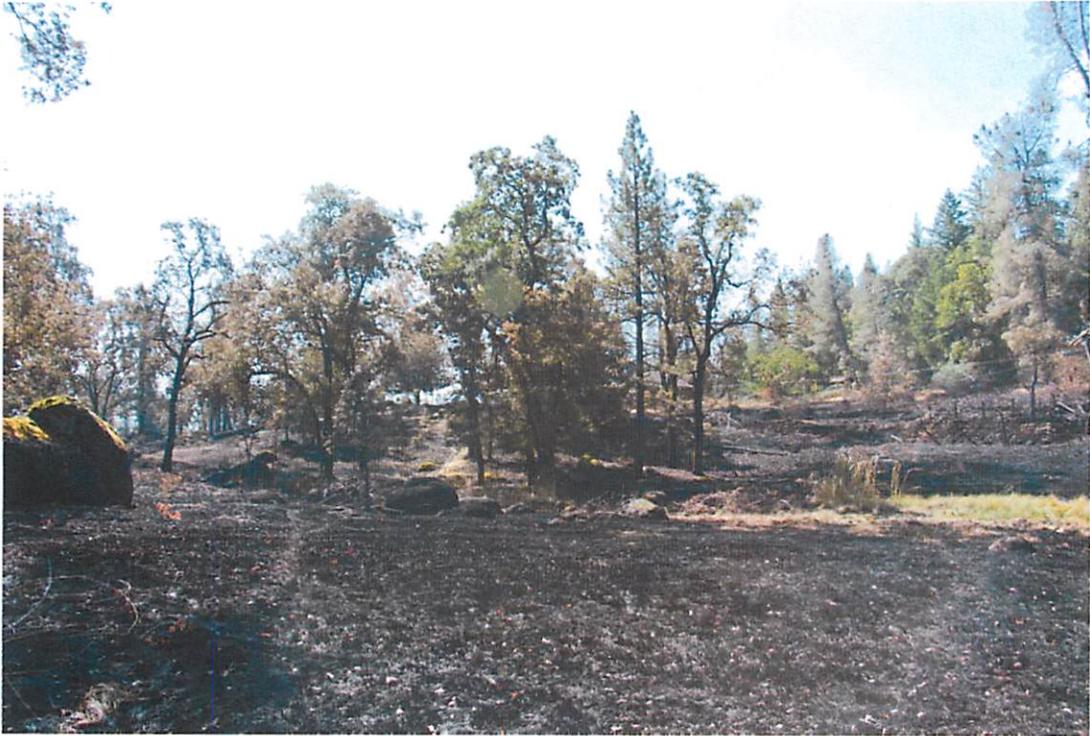
IMG\_0003 - Heel of fire, looking southerly.

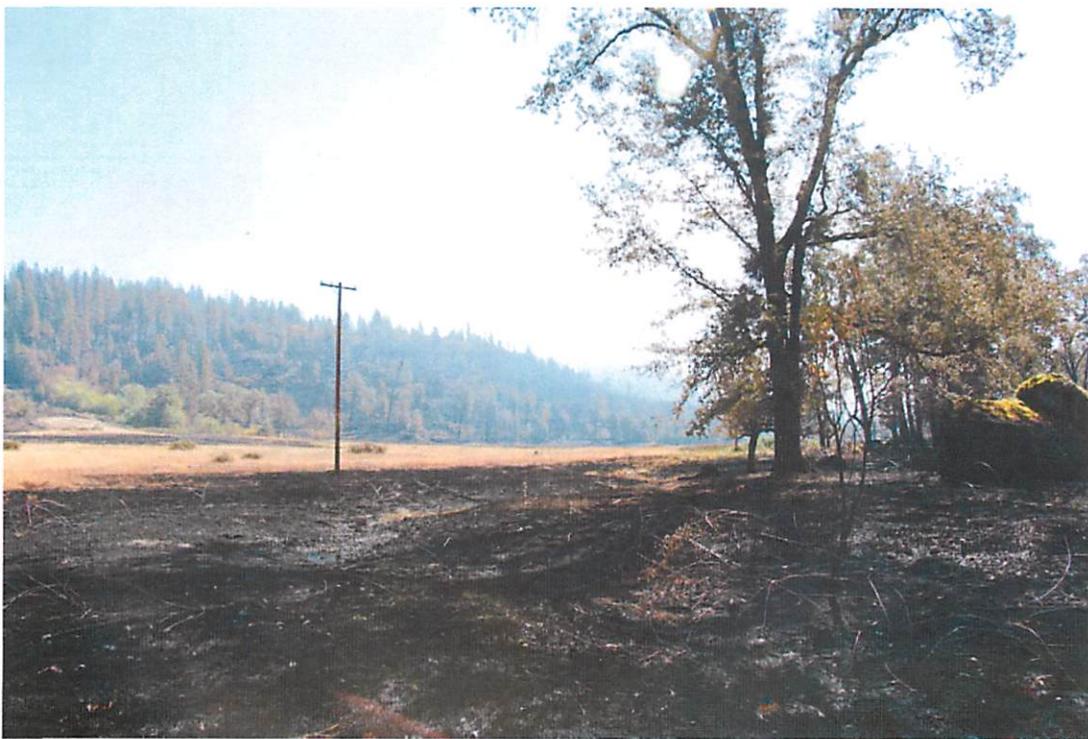
IMG\_0004 - Heel of fire, looking southeasterly.

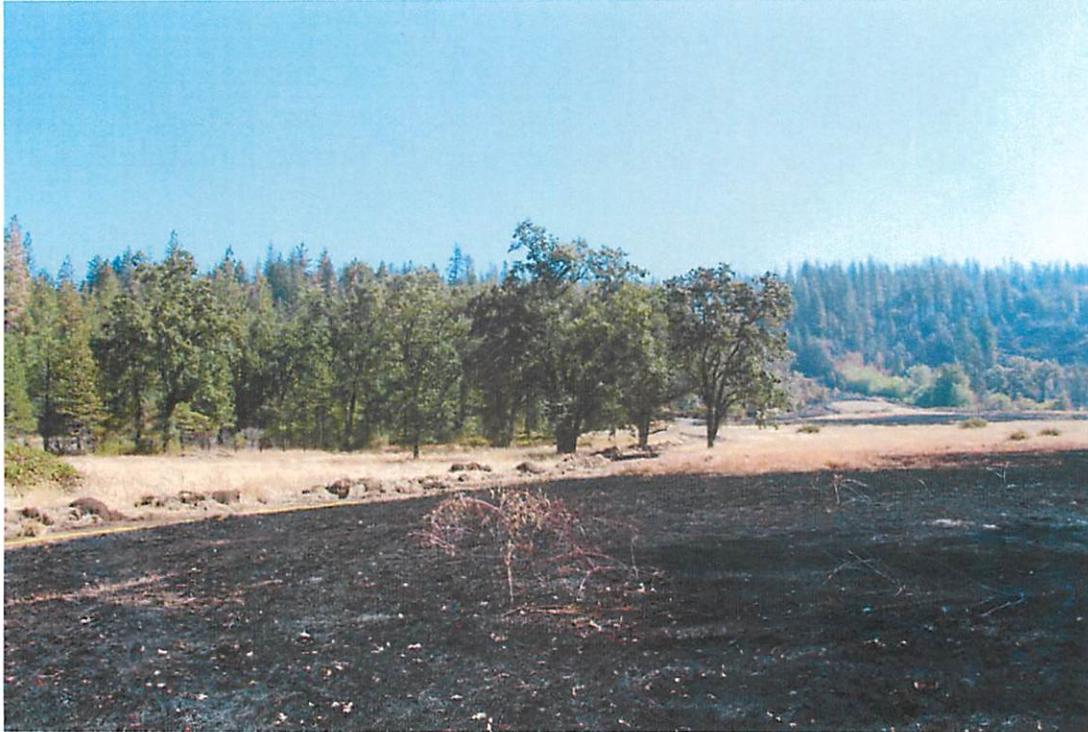
IMG\_0005 - Heel of fire, looking easterly.

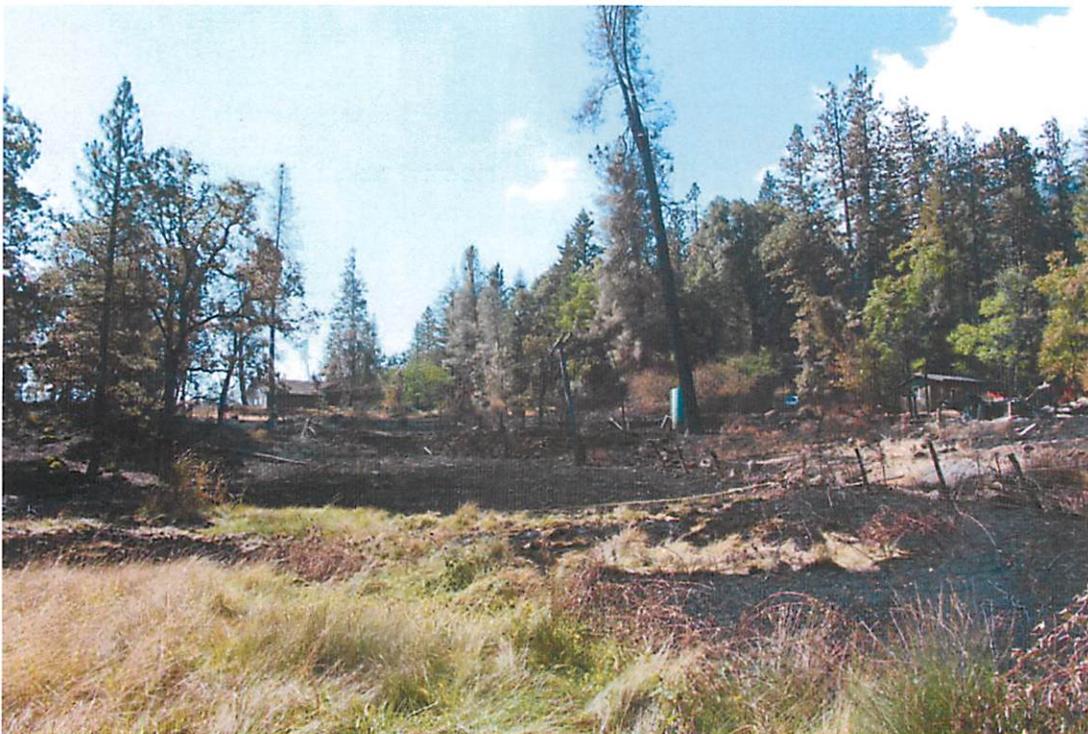
IMG\_0006 - Taken from creek, near heel of fire, looking southwesterly.

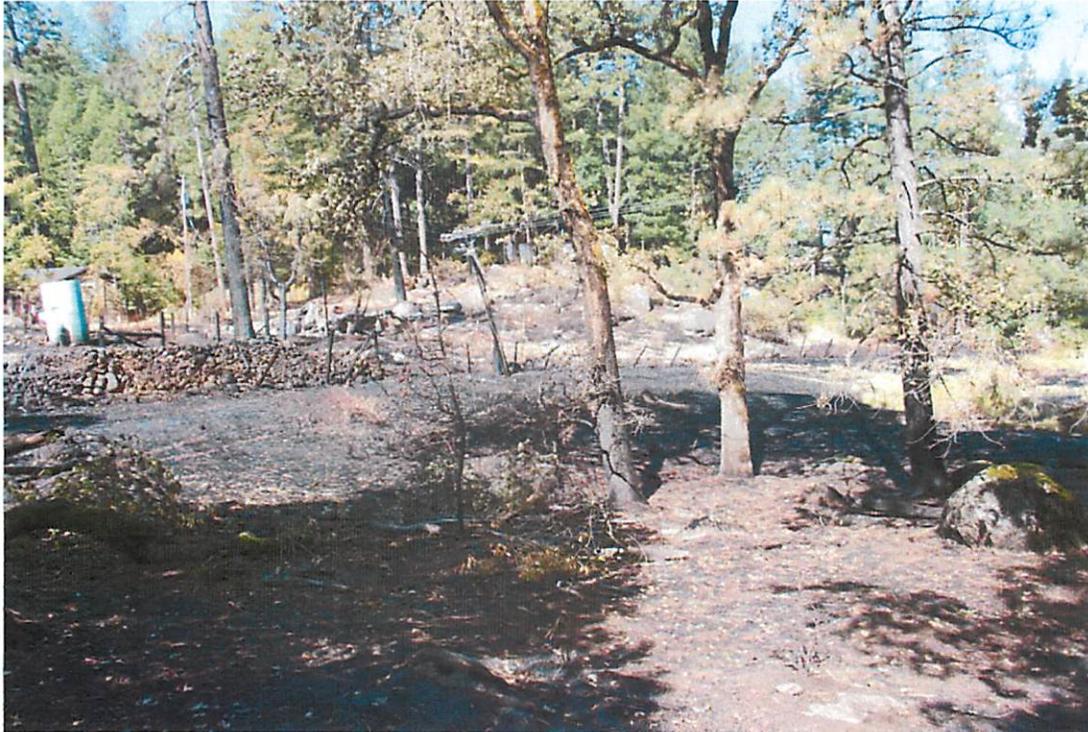
IMG\_0007 - Taken from creek/hose line, looking southwesterly at burnt power pole in center of picture and blue water tank on left side.

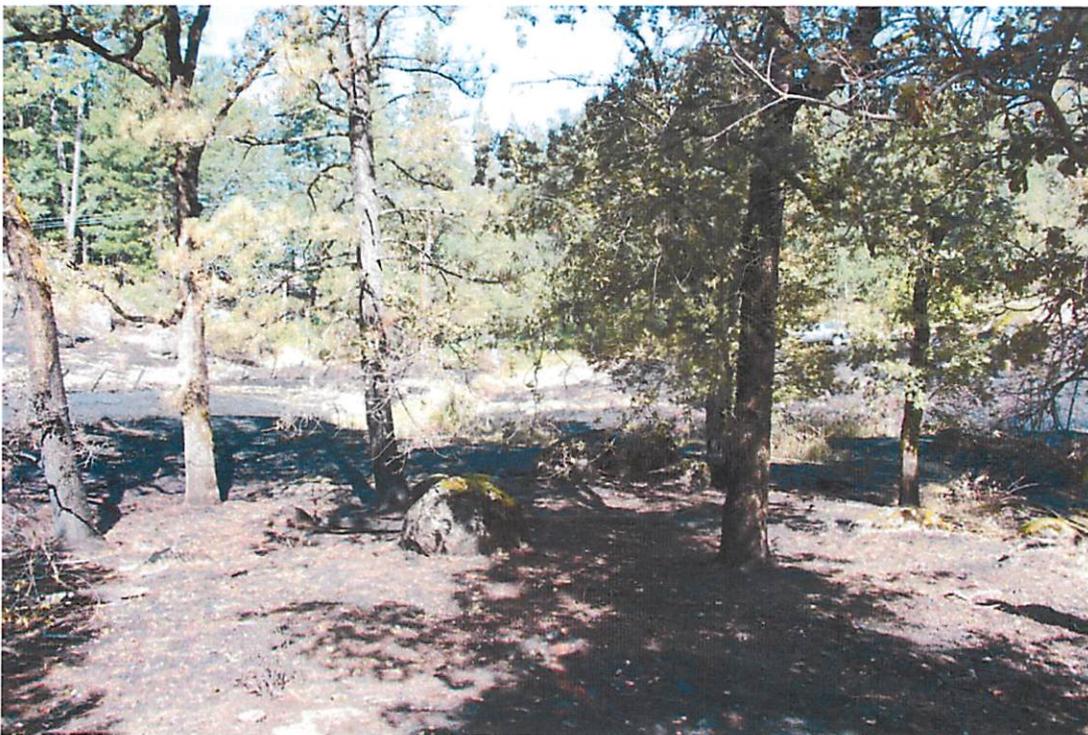
IMG\_0008 - Taken from creek/hose line, looking northwesterly toward heel of the fire.

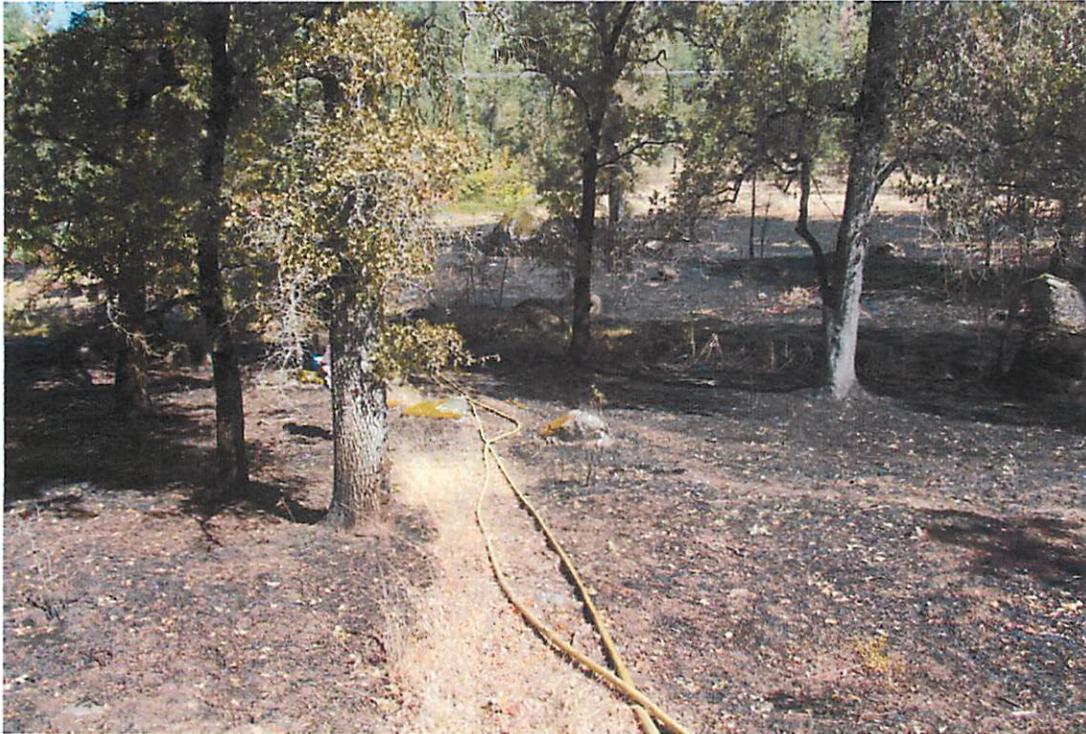
IMG\_0009 - Taken from hose line, which would have been the east flank of the fire at the time of the suppression action, looking northwesterly.

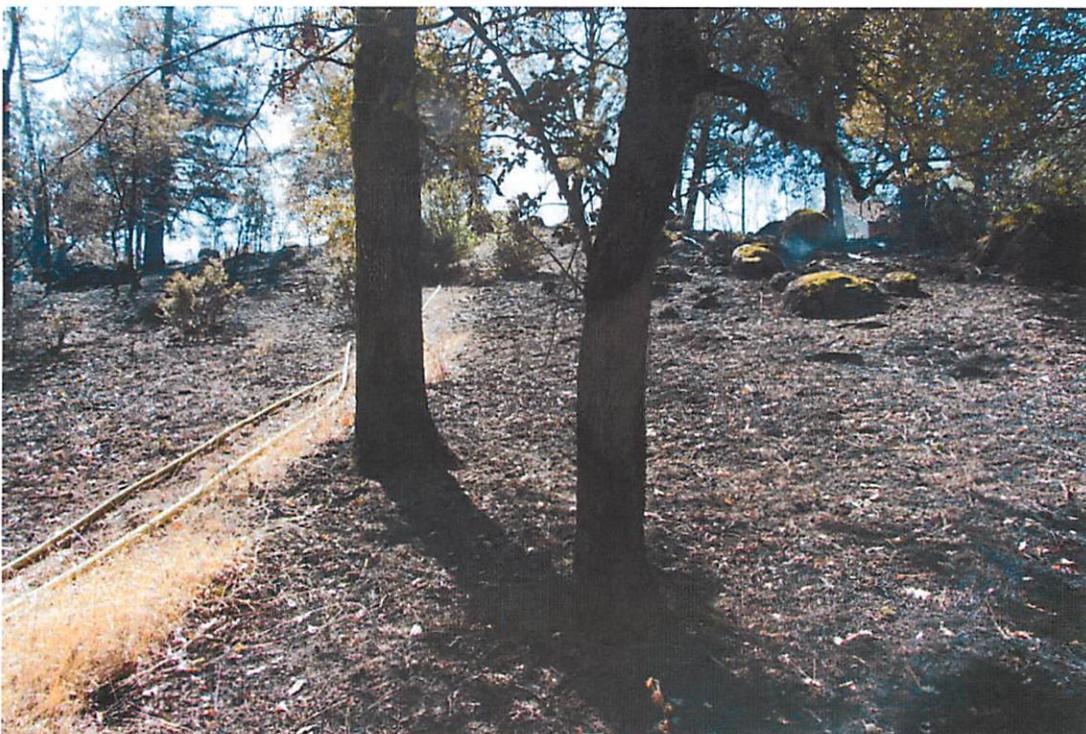
IMG\_0010- Taken from hose line, which would have been the east flank of the fire at the time of the suppression action, looking southeasterly.

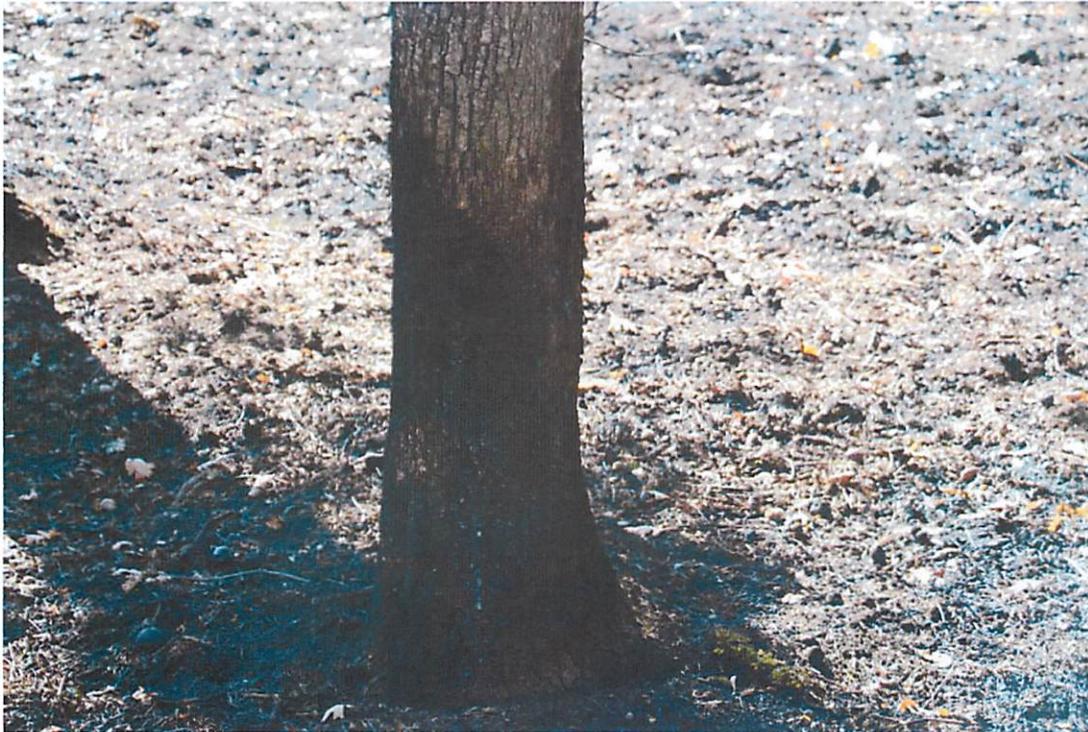
IMG\_0011- Angle of char indicator showing advancing fire from right to left.

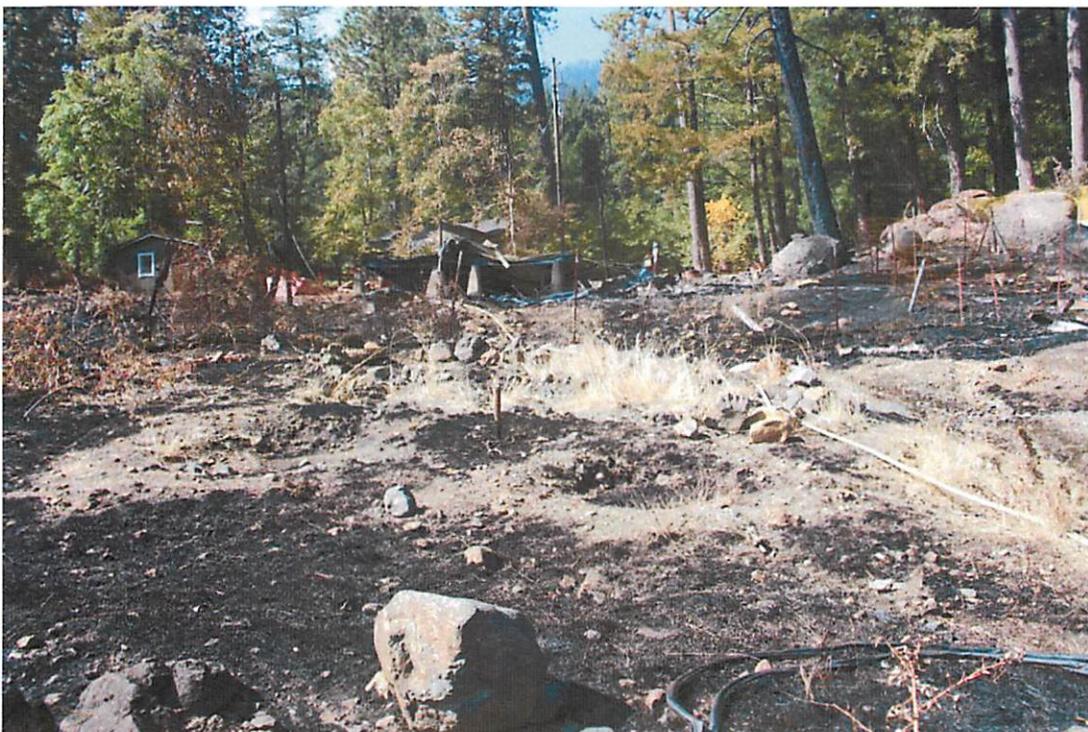
IMG\_0012- Taken from near creek/hose line, toward destroyed residence, looking southwesterly. Shows what was likely the heel of the fire when suppression action taken.

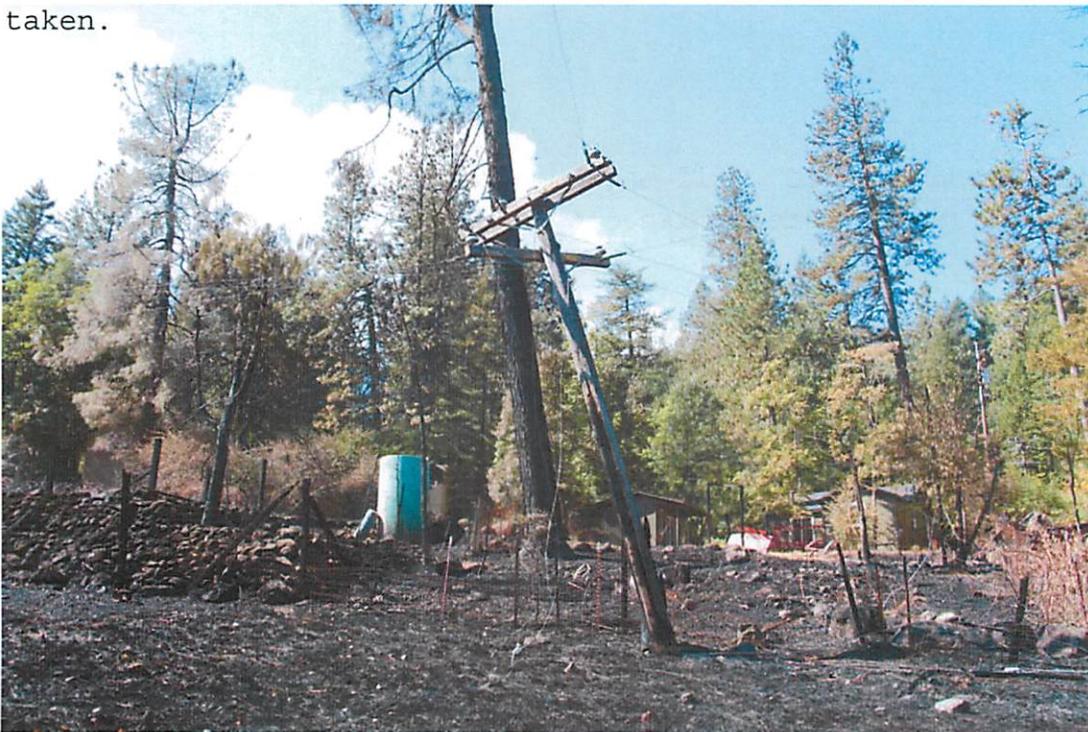
IMG\_0014- Taken from near creek/hose line, looking southwesterly at water tank and burnt through, 3 crossarm, corner, power pole.

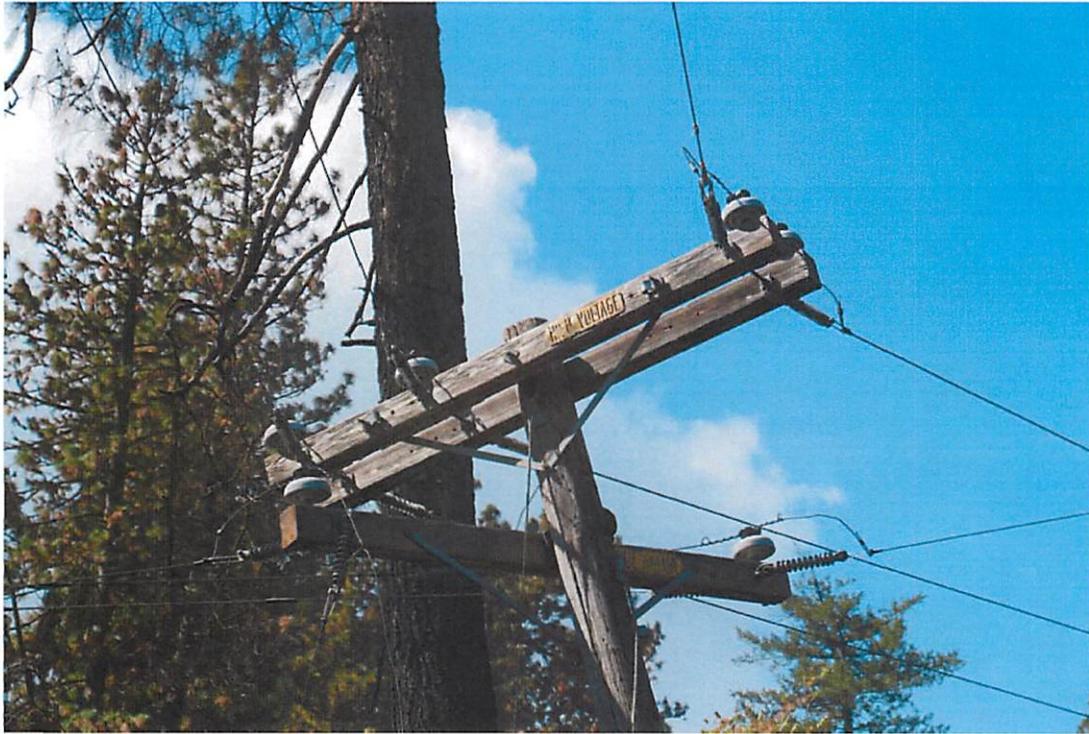
IMG\_0015- Close-up of corssarms on burnt through corner power pole.

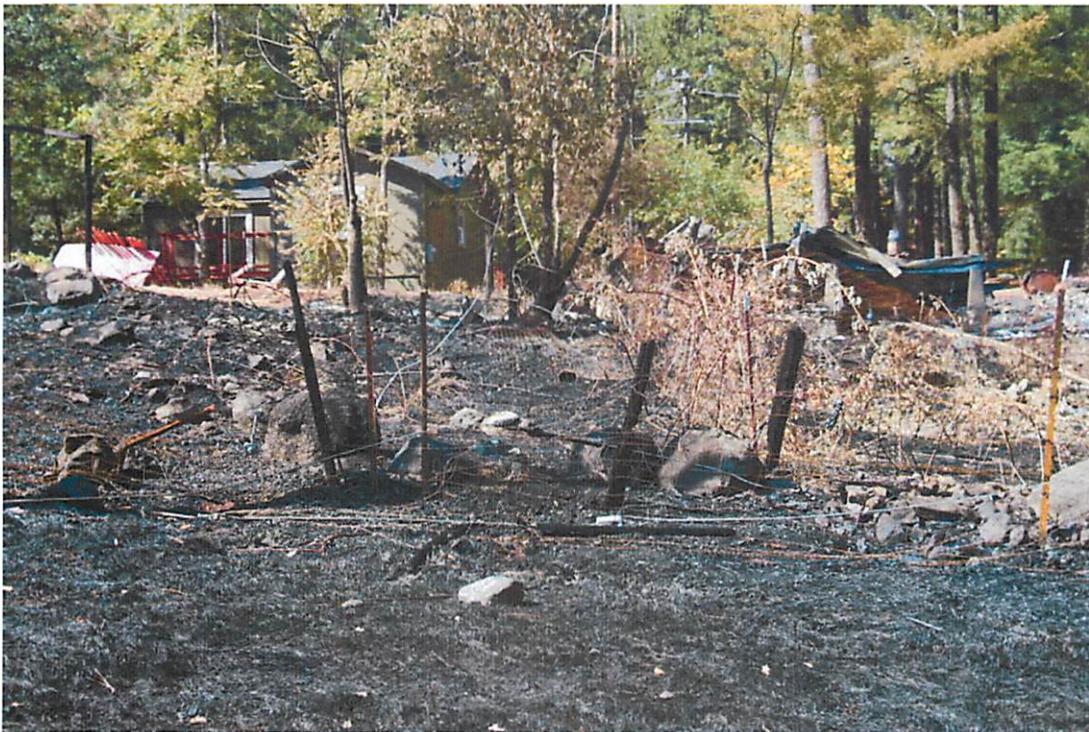
IMG\_0016- Looking westerly toward the destroyed residence.

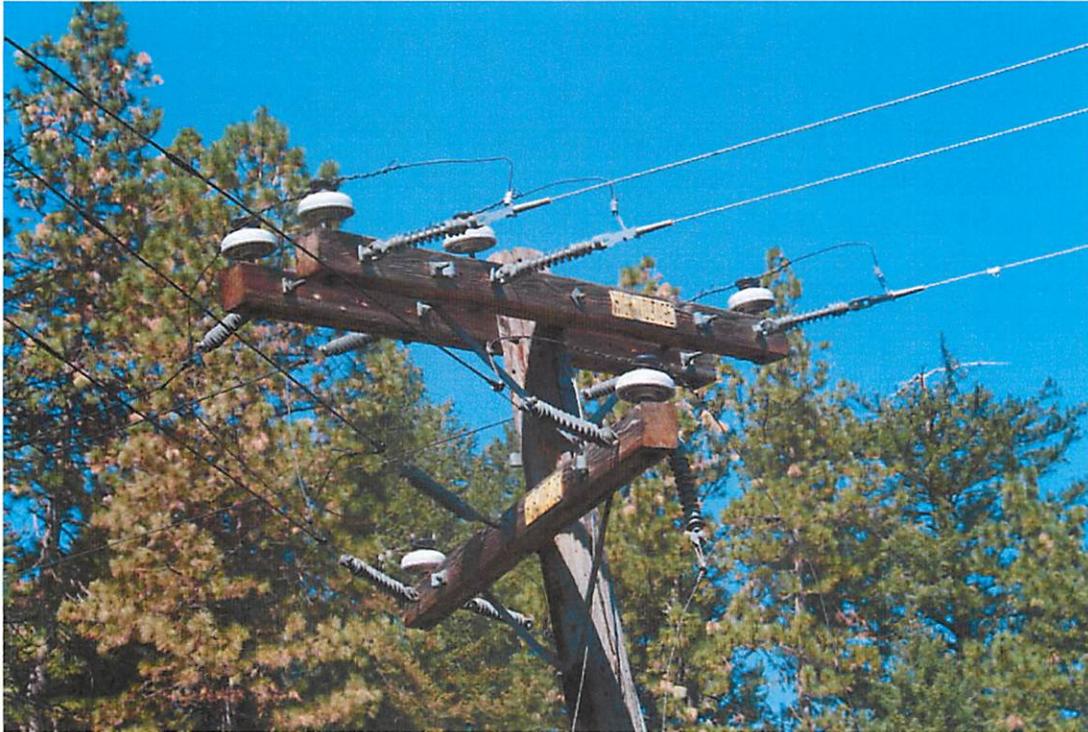
IMG\_0017- Close-up of corssarms on burnt through corner power pole.

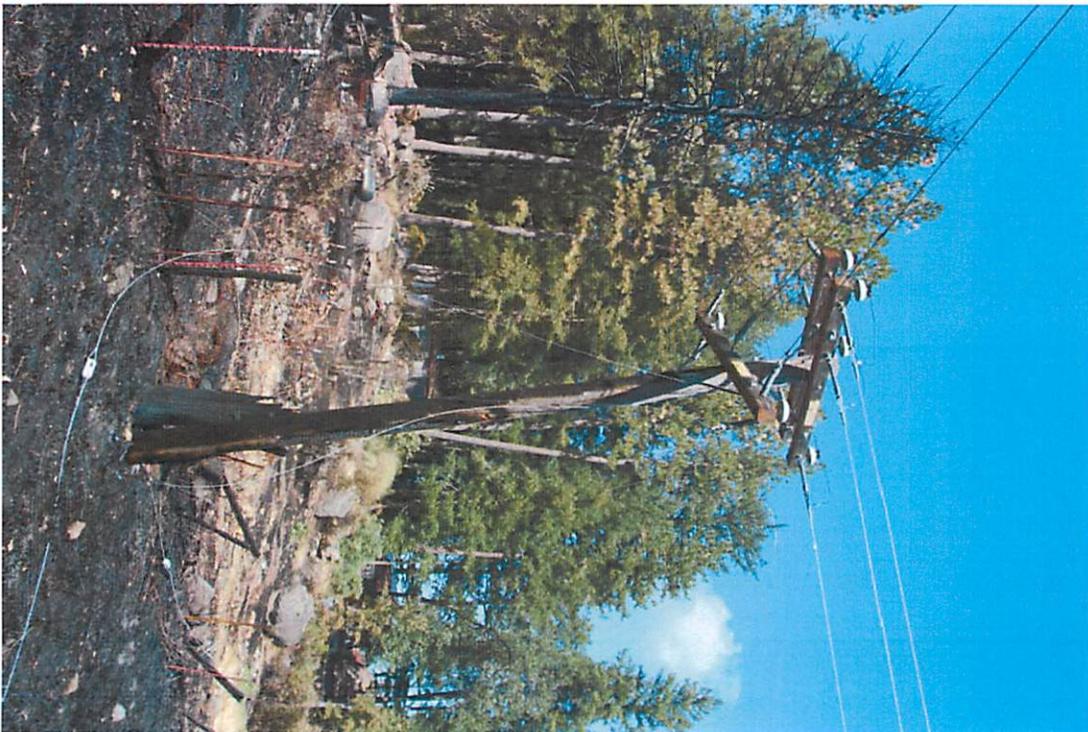
IMG\_0018- Burnt through corner power pole.

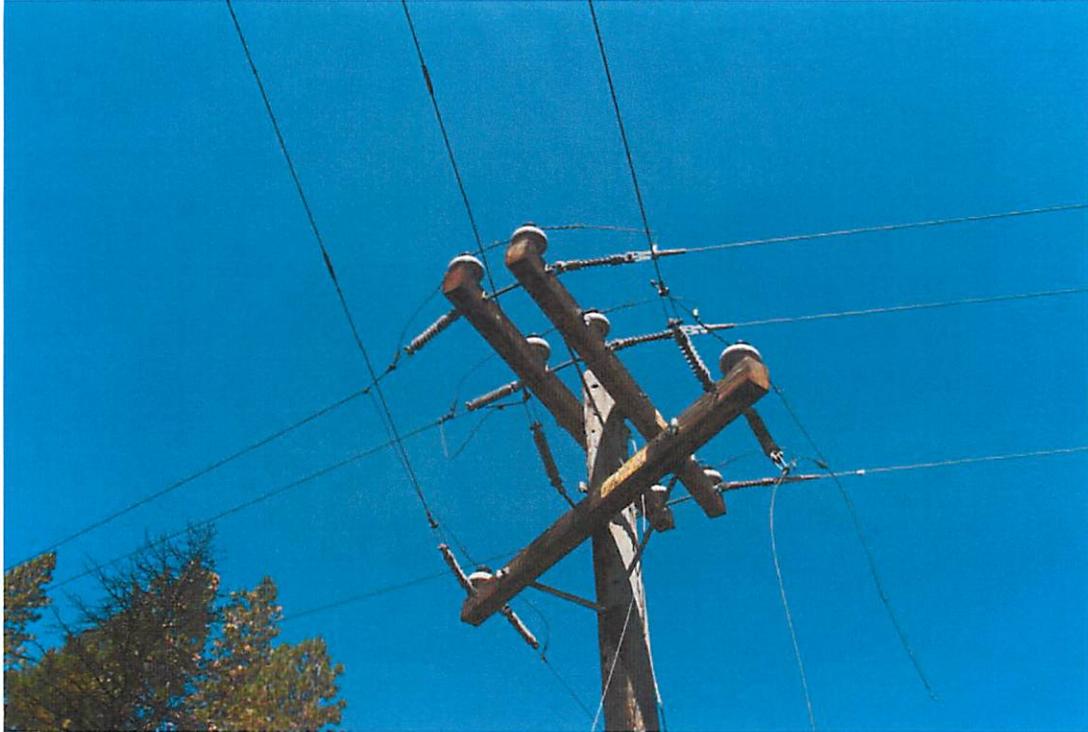
IMG\_0019- Close-up of crossarms on burnt through corner power pole.

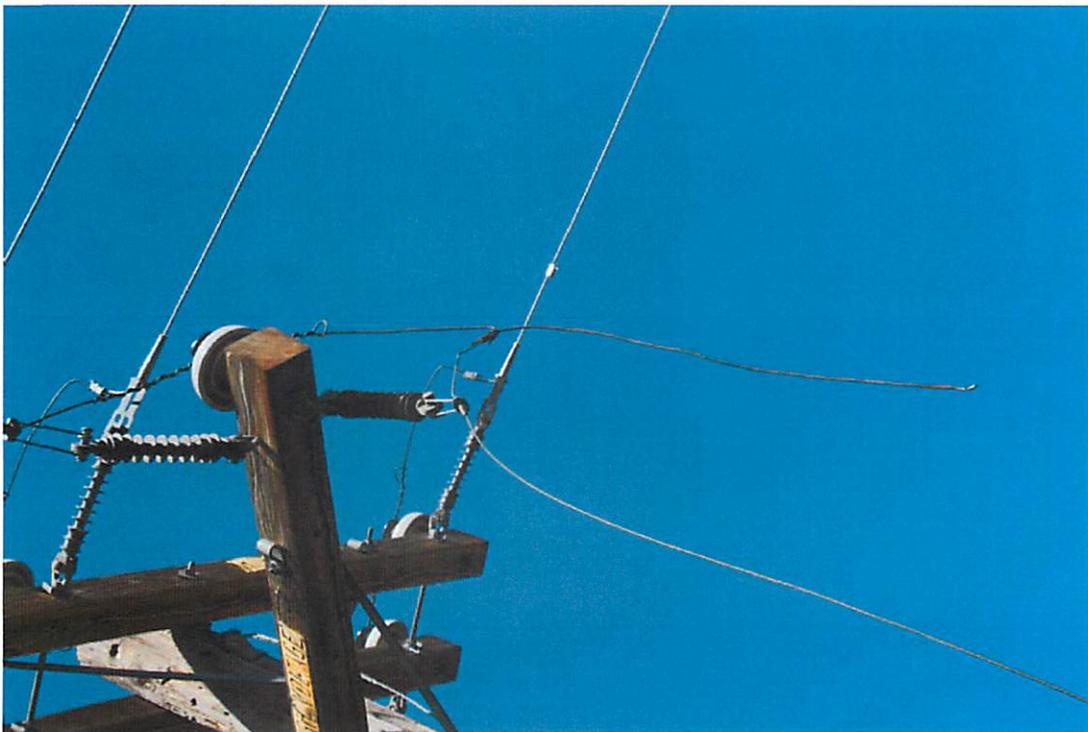
IMG\_0020- Close-up of conductors, deadends, jumpers, connectors, and insulators, on crossarms of the burnt through corner power pole.

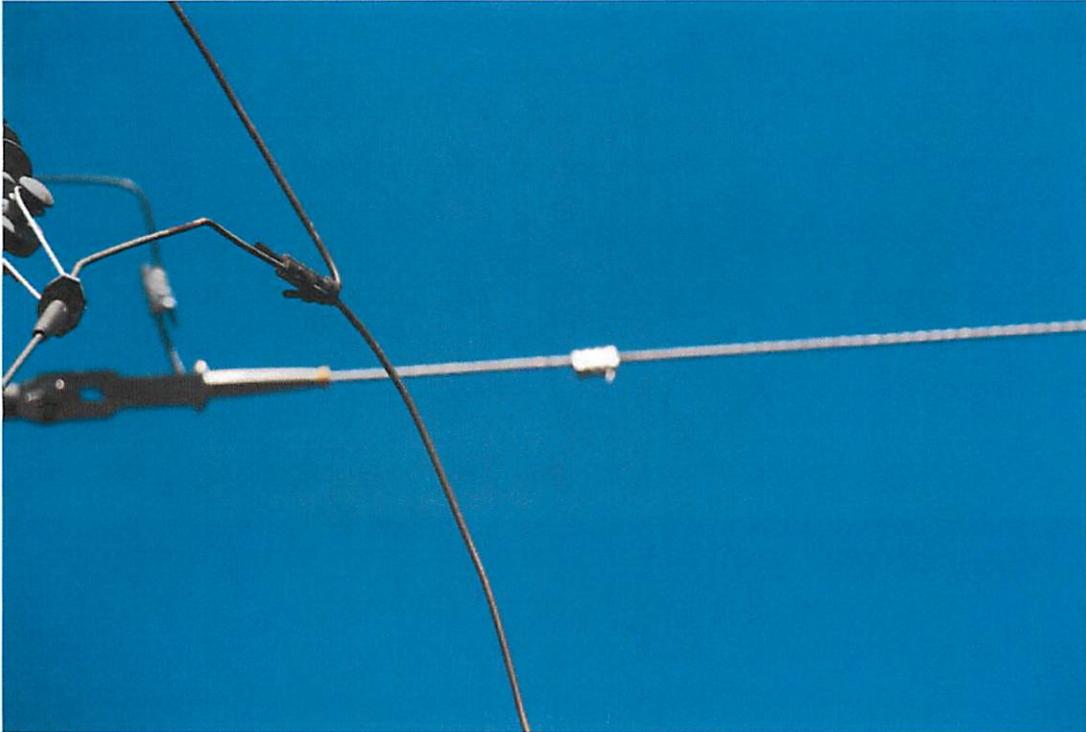
IMG\_0021- Close-up of conductor, deadend, jumpers, and connectors on crossarm of the burnt through corner power pole.

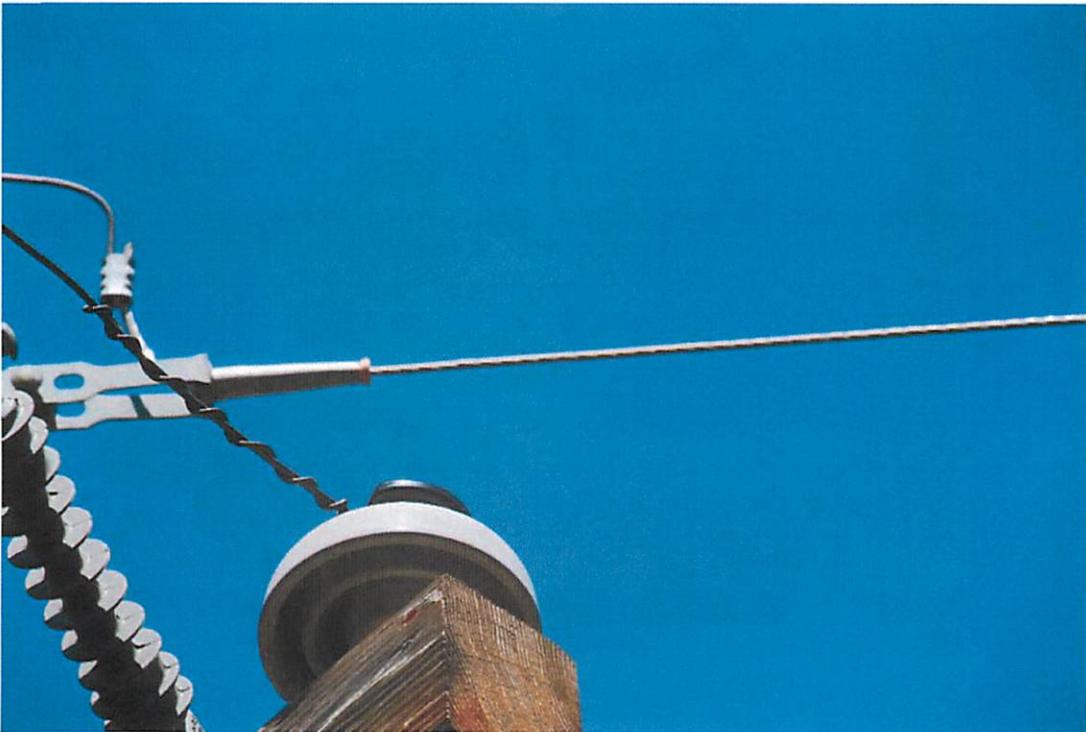
IMG\_0022- Close-up of conductor, deadend, jumper, connector and insulator on crossarm of the burnt through corner power pole.

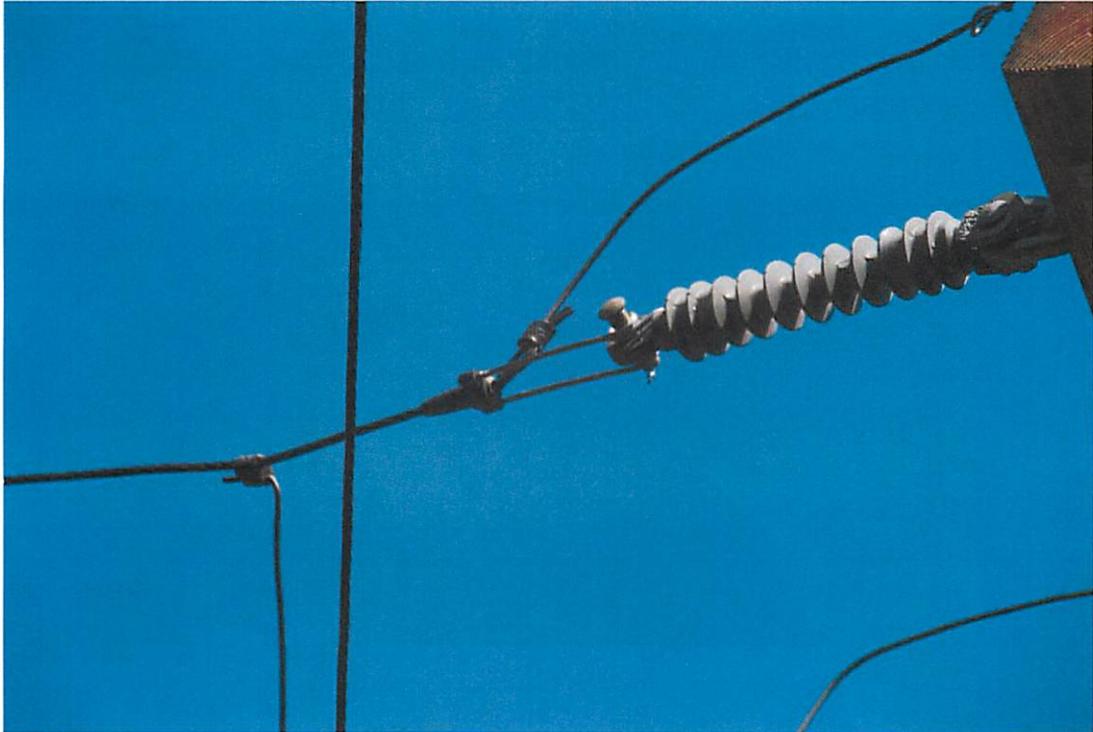
IMG\_0023- Close-up of conductor, deadend, jumper, connector and insulator on crossarm of the burnt through corner power pole.

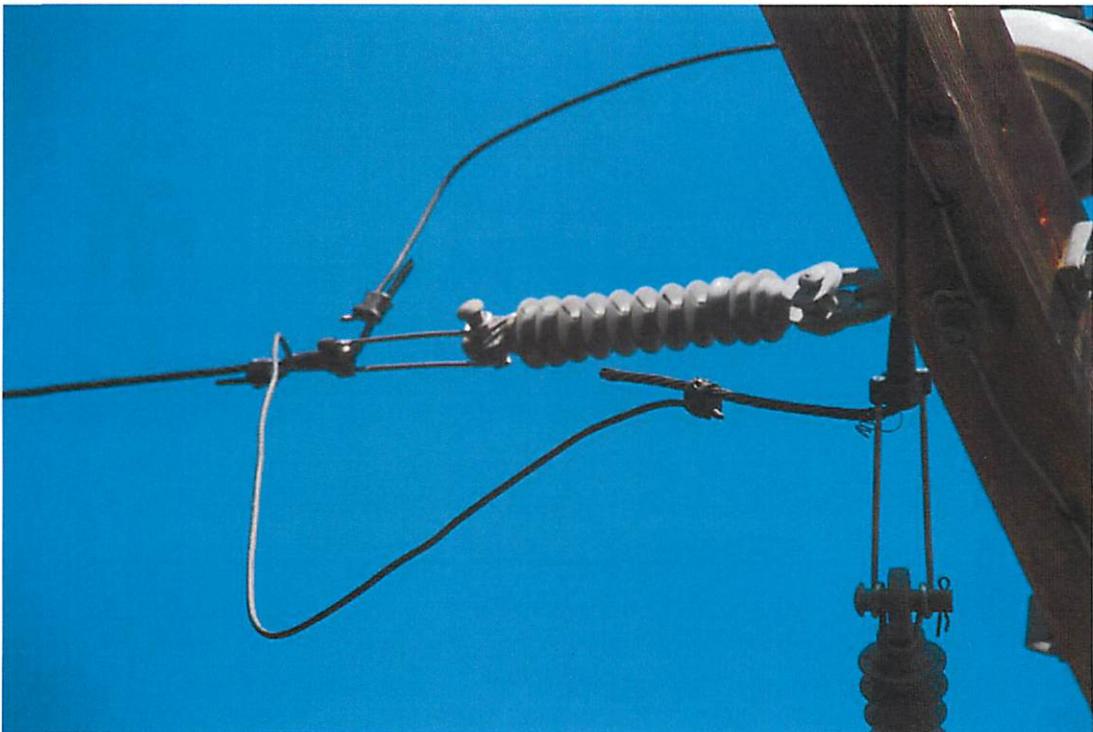
IMG\_0024- Close-up of conductor, deadend, jumper, connector and insulator on crossarm of the burnt through corner power pole.

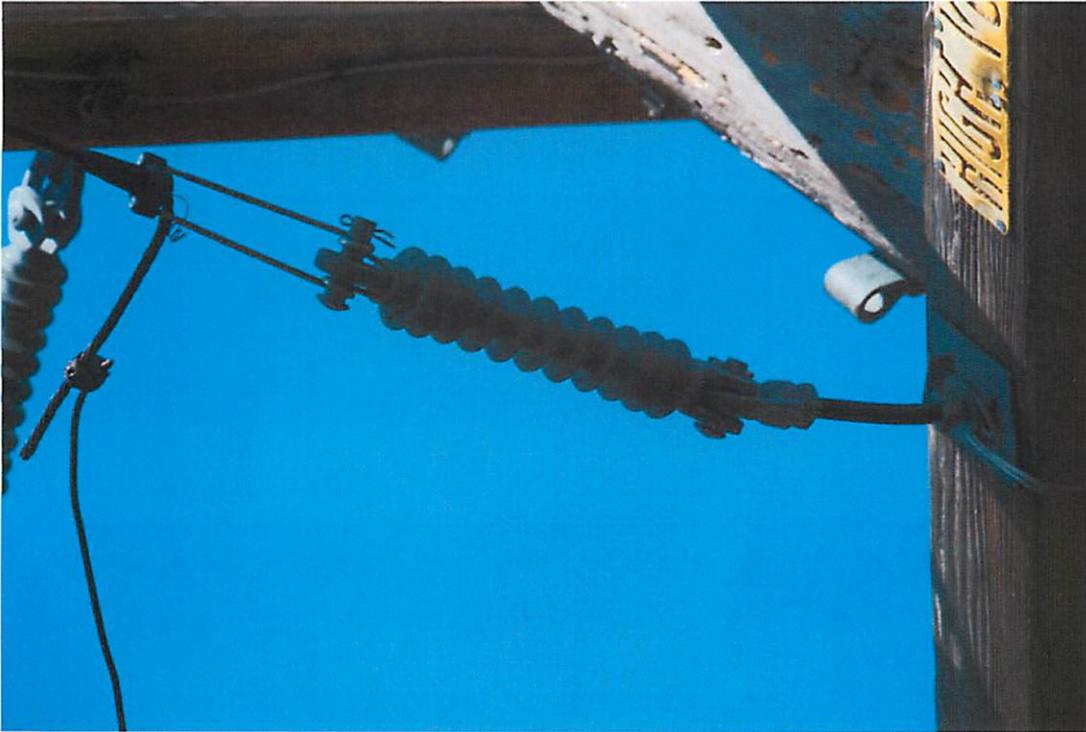
IMG\_0025- Close-up of deadend, jumper, connector and insulator on crossarm of the burnt through corner power pole.

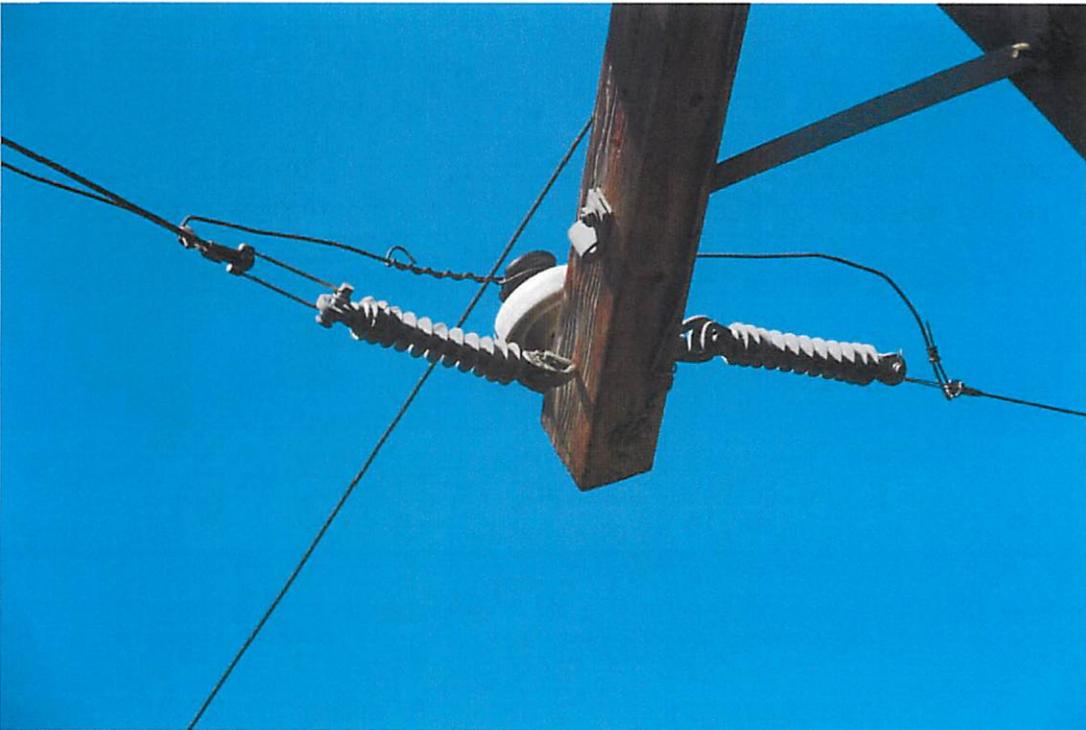
IMG\_0026- Close-up of conductors, deadends, jumpers, connectors, and insulators, on crossarms of the burnt through corner power pole.

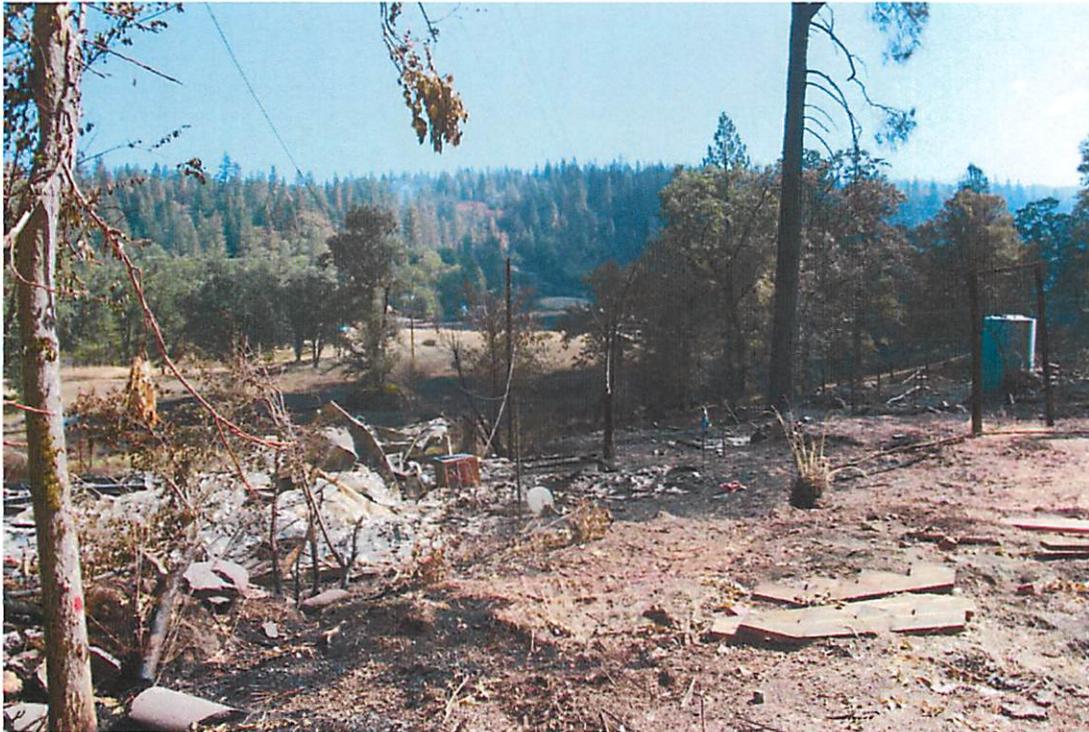
IMG\_0027- Taken from southwest of destroyed residence, looking southeasterly at burnt power pole in center of picture and blue water tank on right side.

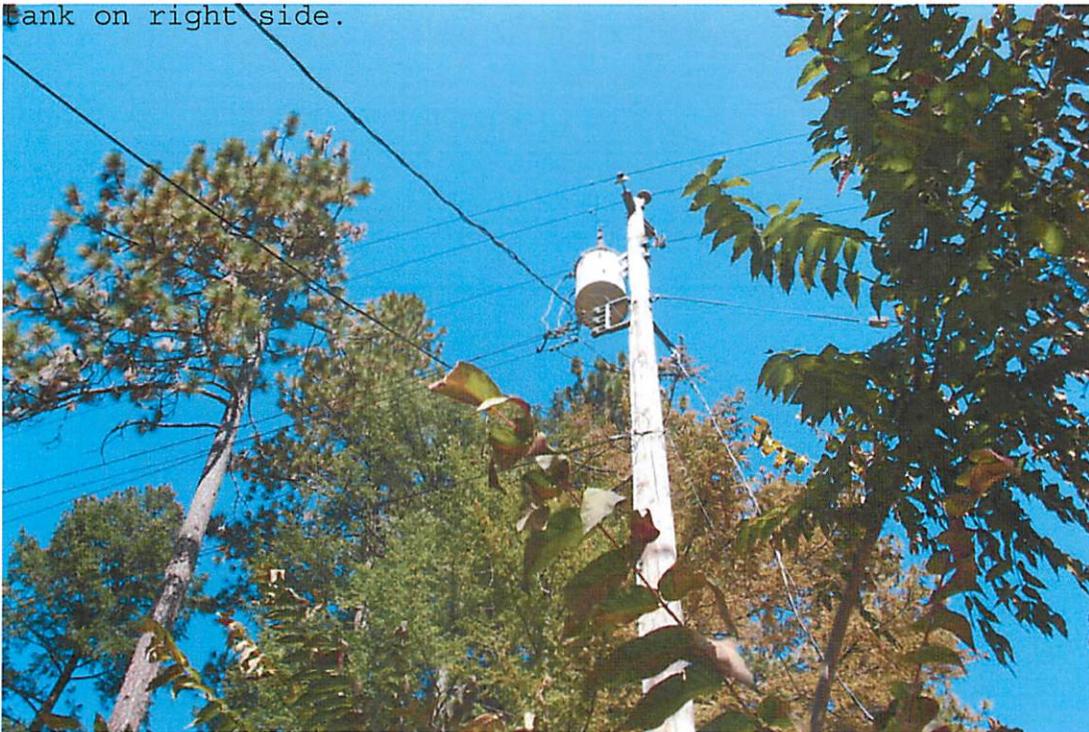
IMG\_0028- Power pole with transformer locate near southwest corner of the destroyed residence.

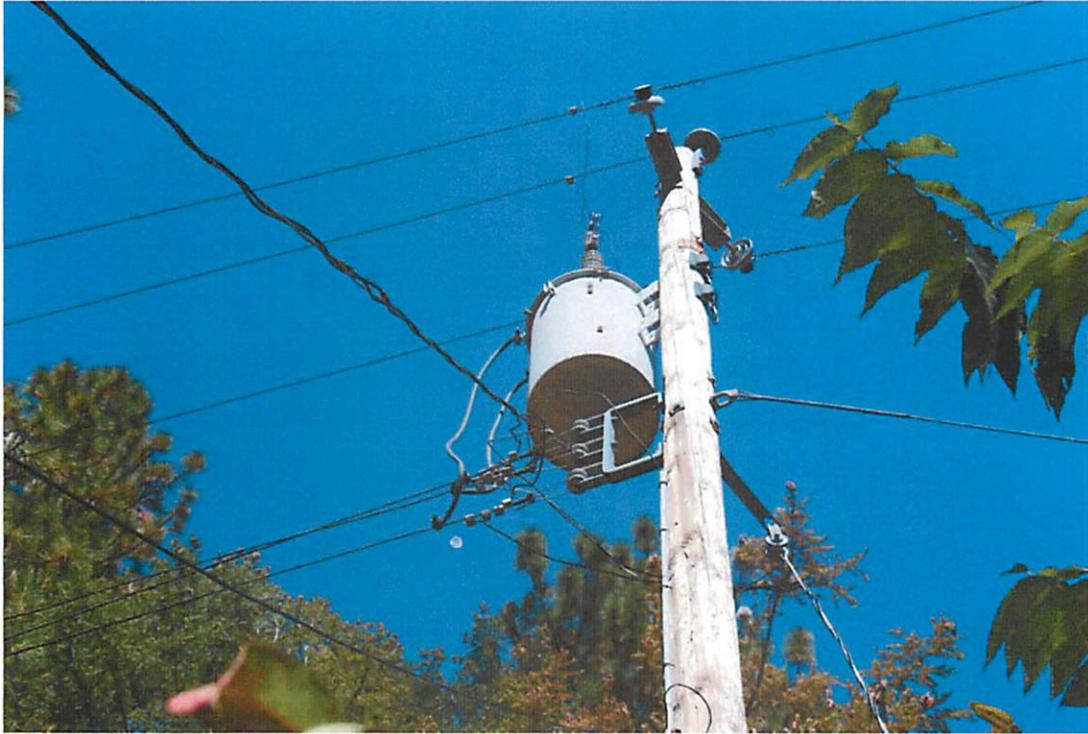
IMG\_0029- Transformer on power pole located near southwest corner of the destroyed residence.
