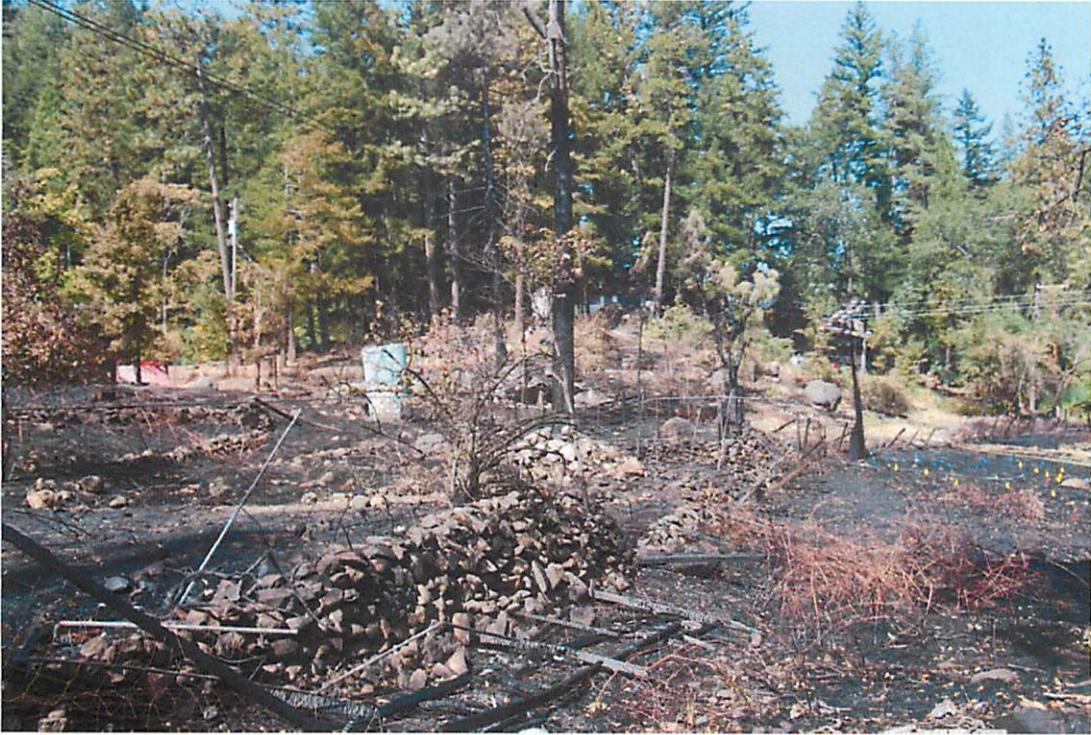
IMG\_0031- Taken near fence/rock wall, south of SOA, looking northerly at indicator flagging.

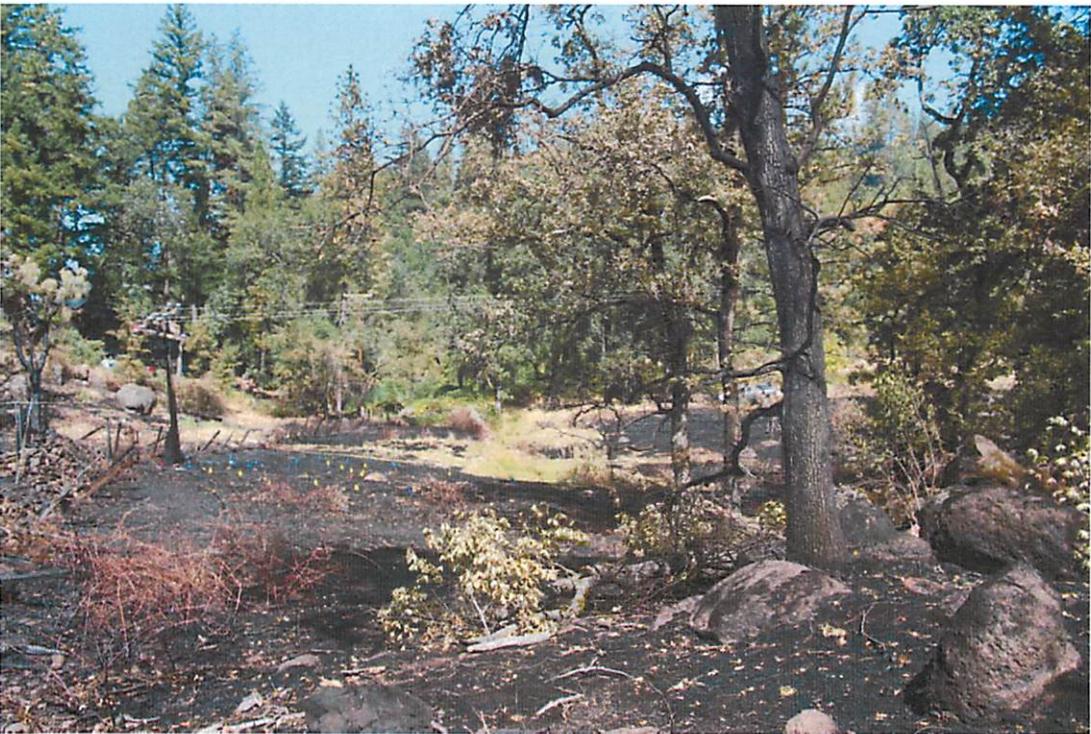
IMG\_0032- Taken south of SOA, looking northerly at indicator flagging.

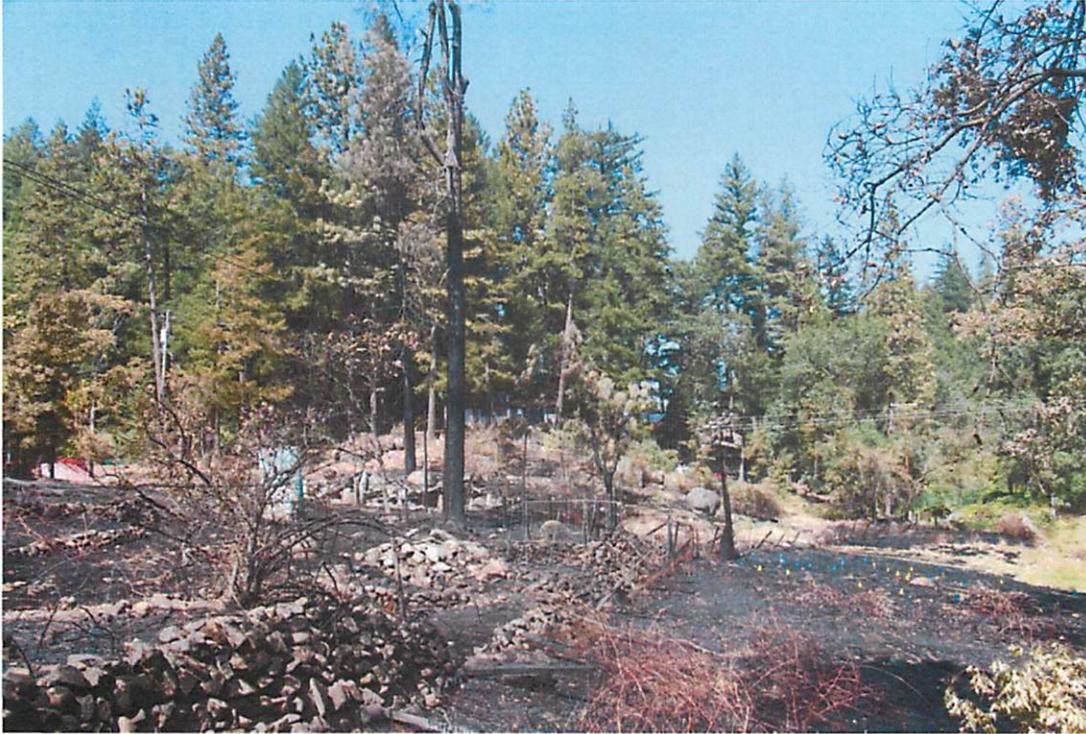
IMG\_0033- Taken near fence/rock wall, south of SOA, looking northerly at indicator flagging.

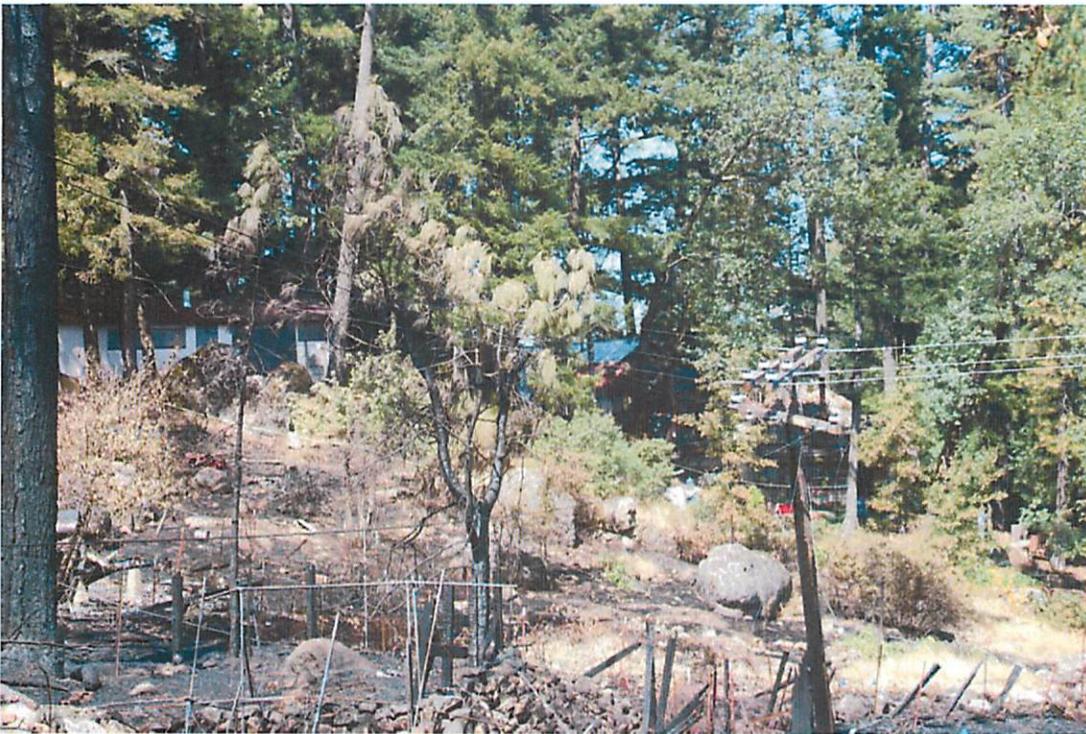
IMG\_0034- Taken near fence/rock wall, south of SOA, looking northerly at angle of char indicator on pine trees.

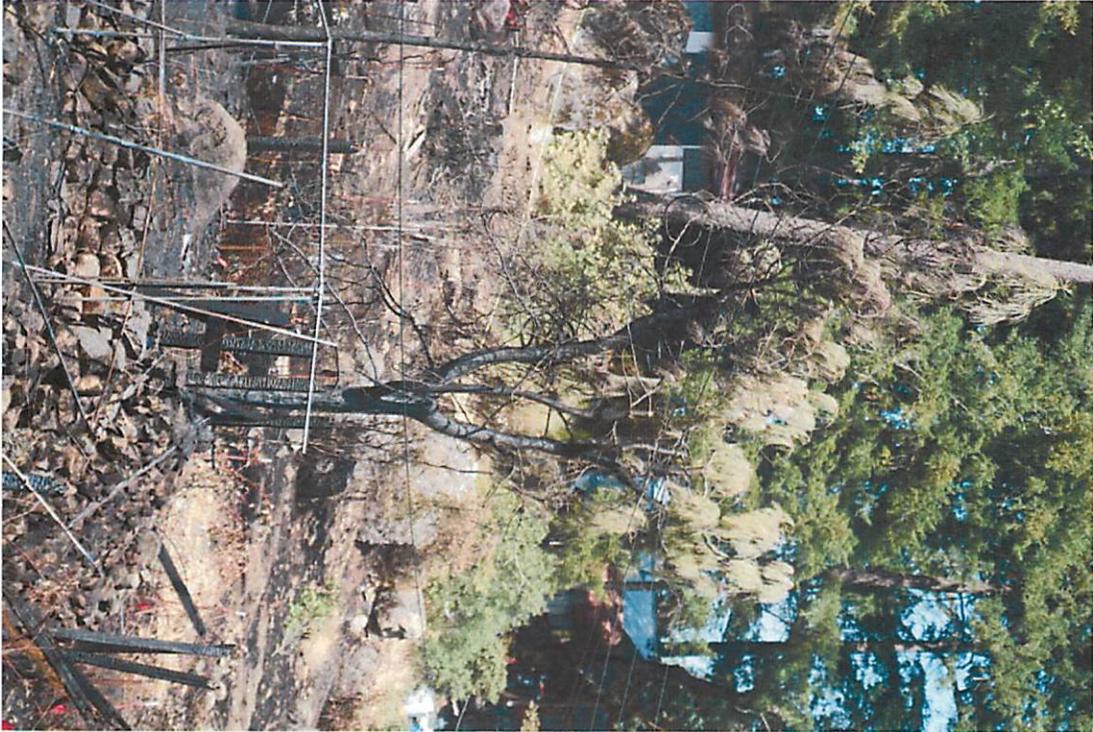
IMG\_0035- Close-up of angle of char indicator on pine tree.

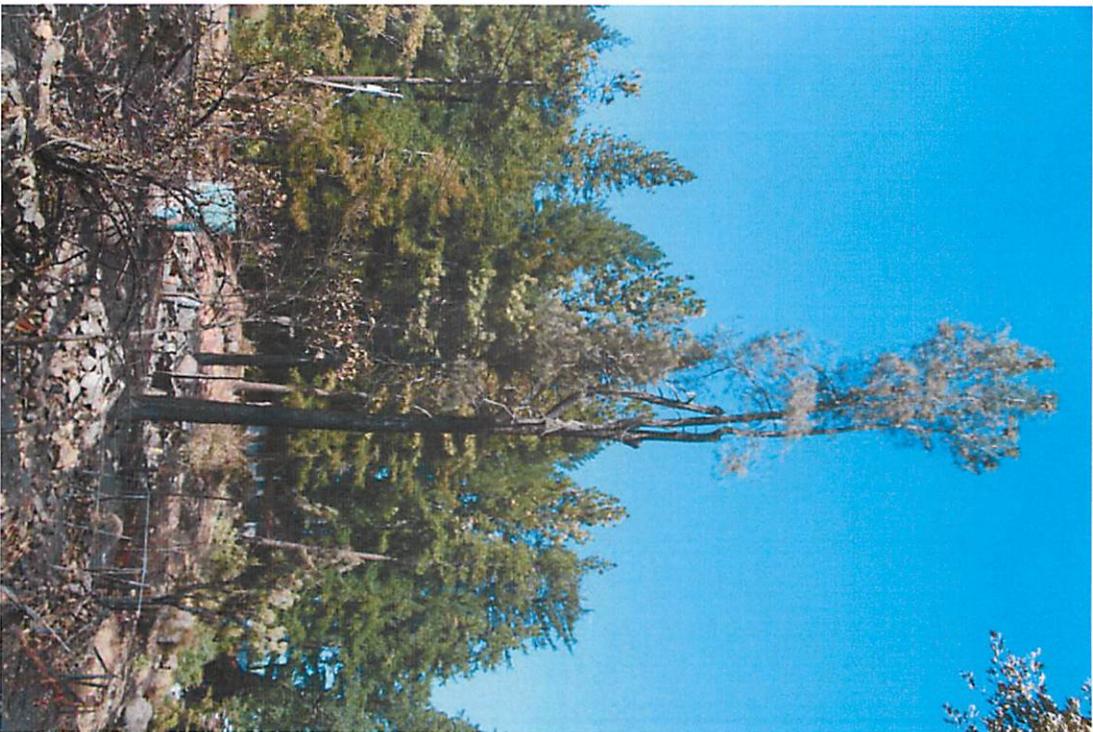
IMG\_0036- Taken south of SOA, looking westerly at angle of char indicator on pine tree and sooting/staining on water tank.

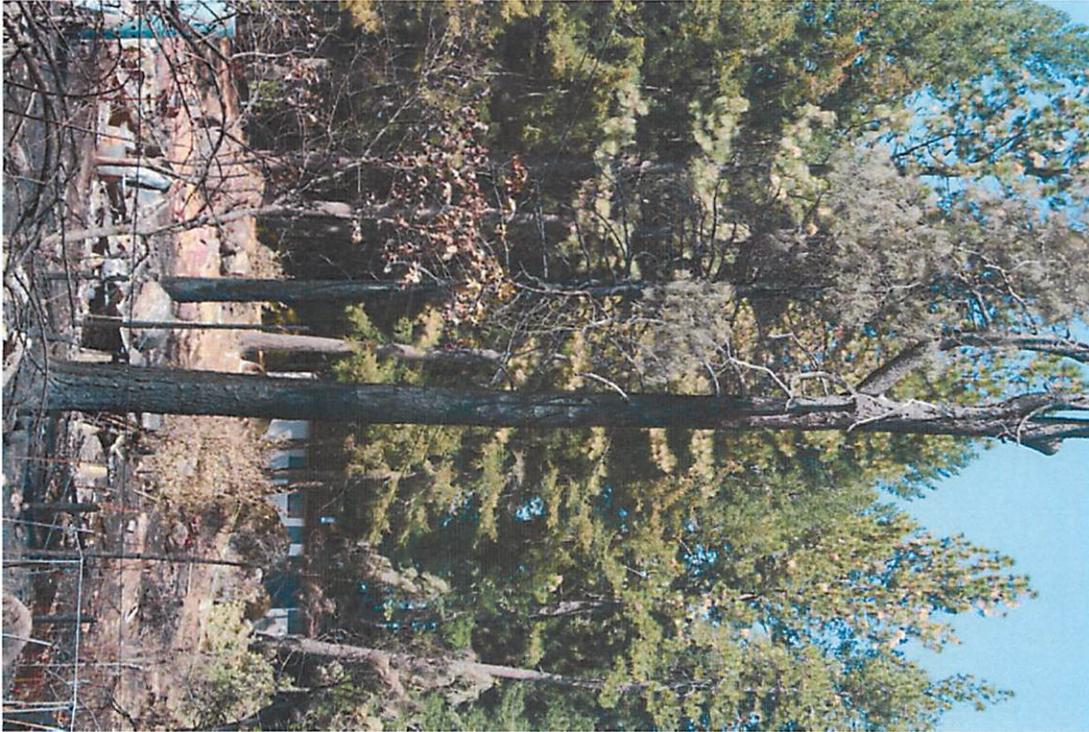
IMG\_0037- Taken south of SOA, looking westerly at angle of char indicators.

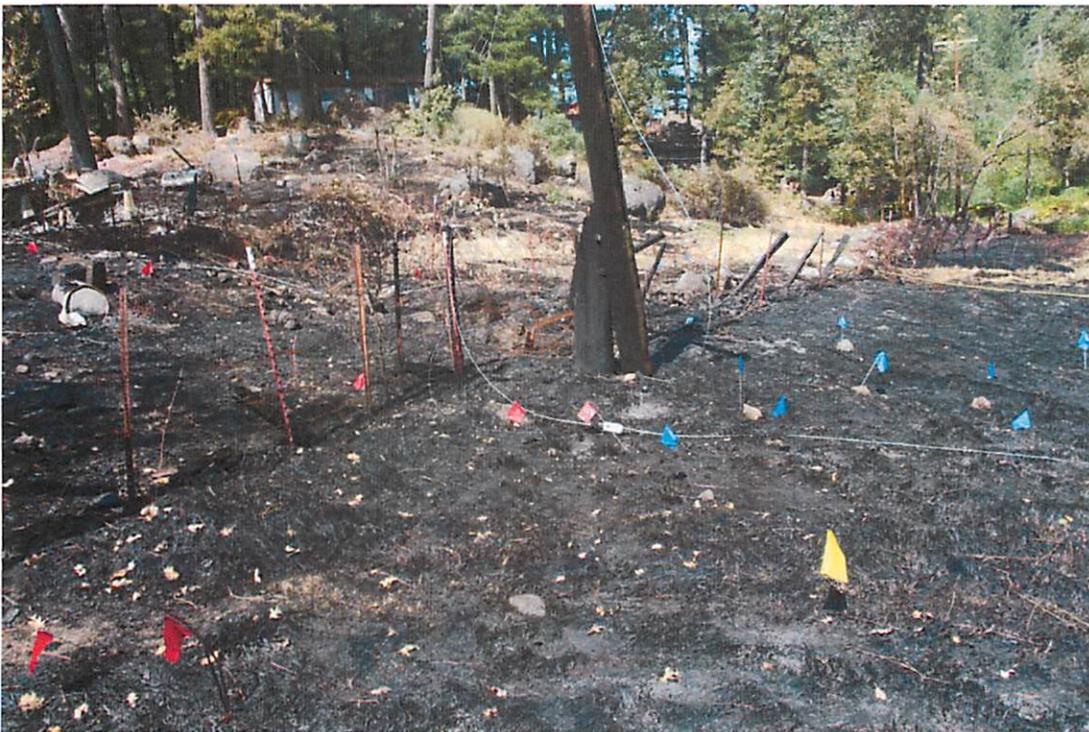
IMG\_0038- Taken southwest of SOA, looking northwesterly at base of corner power pole and burn indicator flagging. SOA in lower right of photograph.

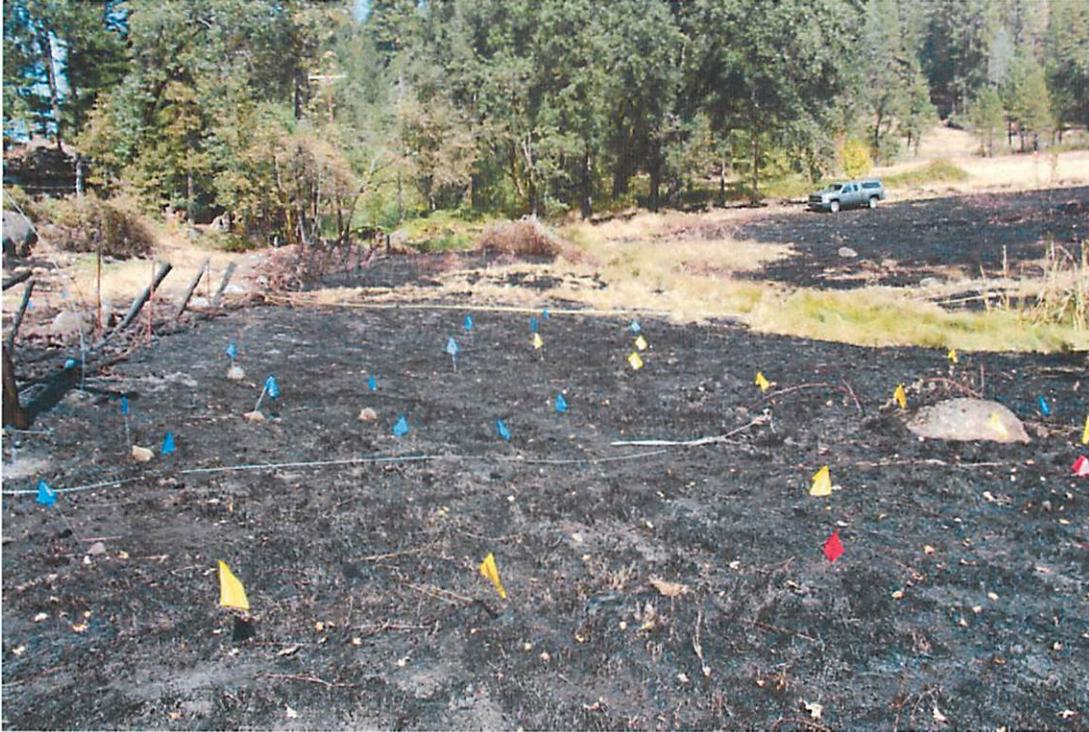
IMG\_0039- Taken south of SOA, looking northerly toward heal of the fire.

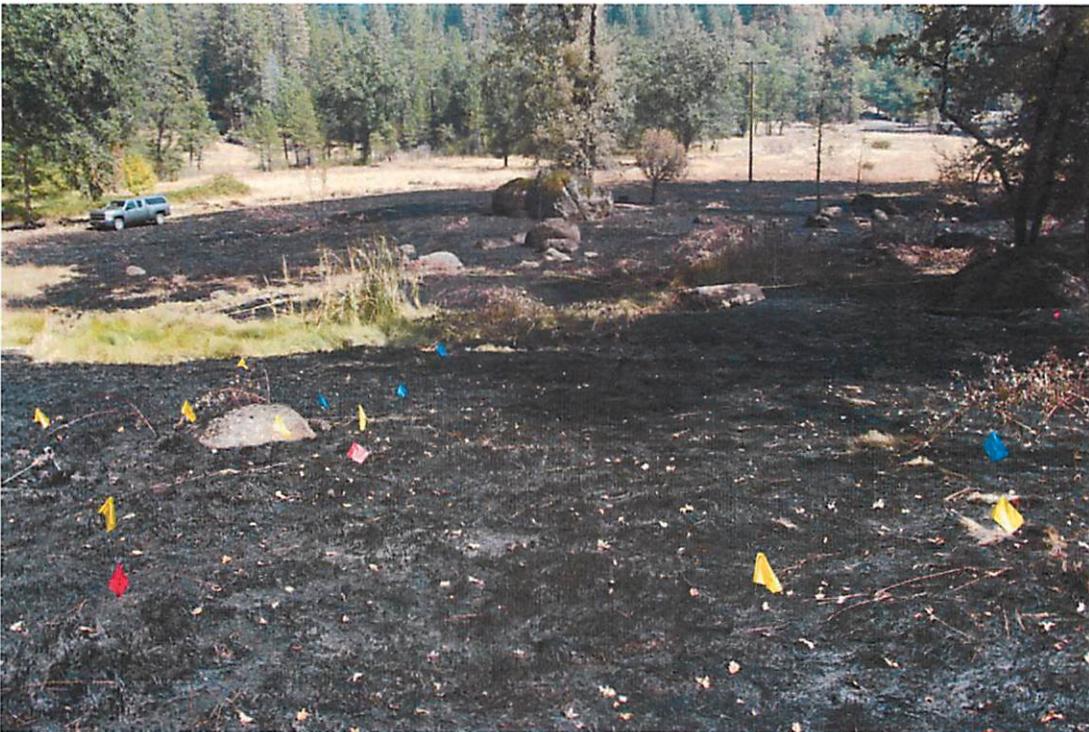
IMG\_0040- Taken south of SOA, looking northeasterly toward heal and left flank of the fire.

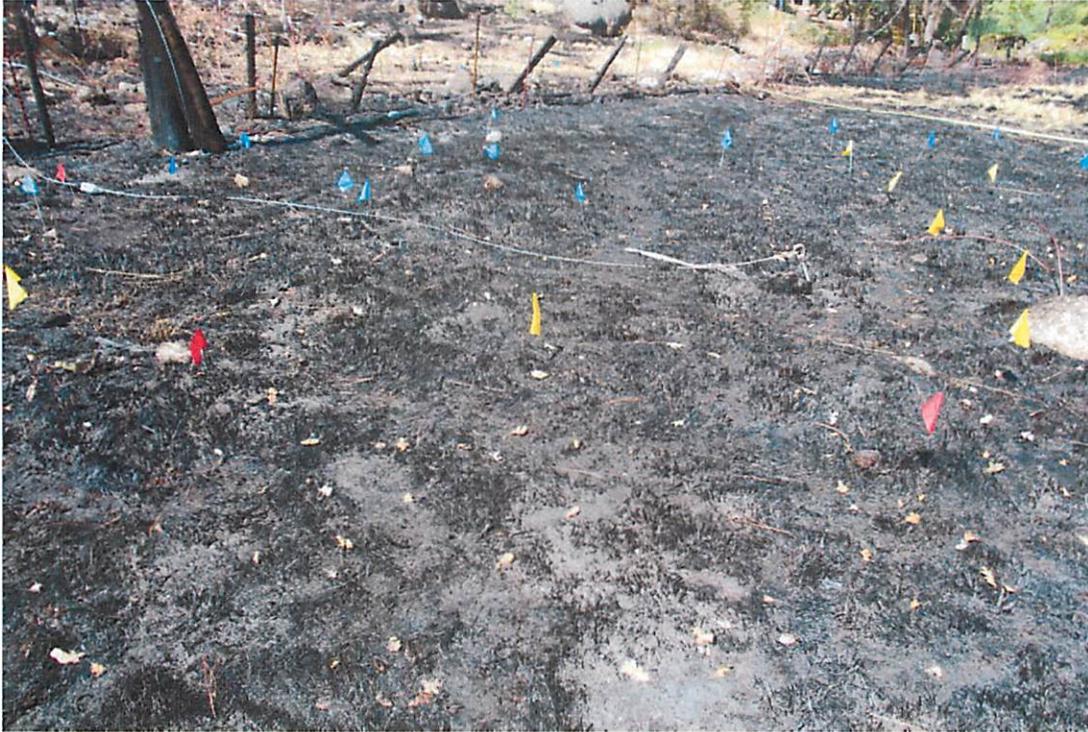
IMG\_0041- Taken southeast of SOA, looking northwesterly toward base of the power pole, at burn indicator flagging.

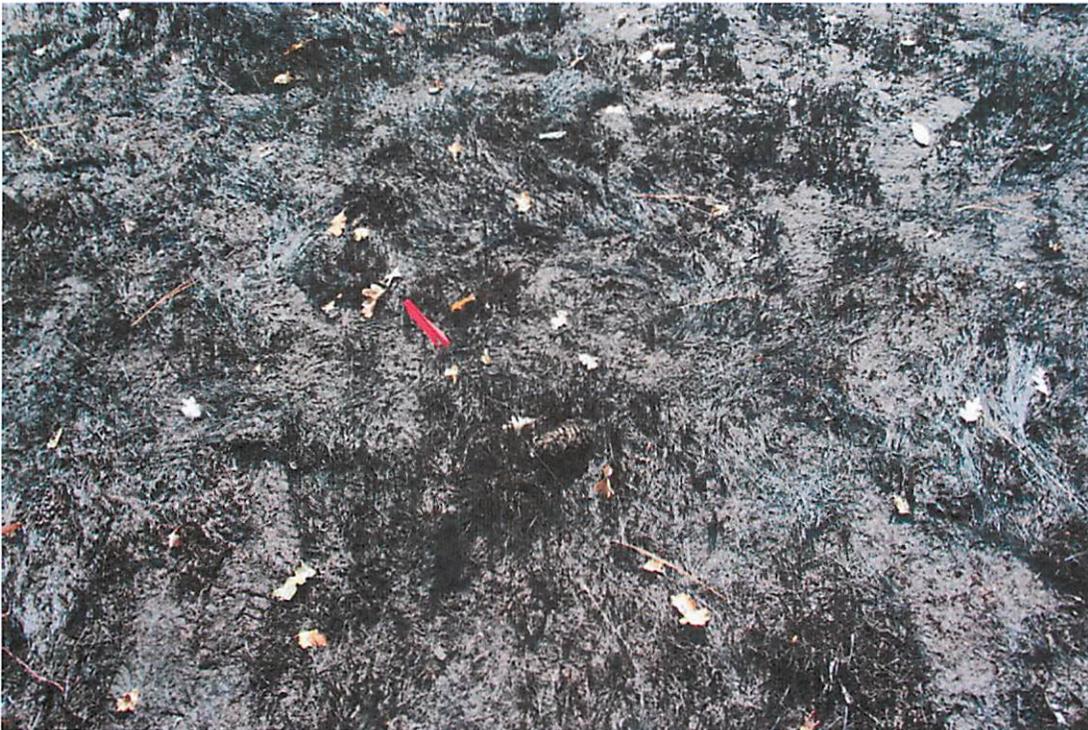
IMG\_0042- Advancing fire spread indicator consisting of protection and degree of damage.

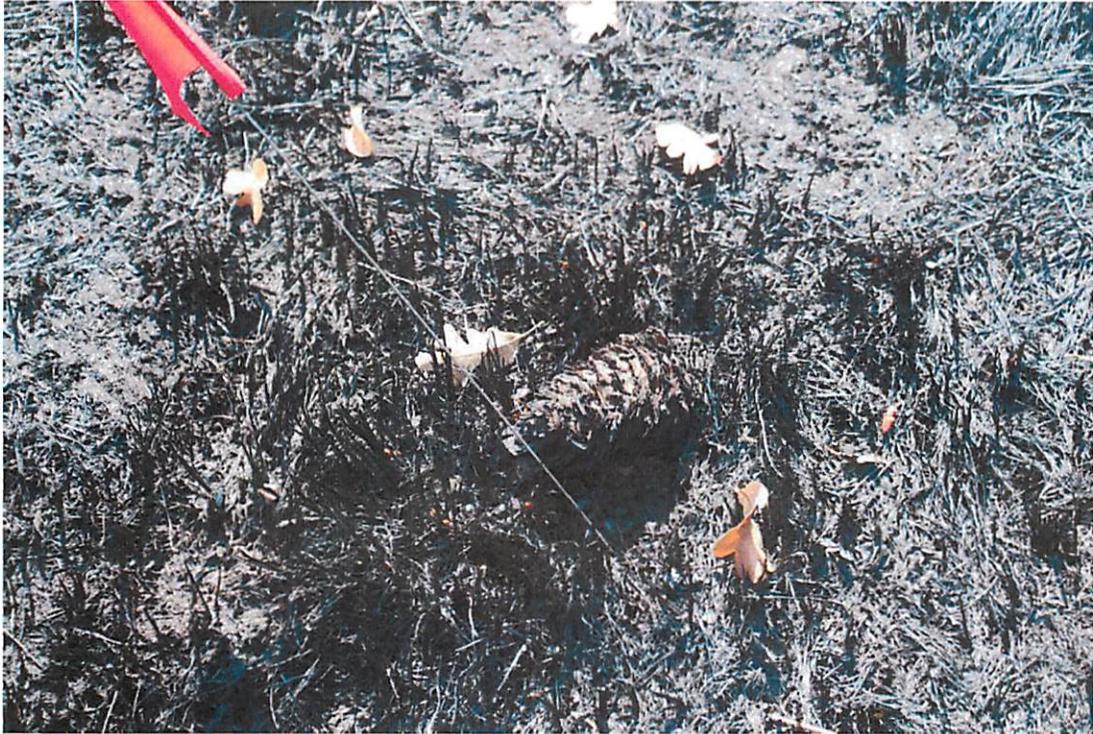
IMG\_0043- Close-up of advancing fire spread indicator consisting of protection and degree of damage.

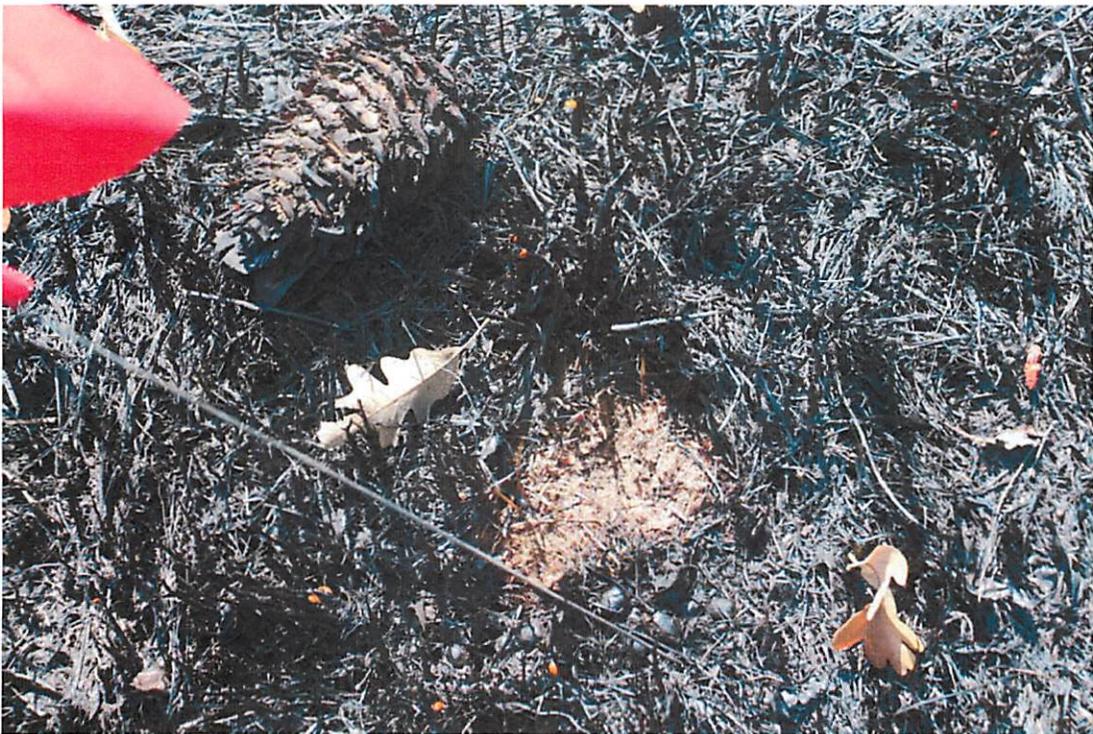
IMG\_0044- Close-up of advancing fire spread indicator consisting of protection and degree of damage.

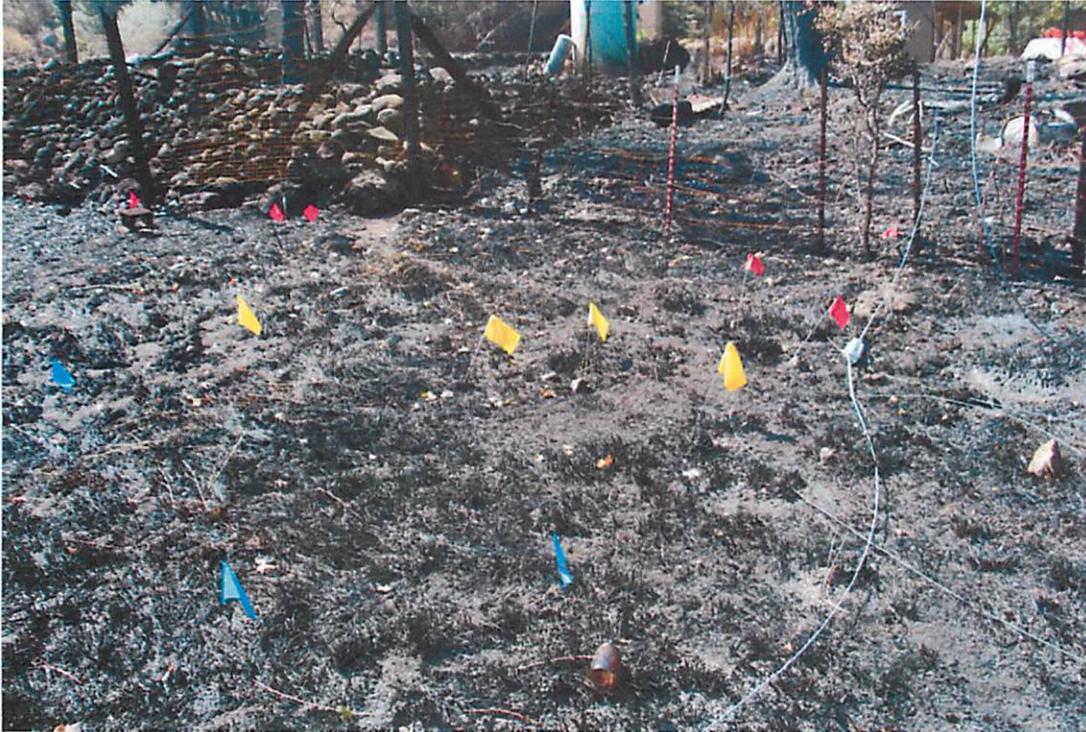
IMG\_0045- Taken east of SOA, looking westerly, toward water tank, at burn indicator flagging.

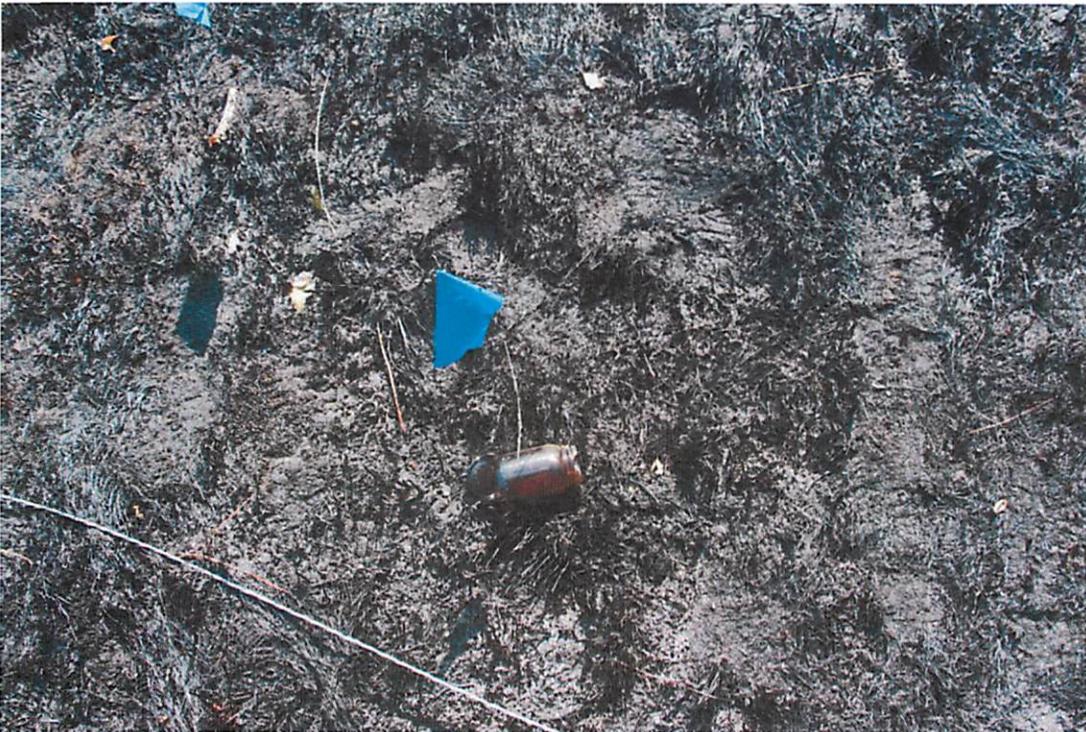
IMG\_0046- Close-up of backing fire spread indicator consisting of even sooting and staining around jar.

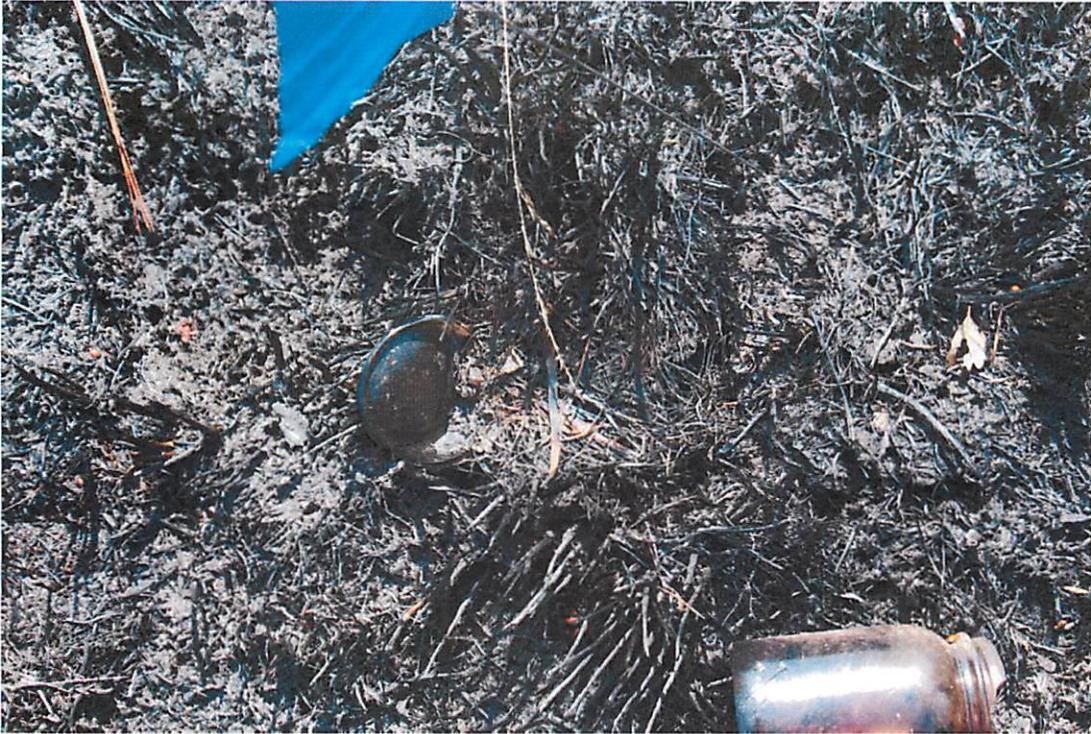
IMG\_0047- Close-up of backing fire spread indicator consisting of even protection around the jar.

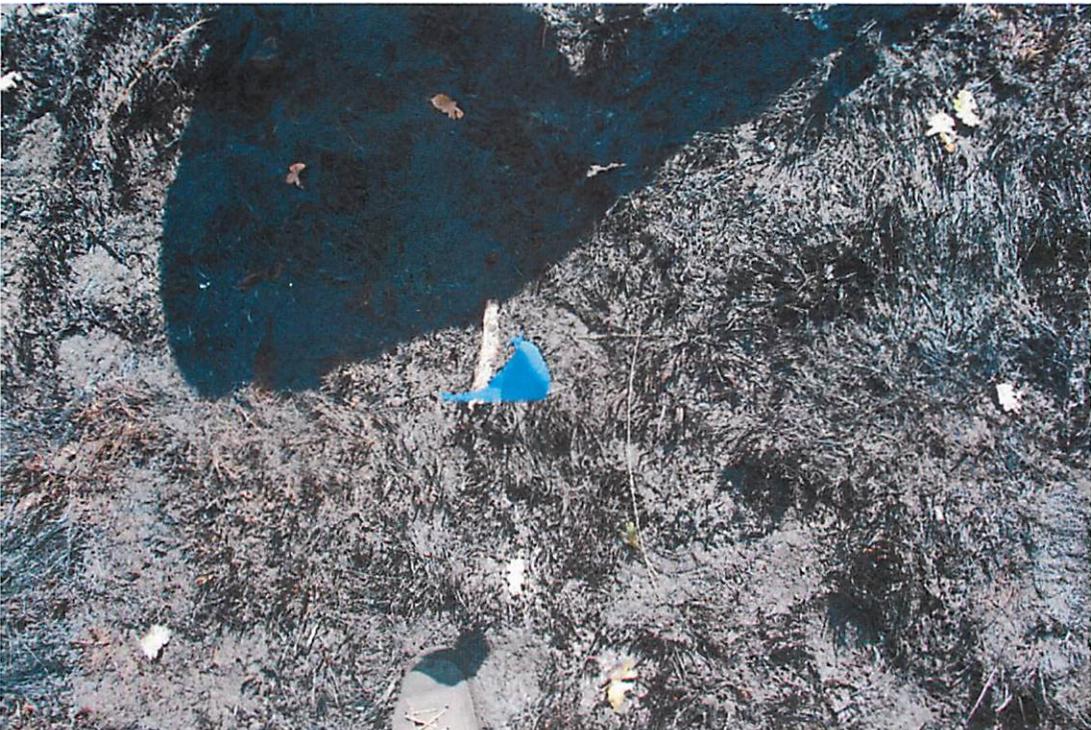
IMG\_0048- Backing fire spread indicator consisting of even, low intensity burning around a stick.

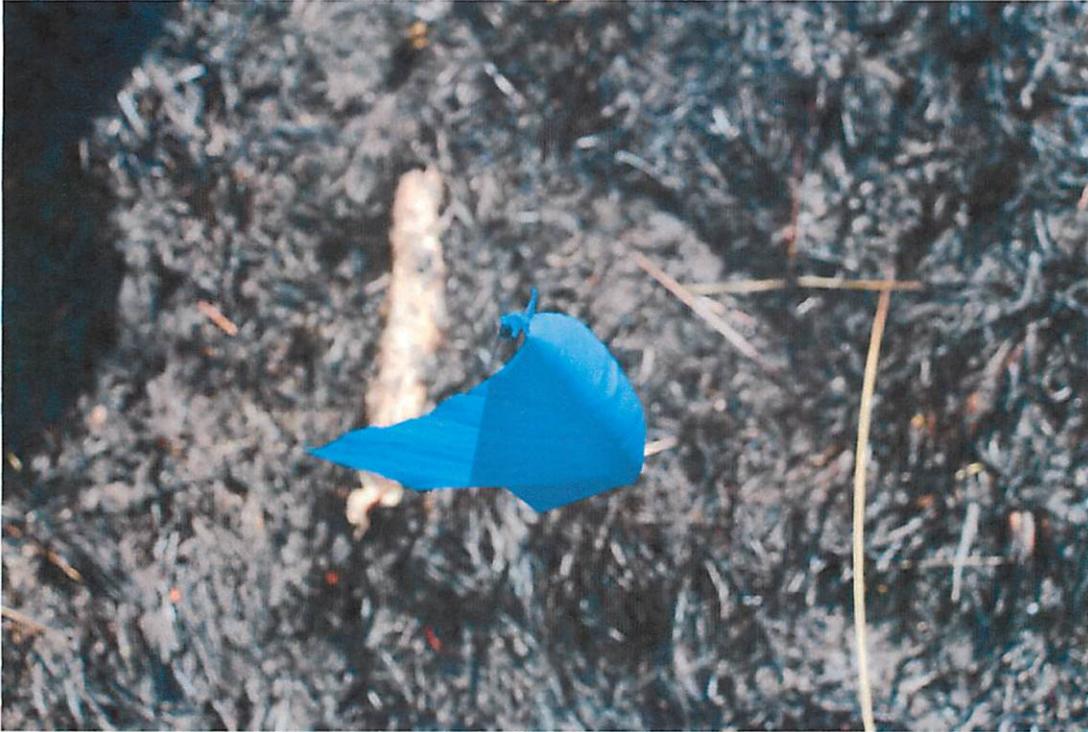
IMG\_0049- Backing fire spread indicator consisting of even, low intensity burning around a stick.

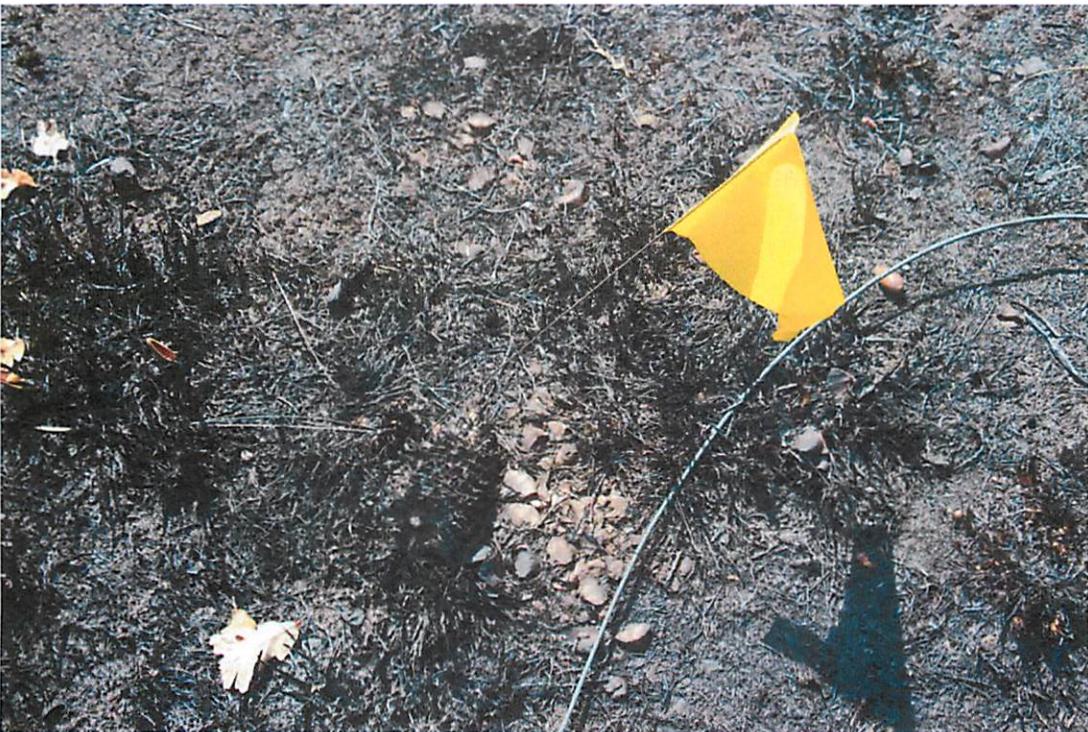
IMG\_0050- Lateral fire spread indicator consisting of degree of damage/ protection.

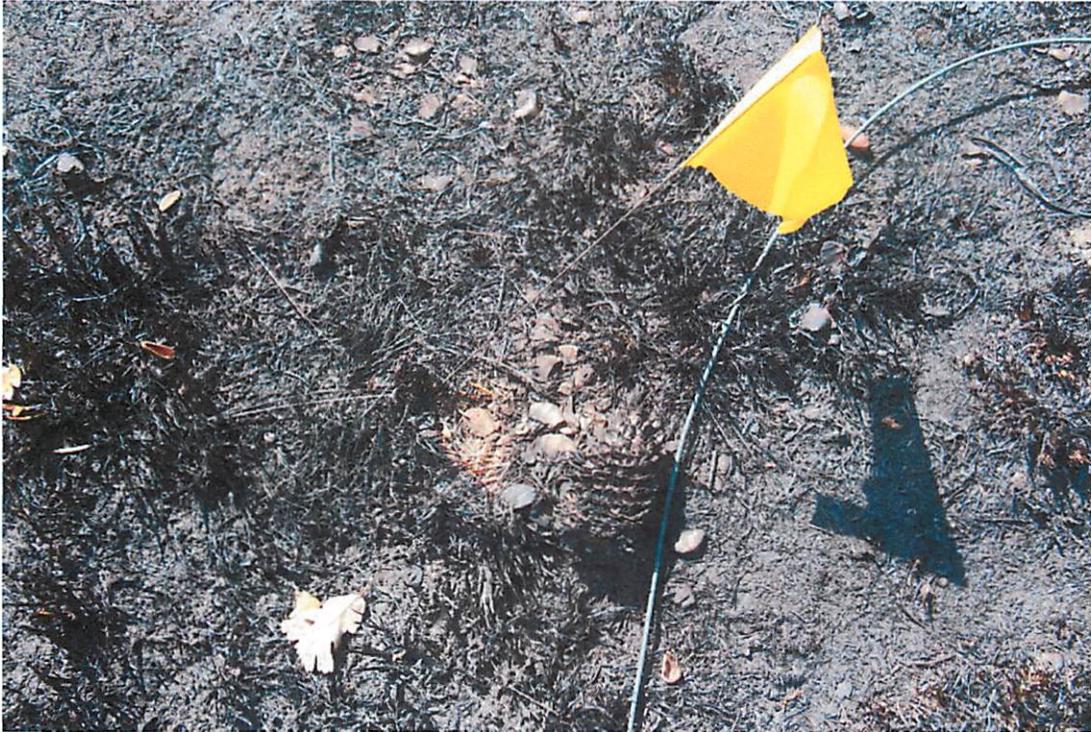
IMG\_0051- Lateral fire spread indicator consisting of degree of damage/ protection.

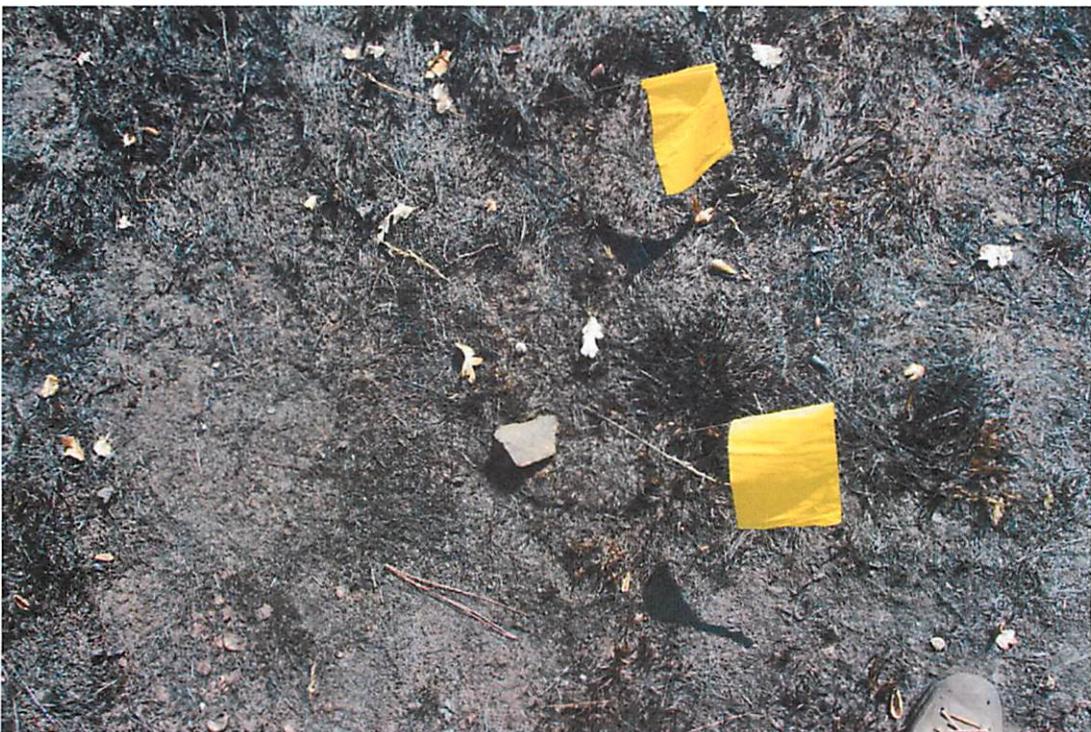
IMG\_0052- Lateral fire spread indicator consisting of sooting/staining shown on rock.

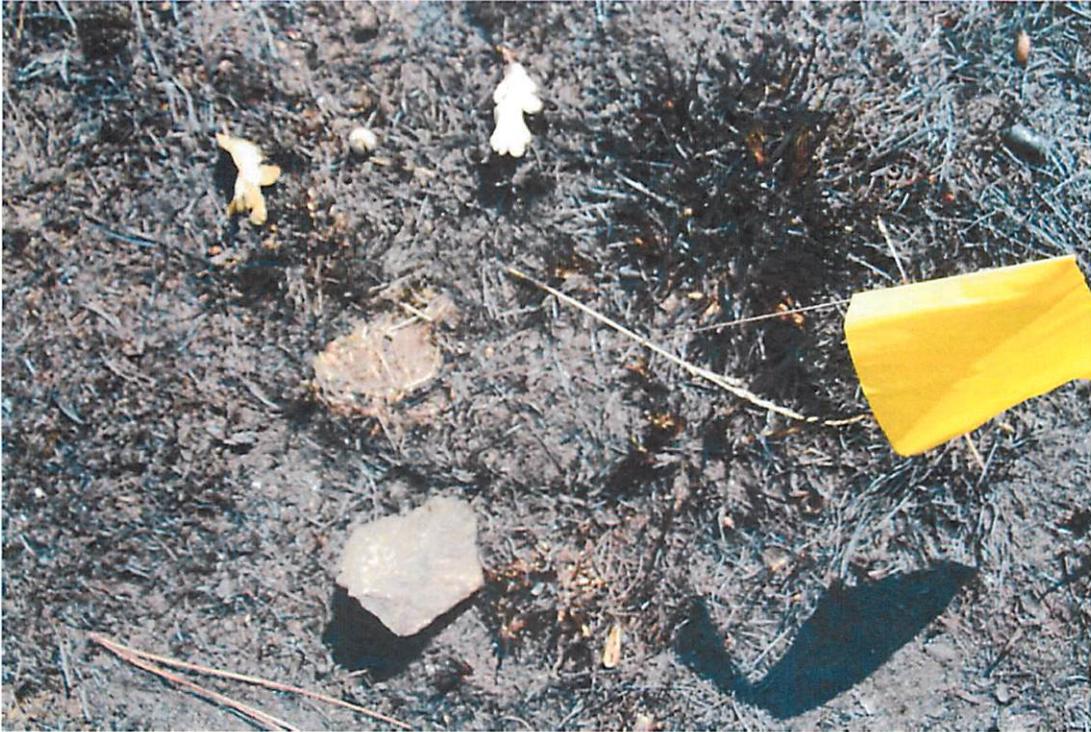
IMG\_0053- Lateral fire spread indicator consisting of protection shown beneath rock having sooting/staining.

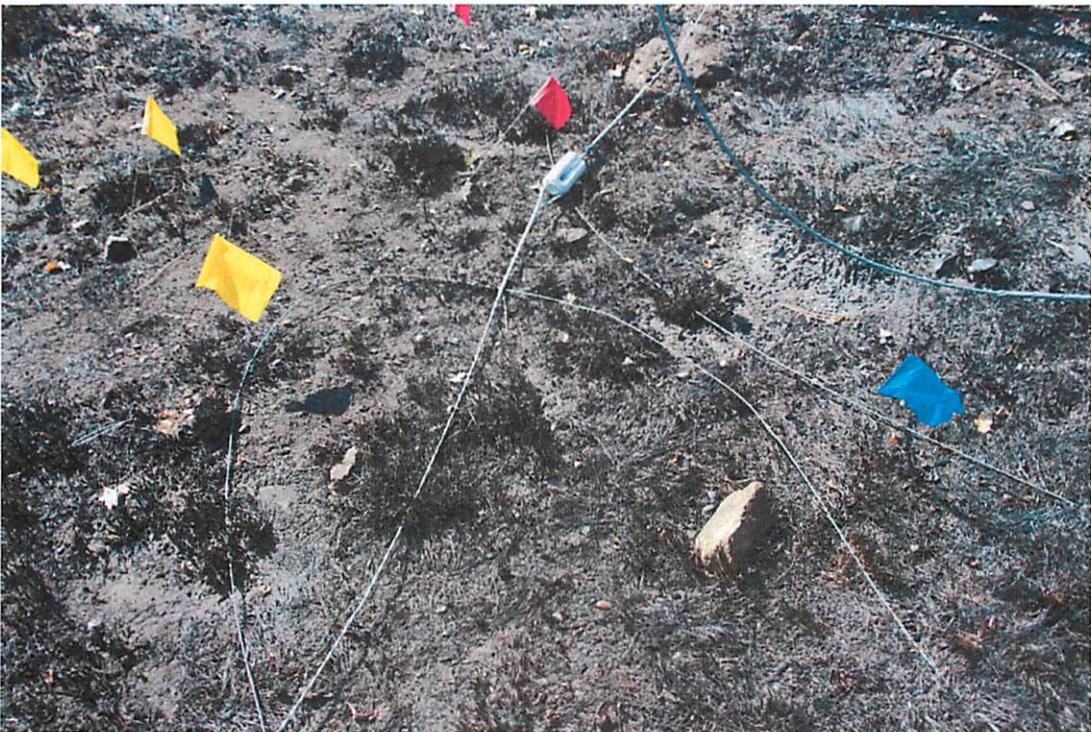
IMG\_0054- Lateral, backing and advancing fire spread indicators north of SOA, looking easterly. Also includes picture of guide wire from burnt through power pole.

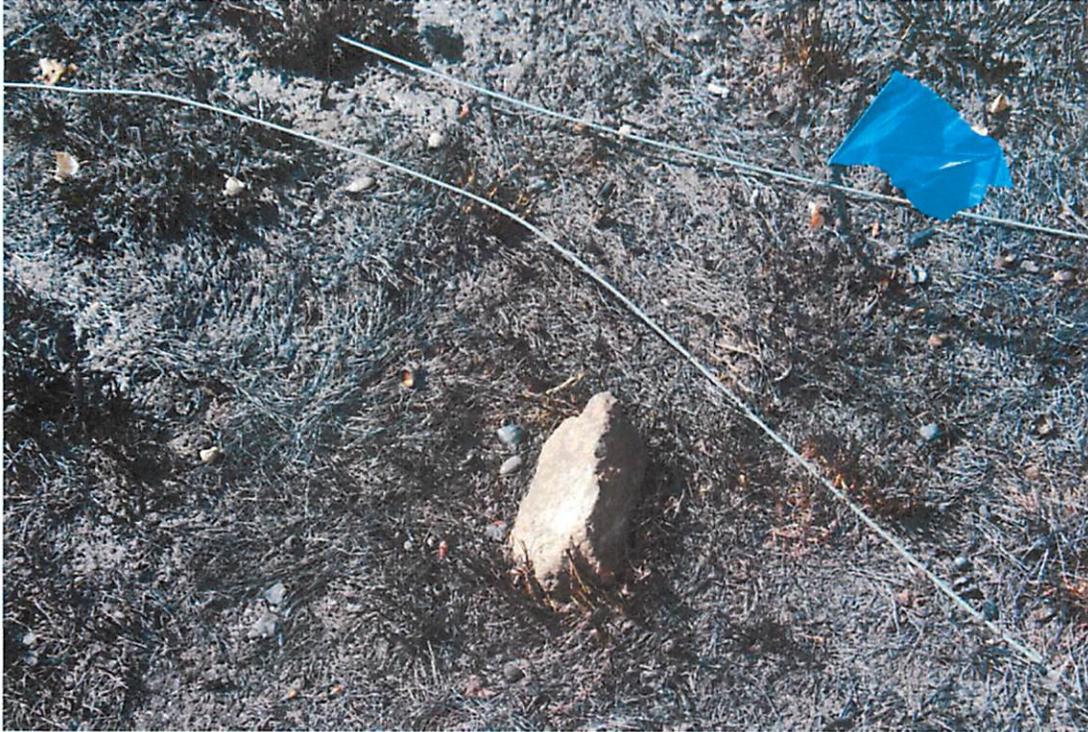
IMG\_0055- Backing fire spread indicator consisting of sooting and even, low intensity burning around a rock.

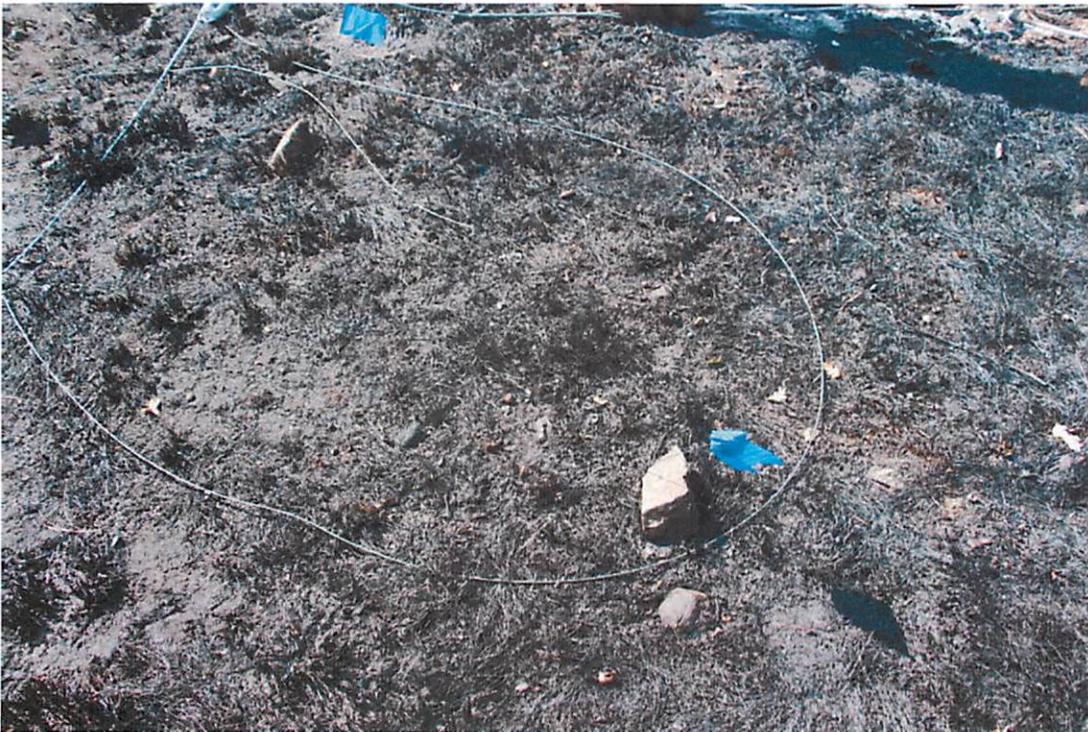
IMG\_0056- Backing fire spread indicator consisting of sooting and even, low intensity burning around a rock.

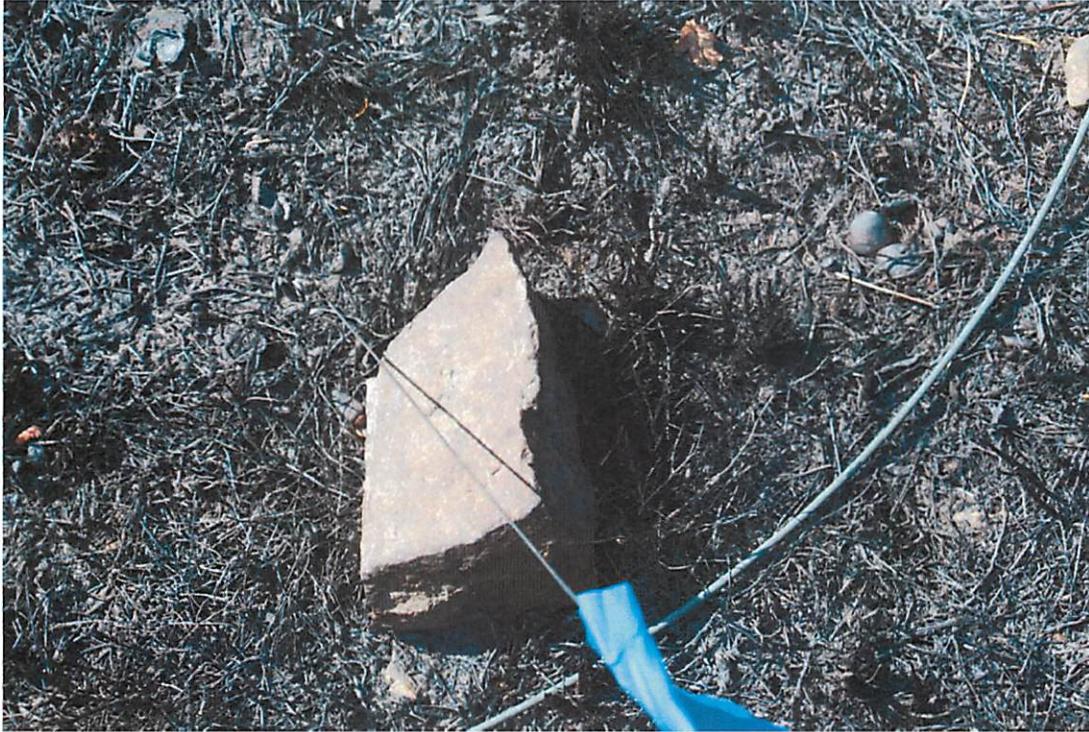
IMG\_0057- Backing fire spread indicator consisting of sooting and even, low intensity burning around a rock.

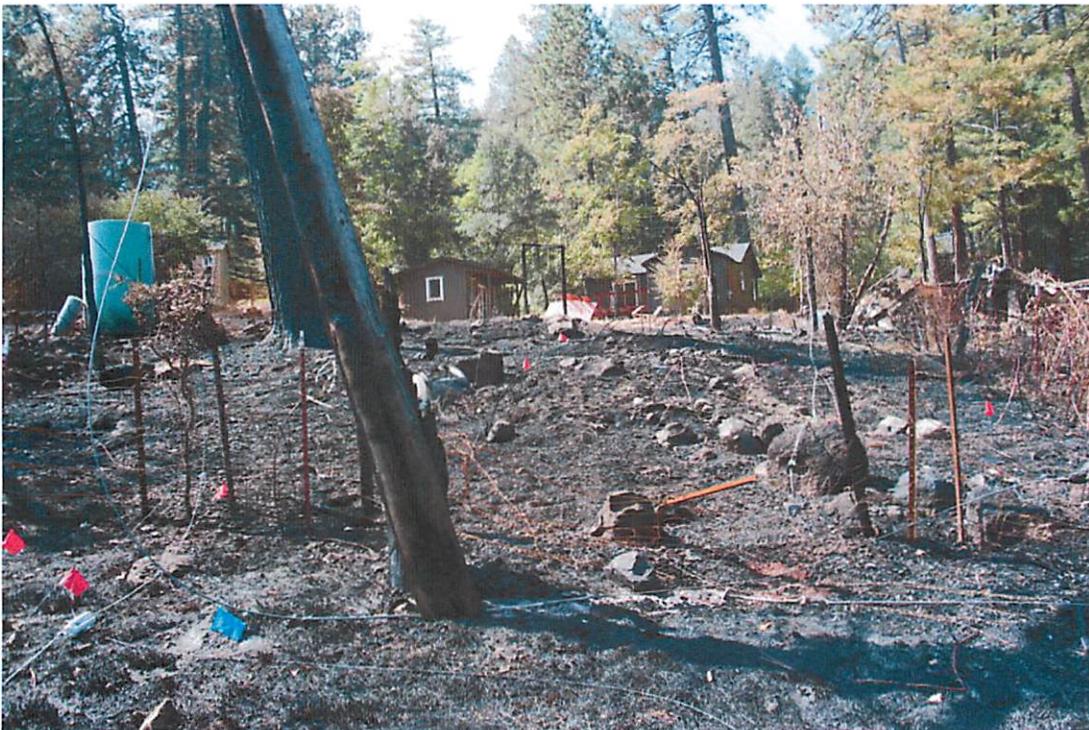
IMG\_0058- Taken north of the SOA, looking southwesterly toward burnt through power pole and water tank.
