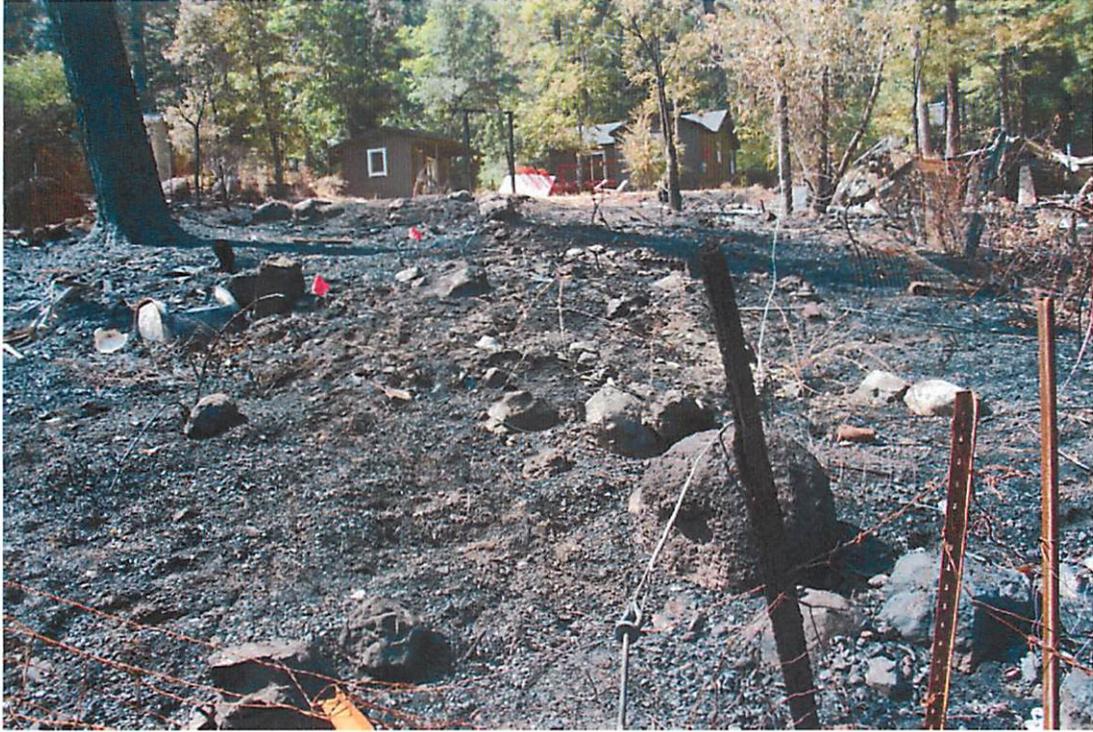
IMG\_0059- Taken from along fence line, north of the SOA, looking southwesterly. Destroyed residence on right of photo.

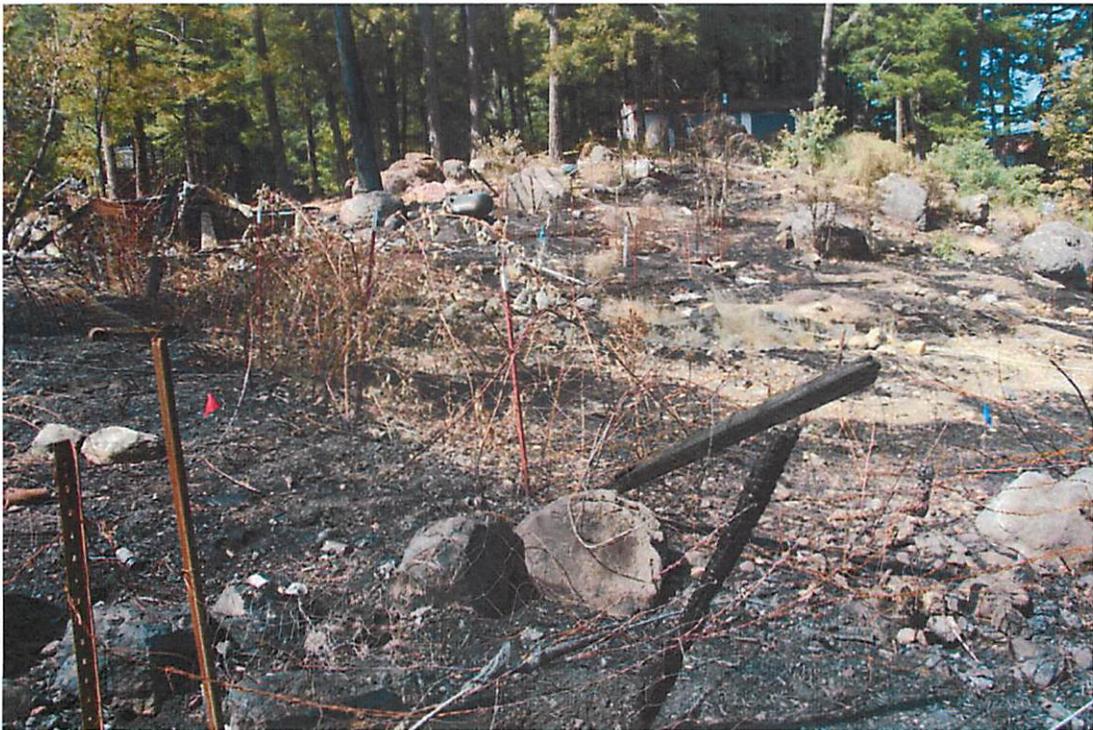
IMG\_0060- Taken from along fence line, north of the SOA, looking westerly. Destroyed residence on left of photo.

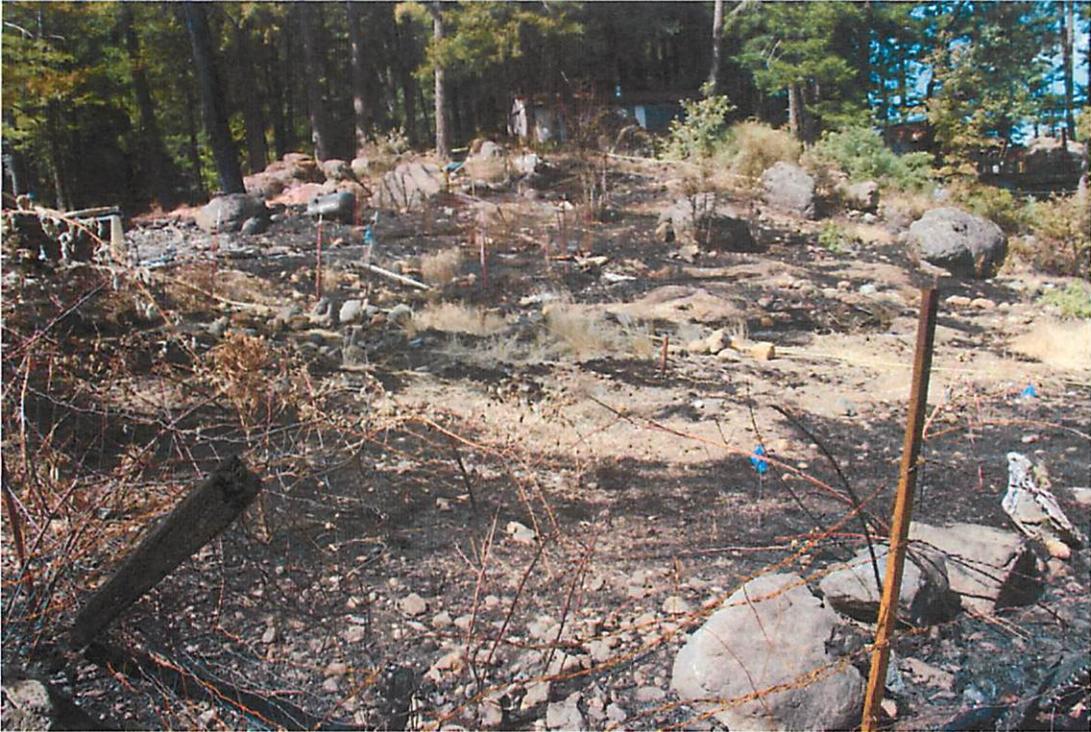
IMG\_0061- Taken from along fence line, north of the SOA, looking northwesterly.

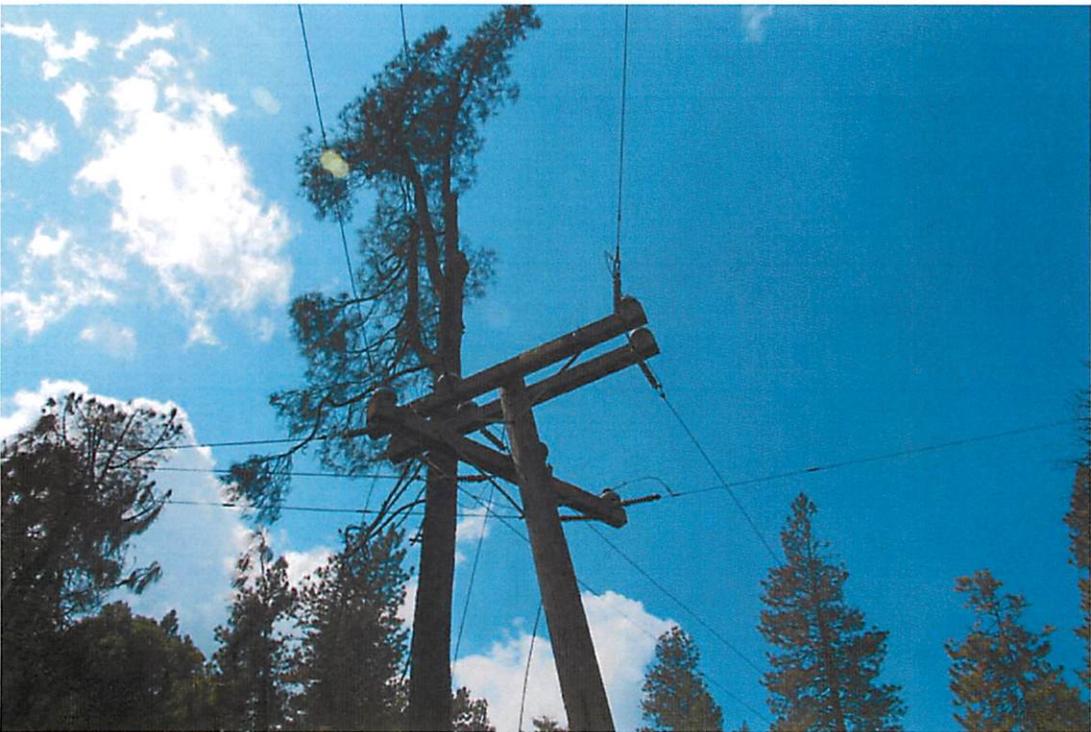
IMG\_0062- Close-up of corssarms on burnt through corner power pole.

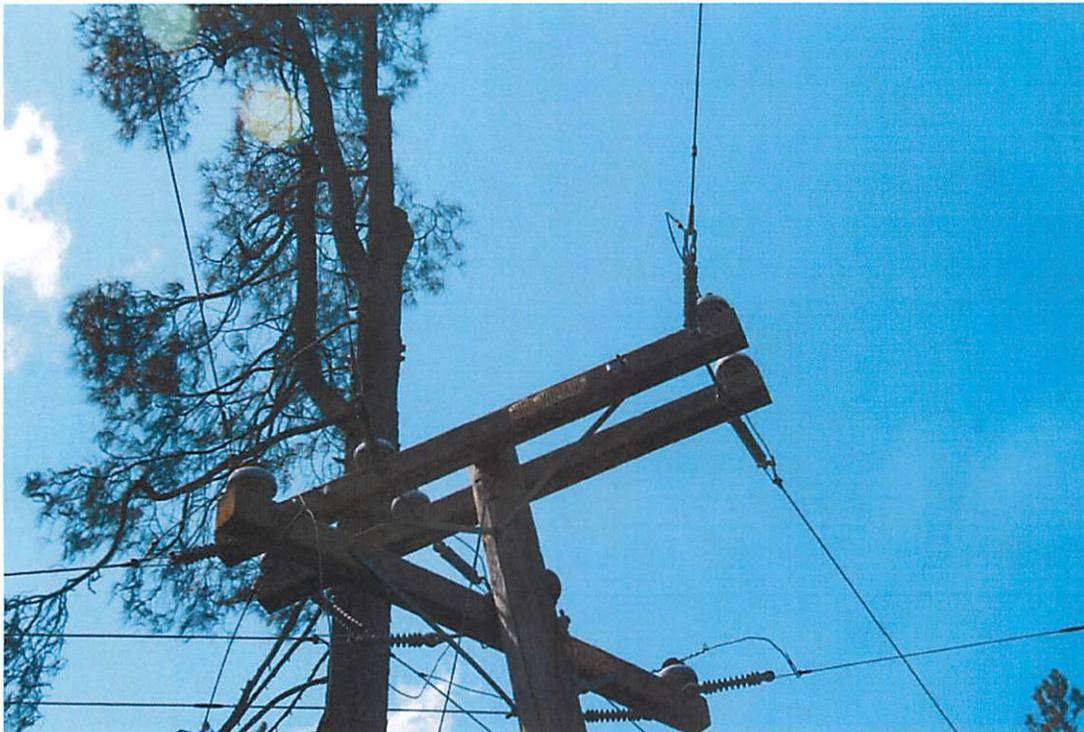
IMG\_0063- Close-up of crossarms on burnt through corner power pole.

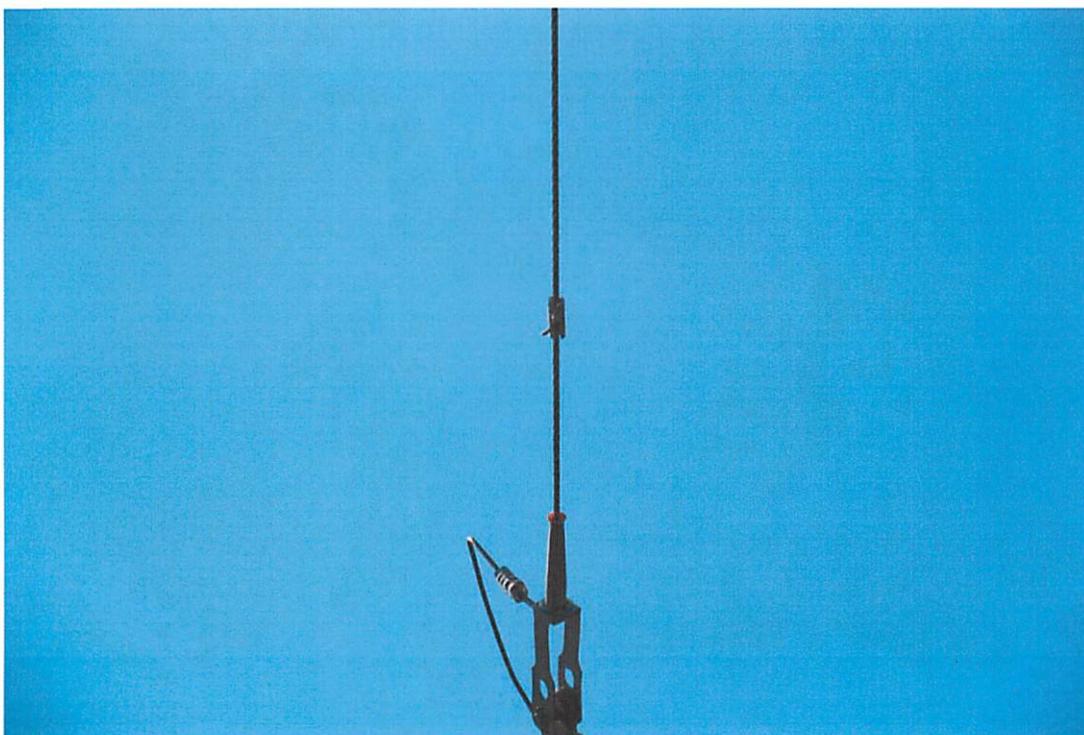
IMG\_0064- Close-up of conductor, deadend, jumper, and connector on crossarms of the burnt through corner power pole.

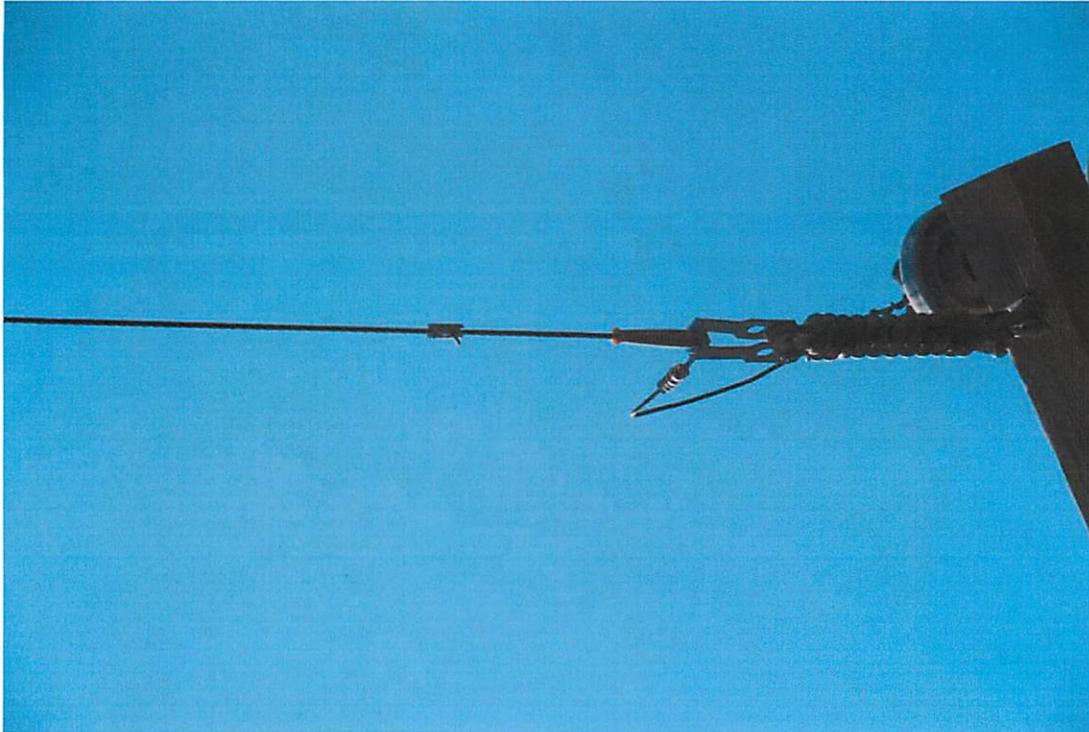
IMG\_0065- Close-up of conductor, deadend, jumper, insulator and connector on crossarms of the burnt through corner power pole.

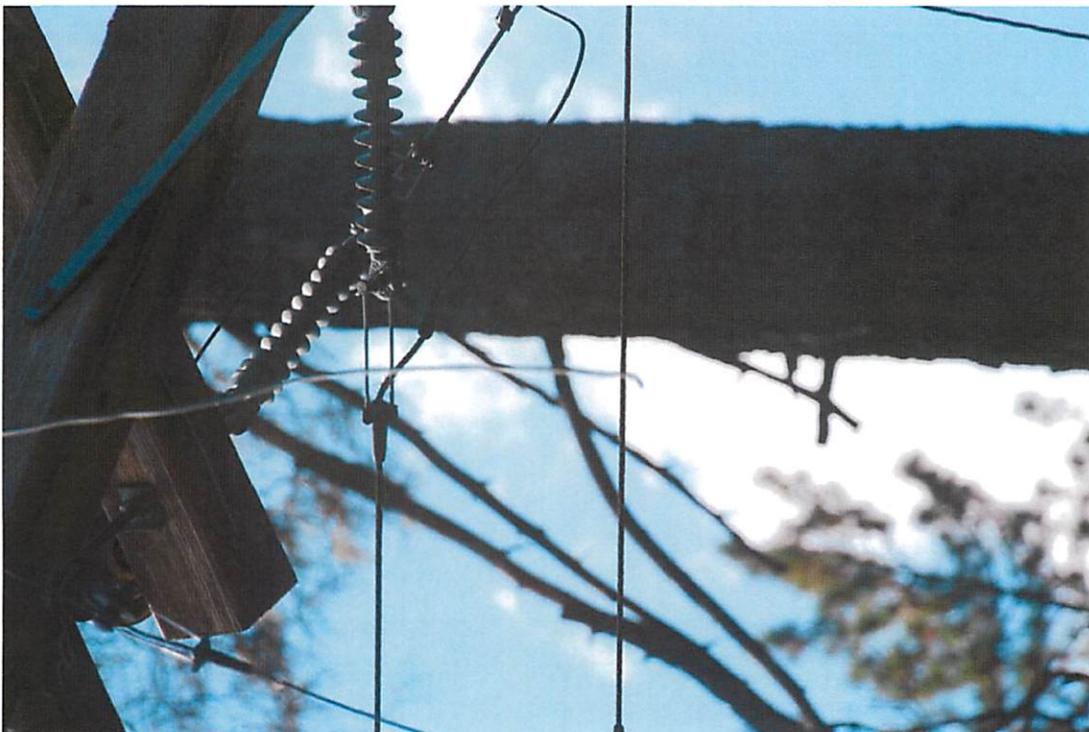
IMG\_0066- Close-up of conductor, deadend, jumper, insulator and connector on crossarms of the burnt through corner power pole.

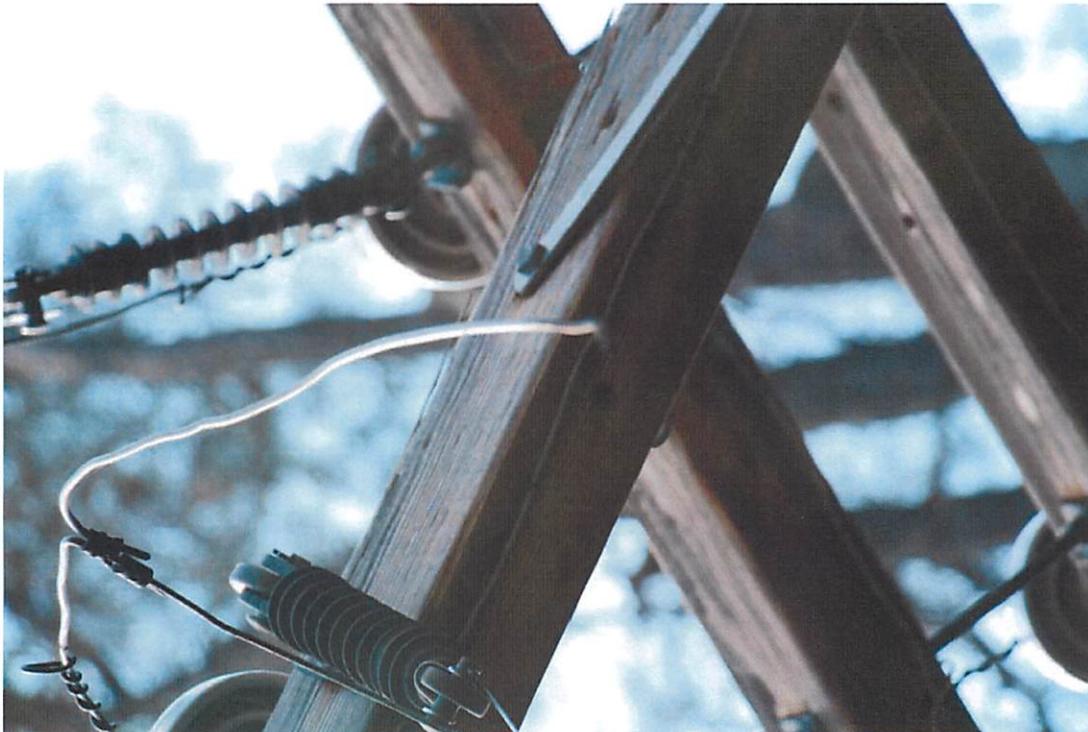
IMG\_0067- Close-up of conductor, deadend, jumper, insulator and connector on crossarms of the burnt through corner power pole.

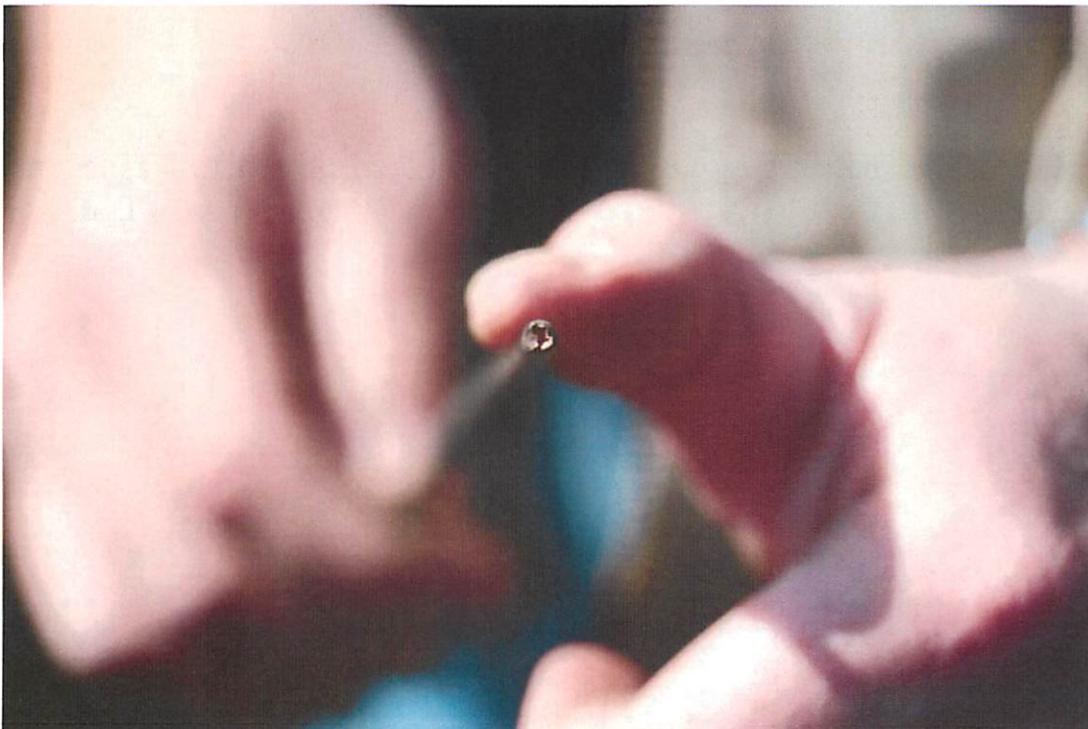
IMG\_0068- Close-up of broken conductor end found on ground north of burn through power pole.
