DEPARTMENT OF FORESTRY
AND FIRE PROTECTION

INVESTIGATION REPORT

Case Name: Cajon

Date: October 22, 2007

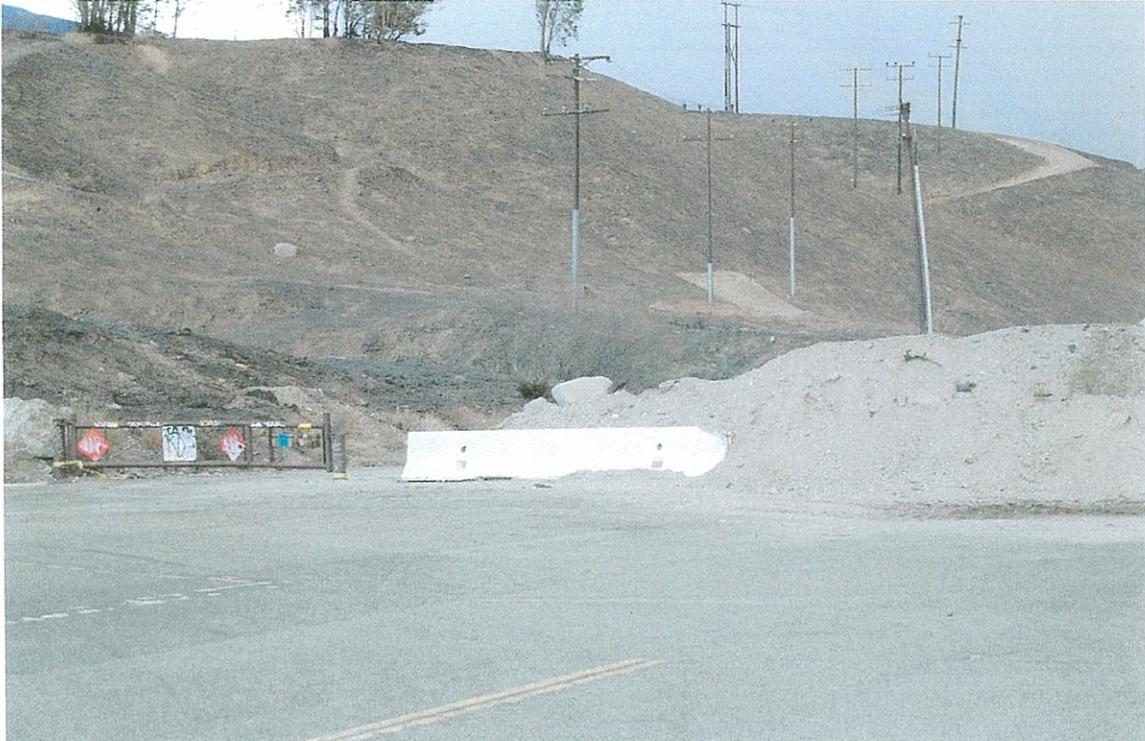
Picture # 1

On October 22 2007, W-1 Julie Gauthier witnessed a “blue ball of light” emitting from the top of a power pole located near the intersection. She estimated the light traveled five feet away from the top of the pole. She described the blue ball of light as an “arc”. Seconds after she witnessed the arc, a fire started on the ground near the base of the power pole. W-2 Melissa GAUTHIER called 9-1-1 and reported the arc and fire (Photo by W-12 FRICK 10-23-07)

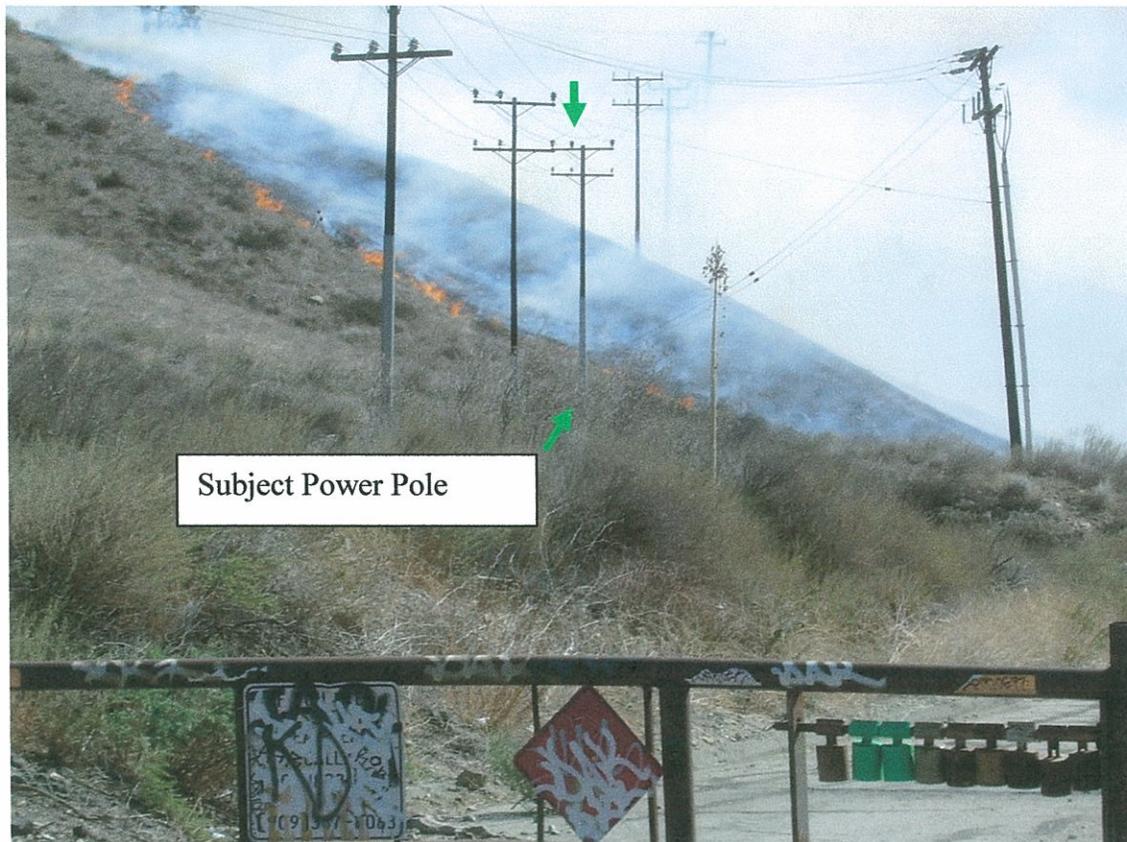
Picture # 2

Photograph taken by W-8 CAMPBELL several minutes after the fire started. He was facing the northeast while located at the intersection of Cajon Boulevard and Kenwood Avenue. The fire was burning near the base of the subject pole on the northeast/east/southeast side of it. (Photo I.D DSCN3053, Evidence Log I.D. # 1E)

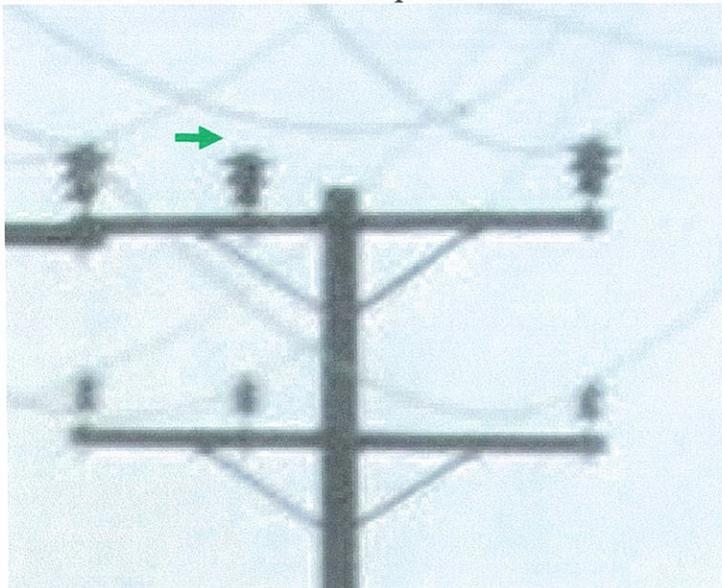
Picture # 3

An enlargement of the subject identified in the preceding photograph shows the conductor located above the top cross arm's center insulator is detached.

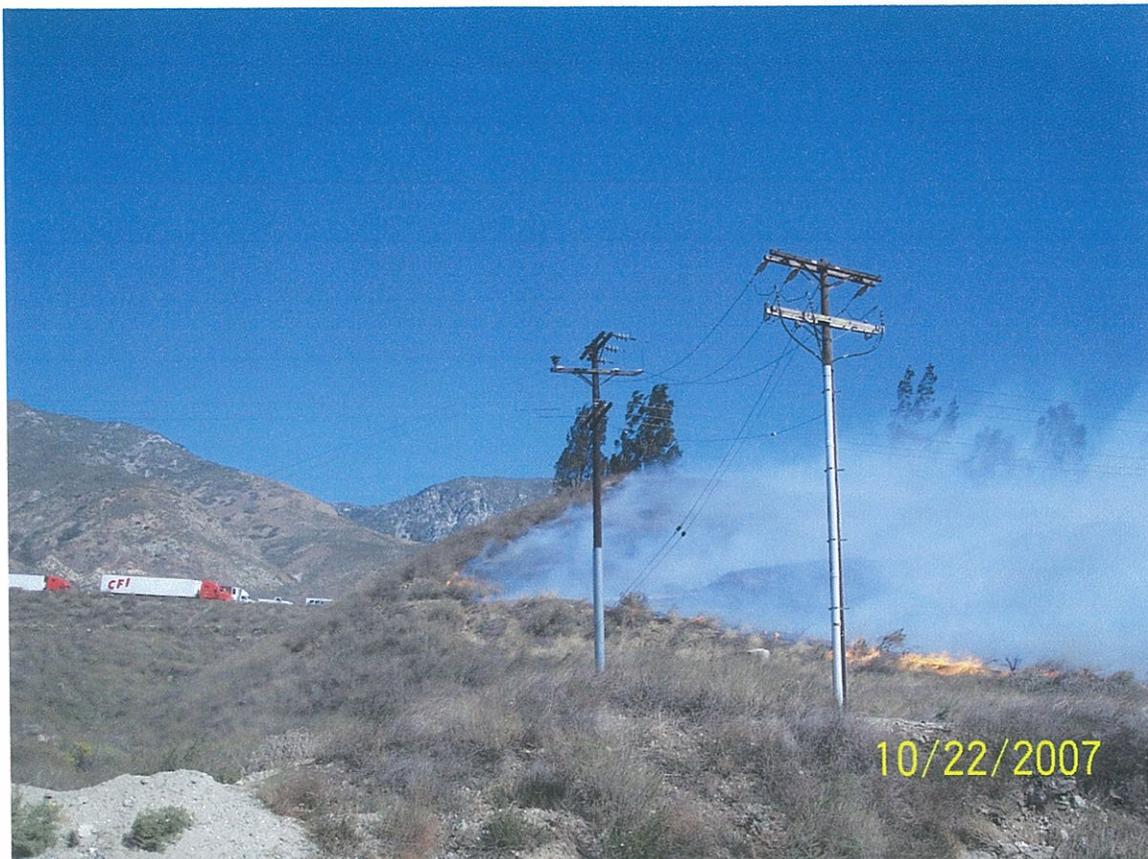
Picture # 4

The fire had back-burned against the wind towards the Kenwood Avenue onramp to southbound Interstate 15. The vehicle traffic can be seen stopped on southbound Interstate 15 above the onramp hidden by the height of the vegetation (Photo I.D. # 1-10. 12:00 p.m.)

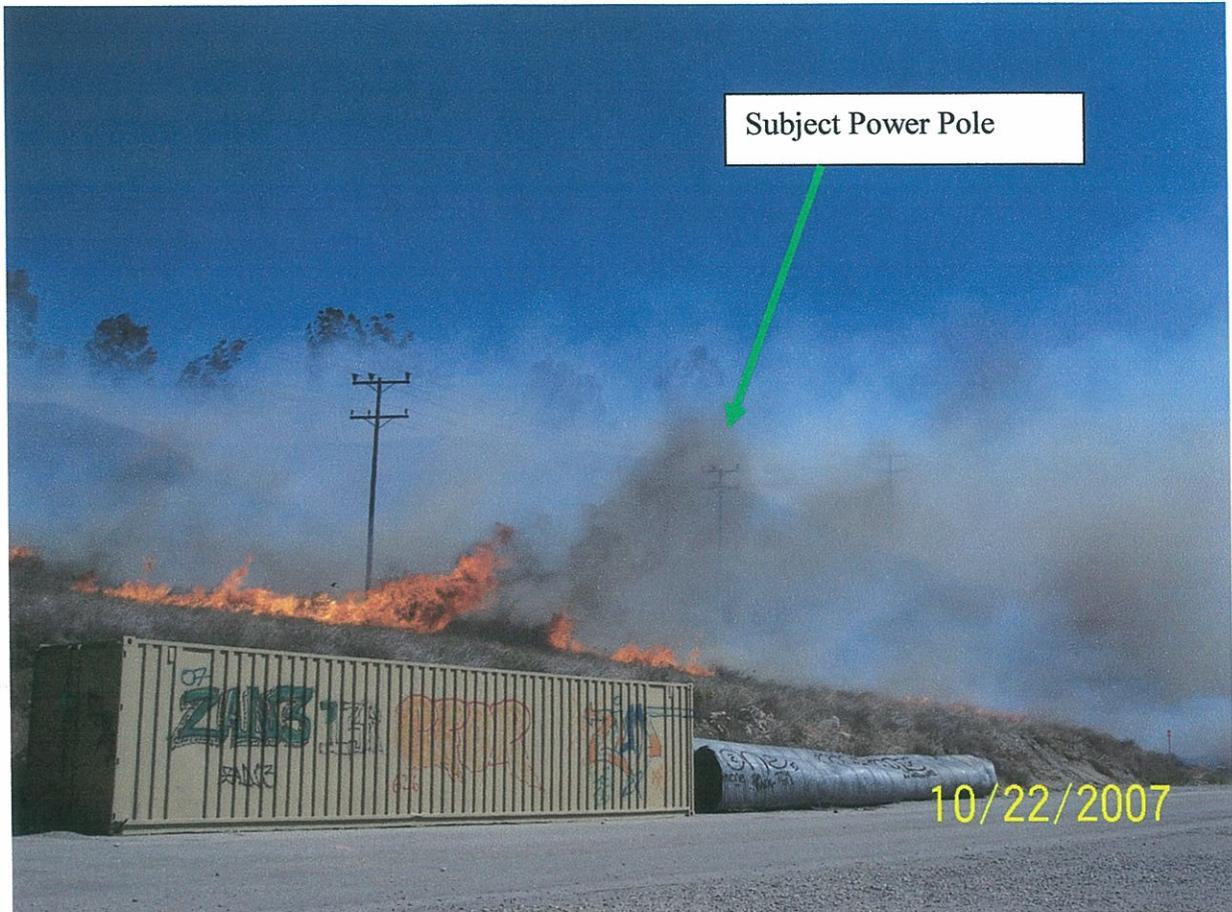
Picture # 5

W-5 HOLMES stated that when he saw the fire it was approximately 50 feet in diameter midway between Cajon Blvd and Interstate 15. Cajon Blvd is in the foreground with the metal storage container, and Interstate 15 is on the other side of the trees at the top left side of the photograph (Photo I.D. # 1-12 taken at 12:00 p.m.)

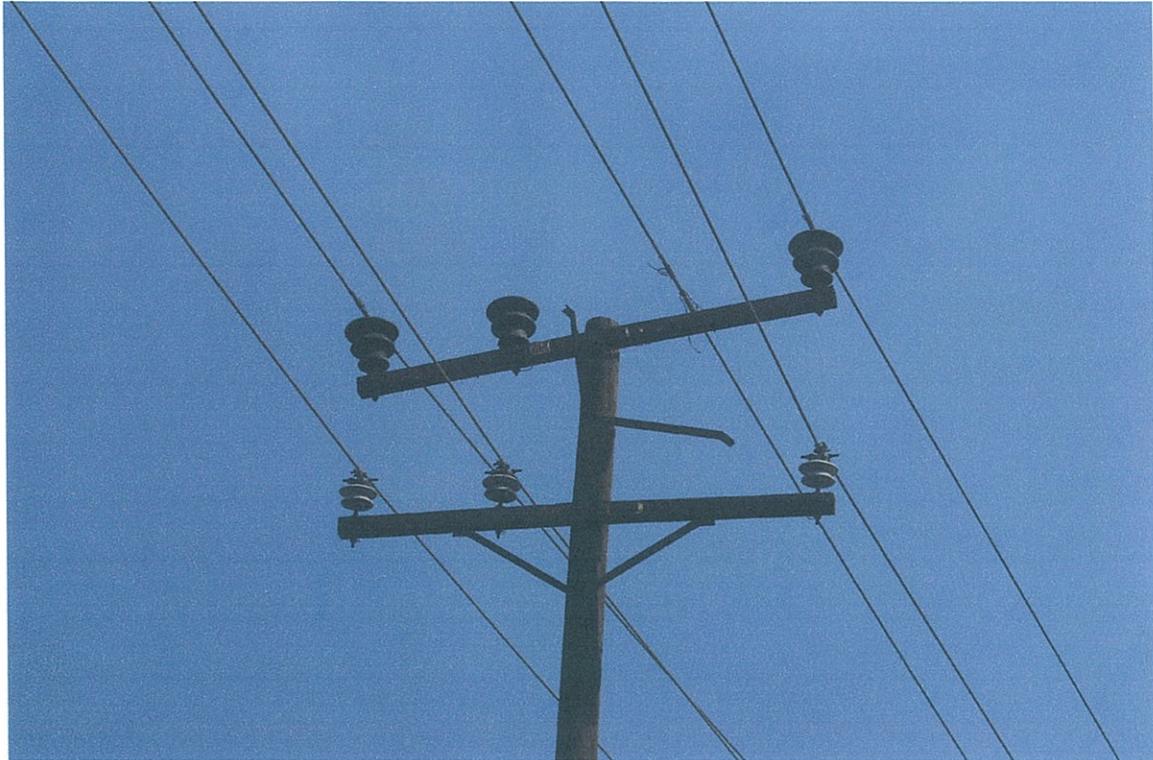
Picture # 6

40
41 Both the upper and lower cross arms were intended to be stabilized with a "V"
42 shaped metal brace attached to the pole and to the underside of each cross arm. Each V-
43 brace had three locations for attaching it in place with a carriage bolt running through
44 each of the holes drilled through it. The locations of the drilled holes on the brace were
45 on the ends and at the "point" of the "V". I had observed the upper cross arm's V-brace
46 had been rotating as the wind gust had steadily increased in strength from the time of my

1 arrival, and the brace stopped rotating after the end of the V-brace reached an
2 11-o'clock position as viewed from the west side. I also observed the top cross arm's
3 northeast and southwest ends were rocking up and down in a teeter-totter motion for lack
4 of support from the V-brace. The free movement of the V-brace indicated the nuts
5 securing it to the upper cross arm were not in place.

Facing northeast: The upper cross arm V-brace on the subject power pole was not secure as evident by its rotation. (Photo I.D. # 2-5)

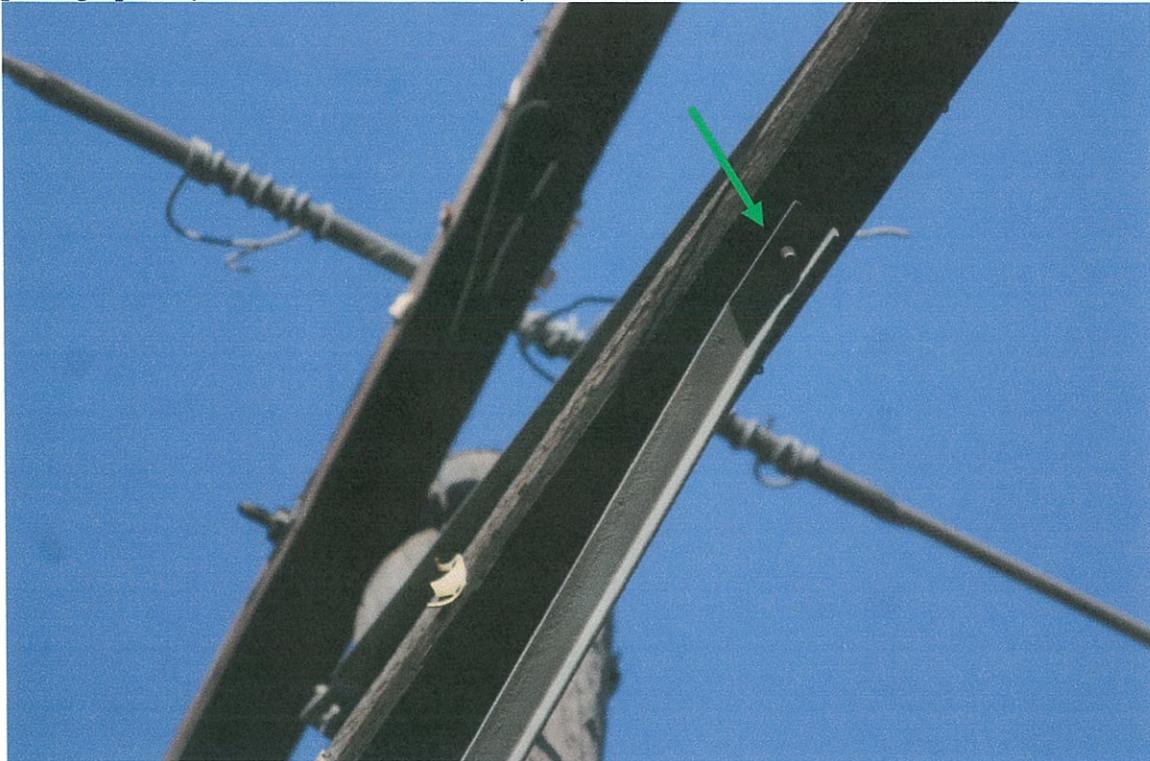
Picture # 7

The missing nuts securing the upper cross arm V-brace were not present resulting in its rotation. The nut missing from the lower cross arm on the southwest end was photographed (Photo I.D. 2-80 10-22-07).

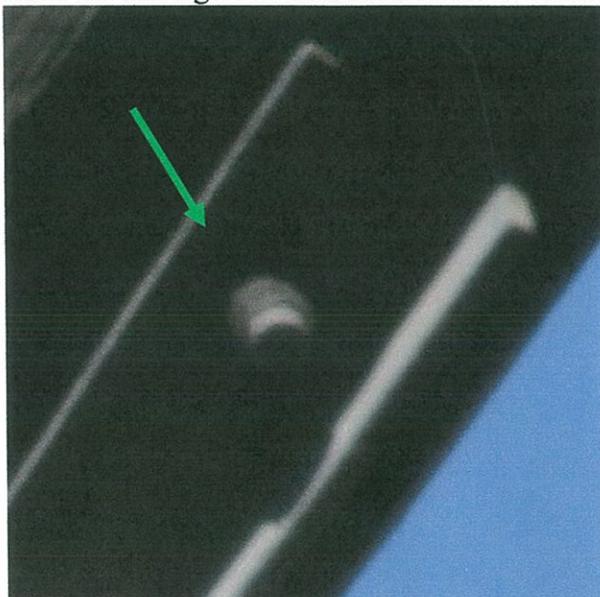
**Picture # 7A**

Enlarged view of the image above showing the area on lower cross arm missing the nut from the carriage bolt that secures the V-brace to the cross arm.

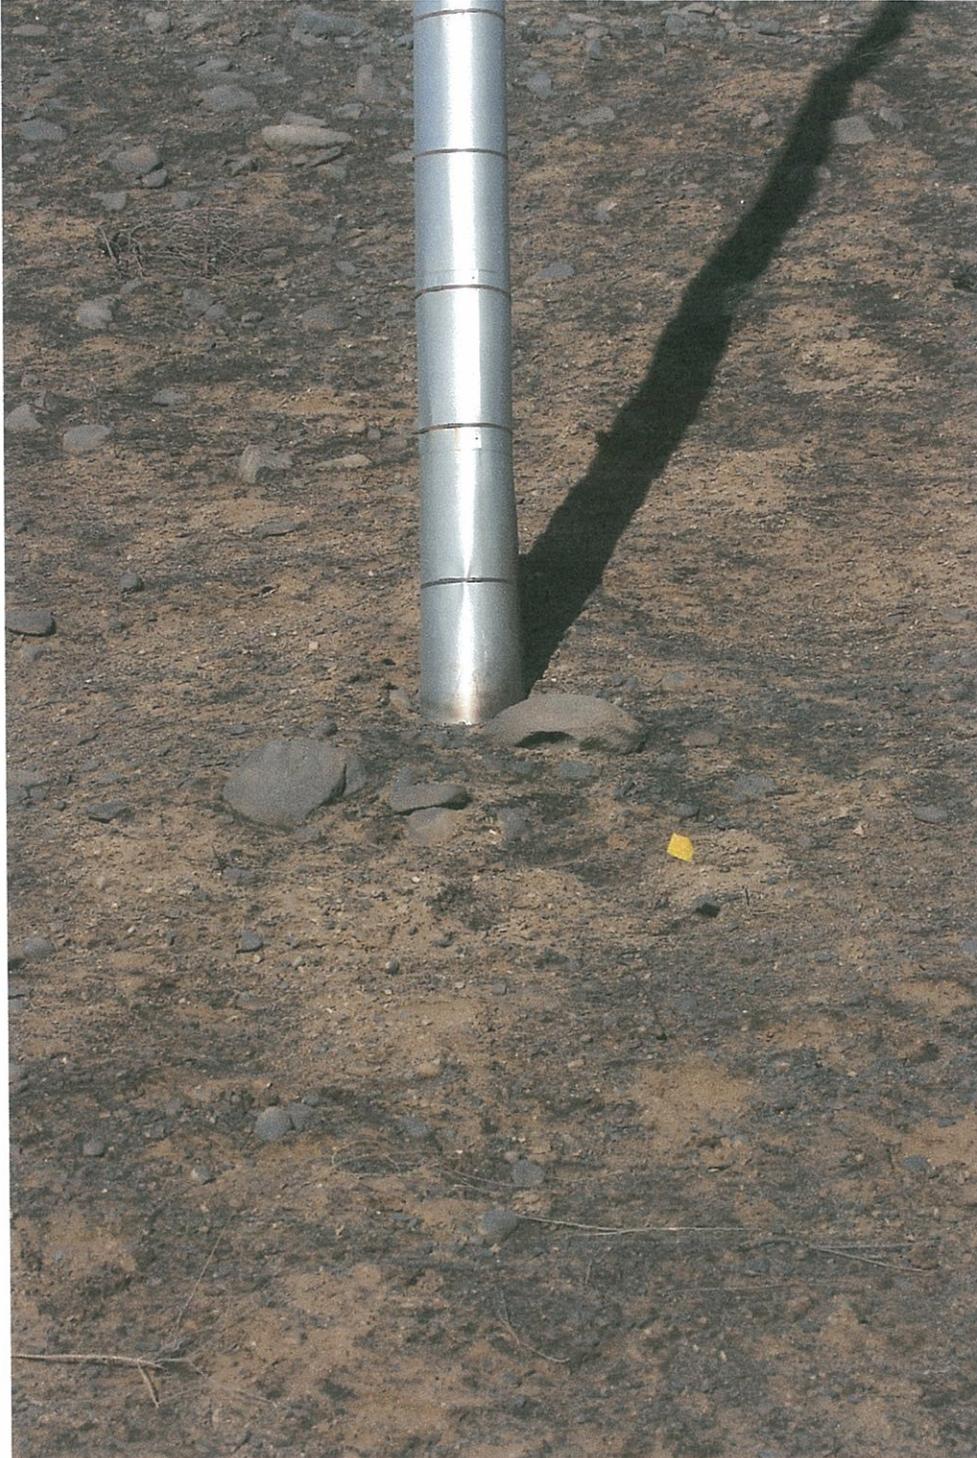
Picture # 8

A nut similar to the size used to secure the carriage bolt extending through the lower cross arm's V-brace was located on the ground approximately six feet south of the base of the subject power pole. The location of the nut on the ground was marked with a yellow flag and photographed (Photo I.D. # 2-85)

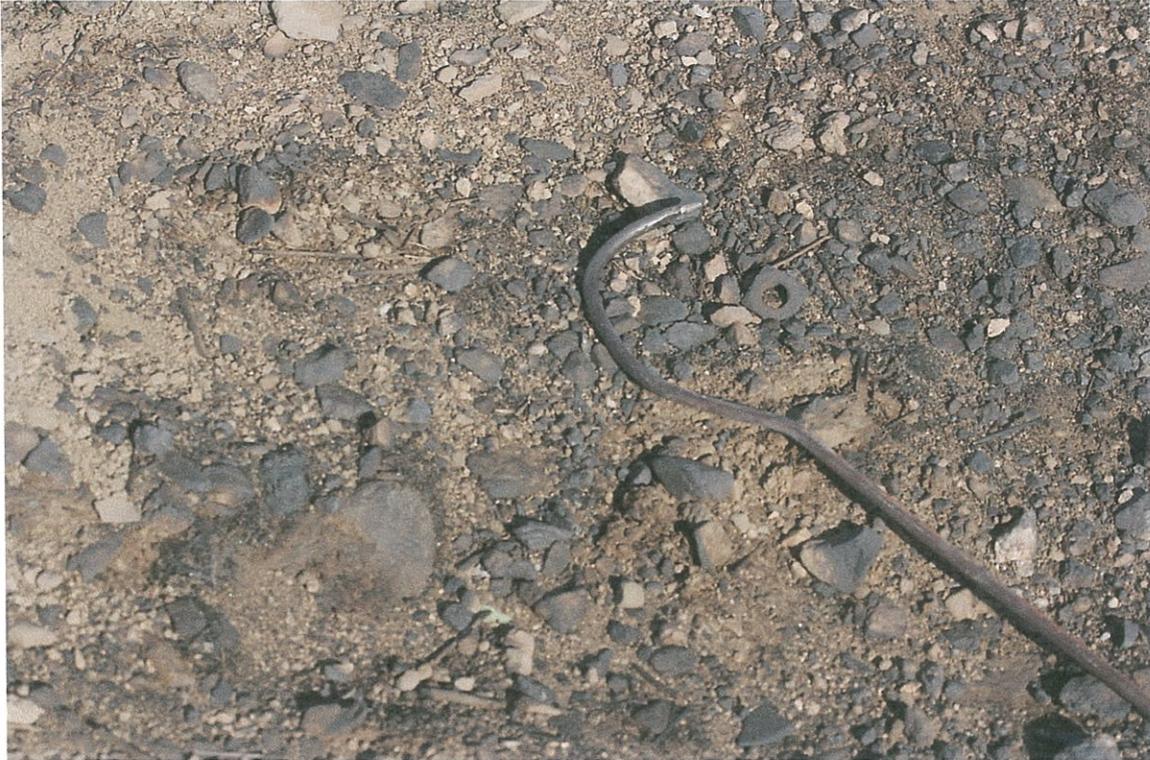
Picture # 9

Close-up photo of the nut; the hook adjacent to the nut was placed on the ground as a size reference, and the hook opening is 4-1/2 inches (Photo I.D. # 2-83, pm)

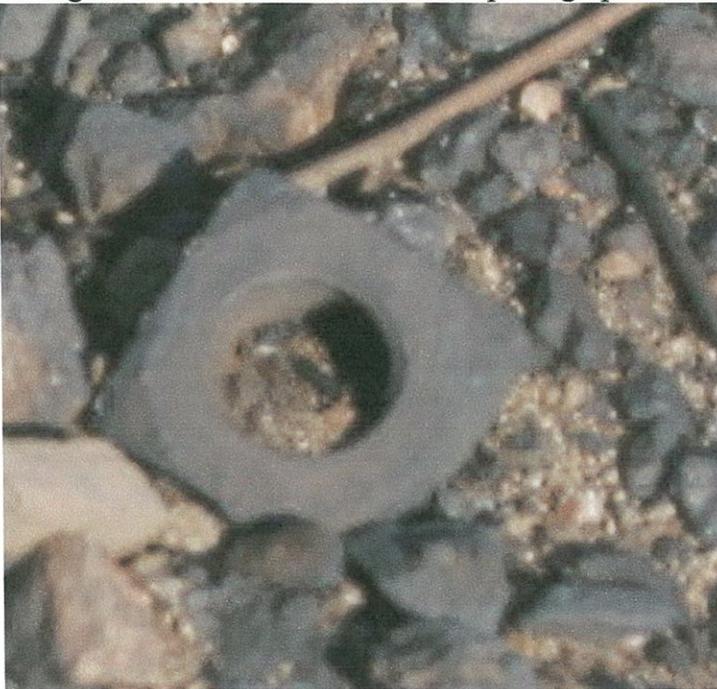
Photo # 9A

Enlarged view of the nut in the above photograph.

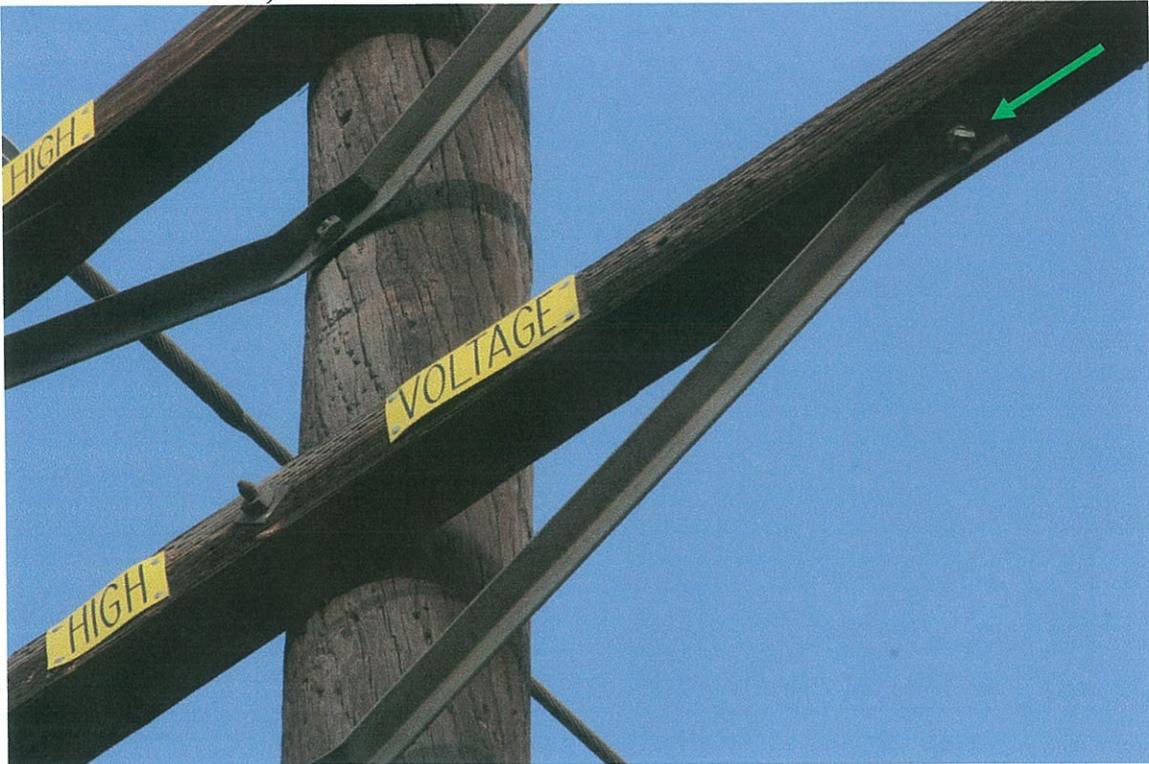
Picture # 10

View of lower cross arm after repairs had been made. Note the nut in place securing the lower cross arm V-bracket is similar in shape and size to the nut seen in the image (Photo I.D. # 6-15 11-06-07)

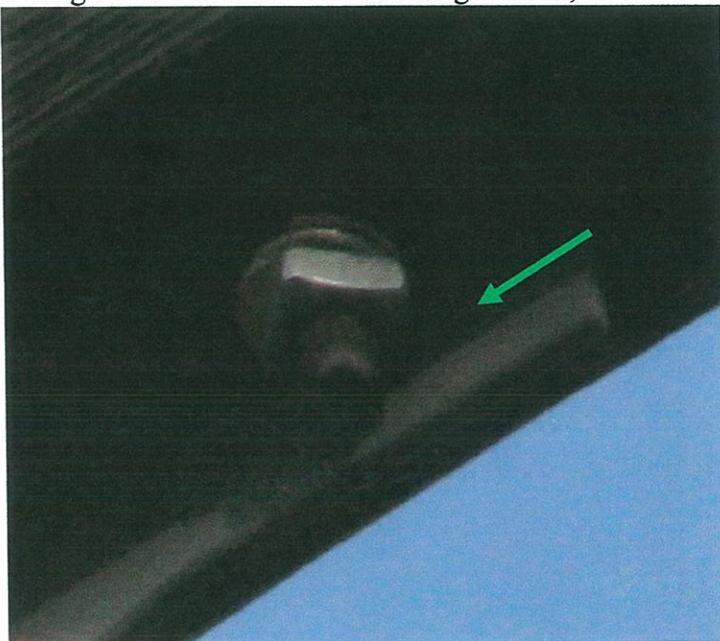
Photo # 10A

Enlarged view of the nut in the image above;

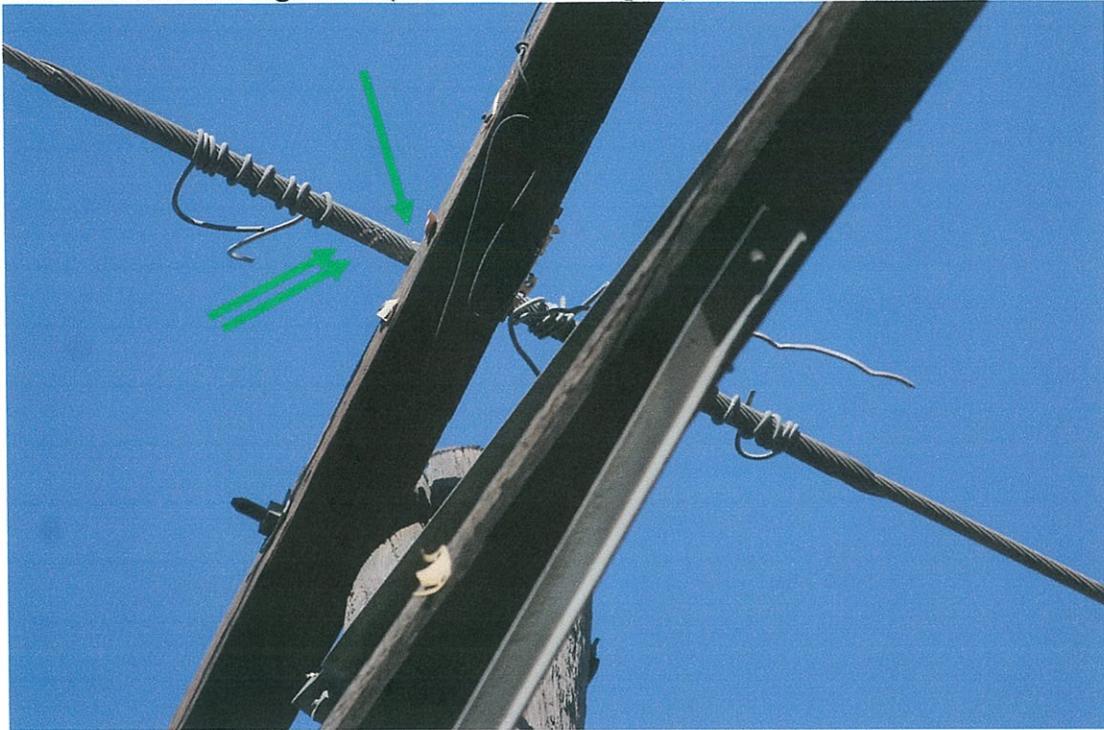
Picture # 11

Evidence of arcing against the center conductor that had detached from its insulator is visible in this image, which also shows the loose aluminum tie wires hanging free. The arcing was evident by the appearance of twin side-by-side grooves fused into the center conductor on both its underside and south-facing side. The aluminum tie wires are on each side of the twin grooves (Photo I.D. # 2-79 p.m.)

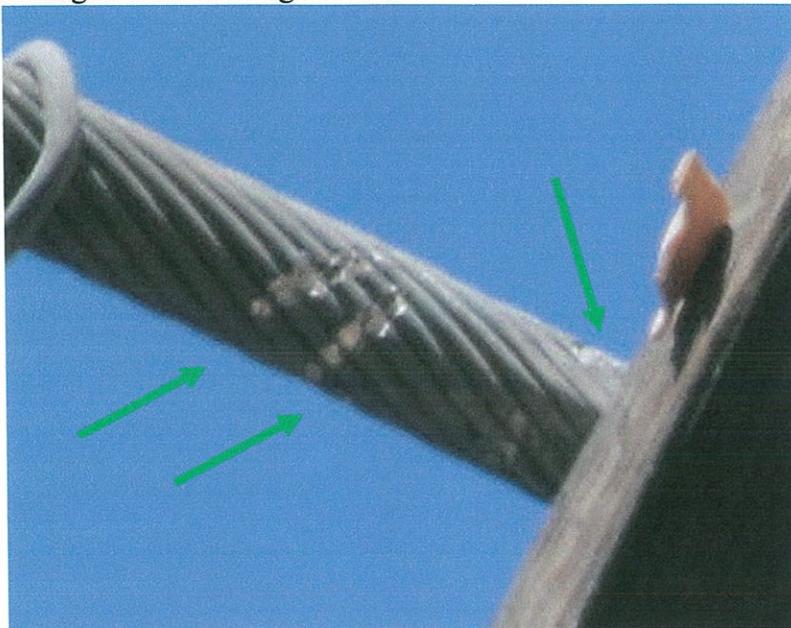
Picture # 11A

Enlarged view of image above.

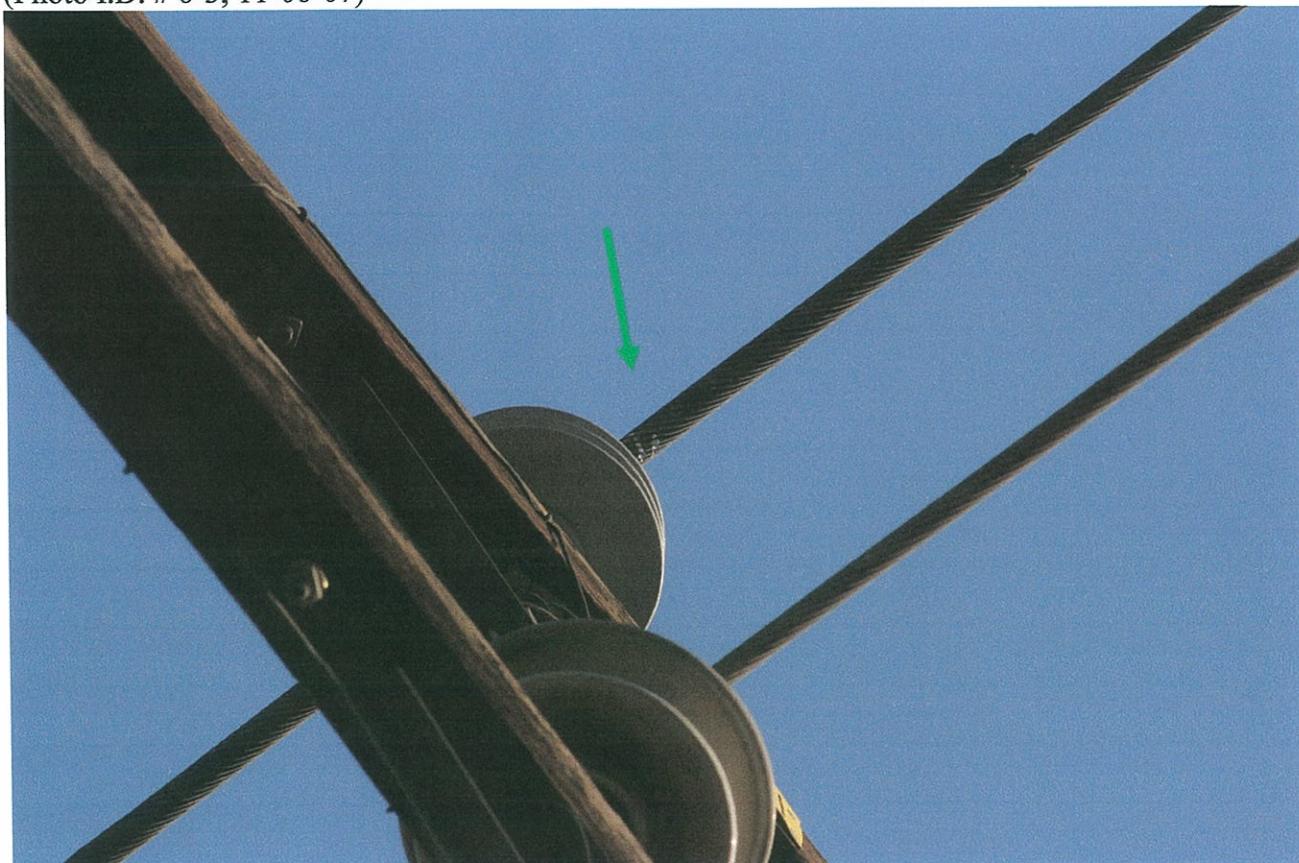
Picture # 13

On 10-23-07 at about 4:14 a.m. a new style insulator was installed in place of the insulator that originally secured the center conductor. The new insulator is shown in this image. Also shown from a different angle are the twin grooves photographed on 10-22-07. Note the aluminum tie wires are not present because the new insulator uses a clamping type system for holding the conductor in place. Also note there are no similar groove impression markings where the aluminum wire wrapping was located on 10-22-07; evidence the tie wires alone do not create grooves into the conductor (Photo I.D. # 6-3, 11-06-07)

35 and said the insulator was "O.K.". I told PIMENTEL I wanted to see the center insulator,
36 so the crew removed the insulator and replaced it with a new insulator with a clamping-
37 type system for securing the conductor in place. At ground level I photographed the
38 aluminum tie wires and the top and bottom of the insulator. The top of the insulator did
39 not appear to be missing any pieces of porcelain around the collar or the three bell-shaped
40 convolutions. There was no discoloration that would indicate arcing had occurred
41 immediately on top of this insulator. There were scratch marks on the collar where the
42 detached conductor had slid back and forth across the rim of its top edge. The bolt
43 attached to the underside of the insulator was examined, and the portion of bolt that
44 would be protected by its insertion through the cross arm had evidence of discoloration
45 similar to burn marks. The three individual aluminum tie wires were examined, and they

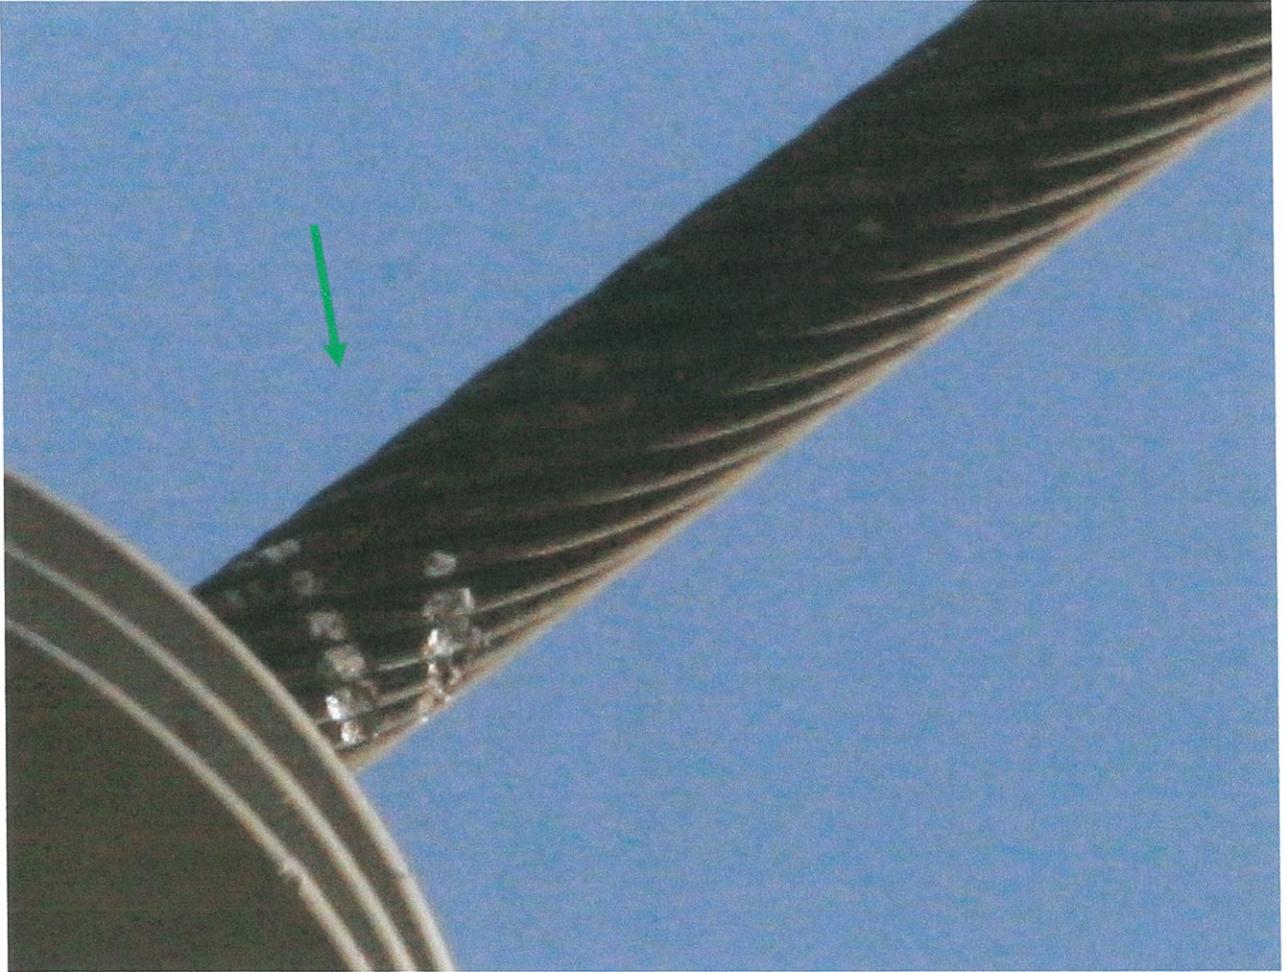
Picture # 13A

Enlarged view of the image displayed on page 40.

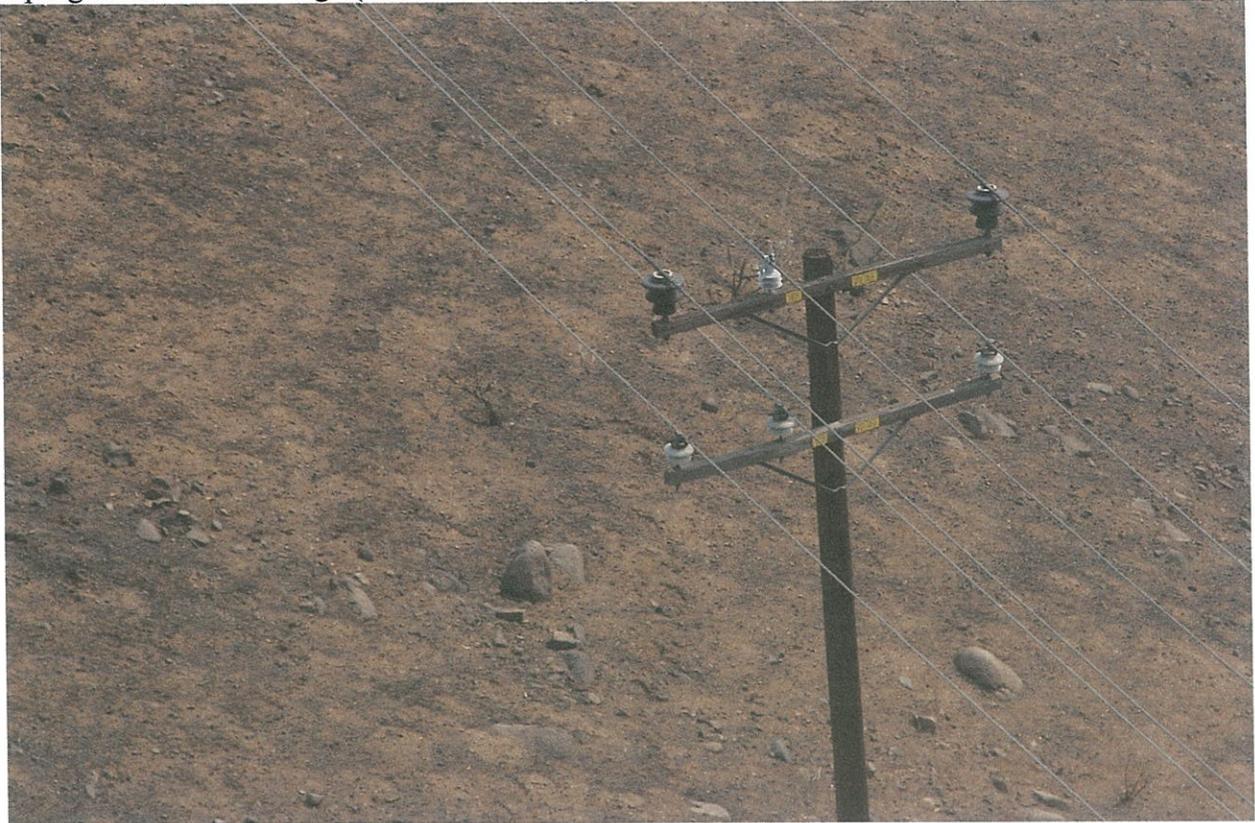
Picture # 14

An aerial photograph shows the new insulator on the top cross arm, distinguished by its grey color compared to the larger dark brown porcelain insulators on each end of the cross arm. The conductor attached to the upper cross arm's grey insulator is the "Center" conductor with the twin grooves. The day of the fire, the center conductor was hitting against the top cross arm insulator on the southwest end identified as the insulator in the top right side of this image (Photo I.D. # 4-31)

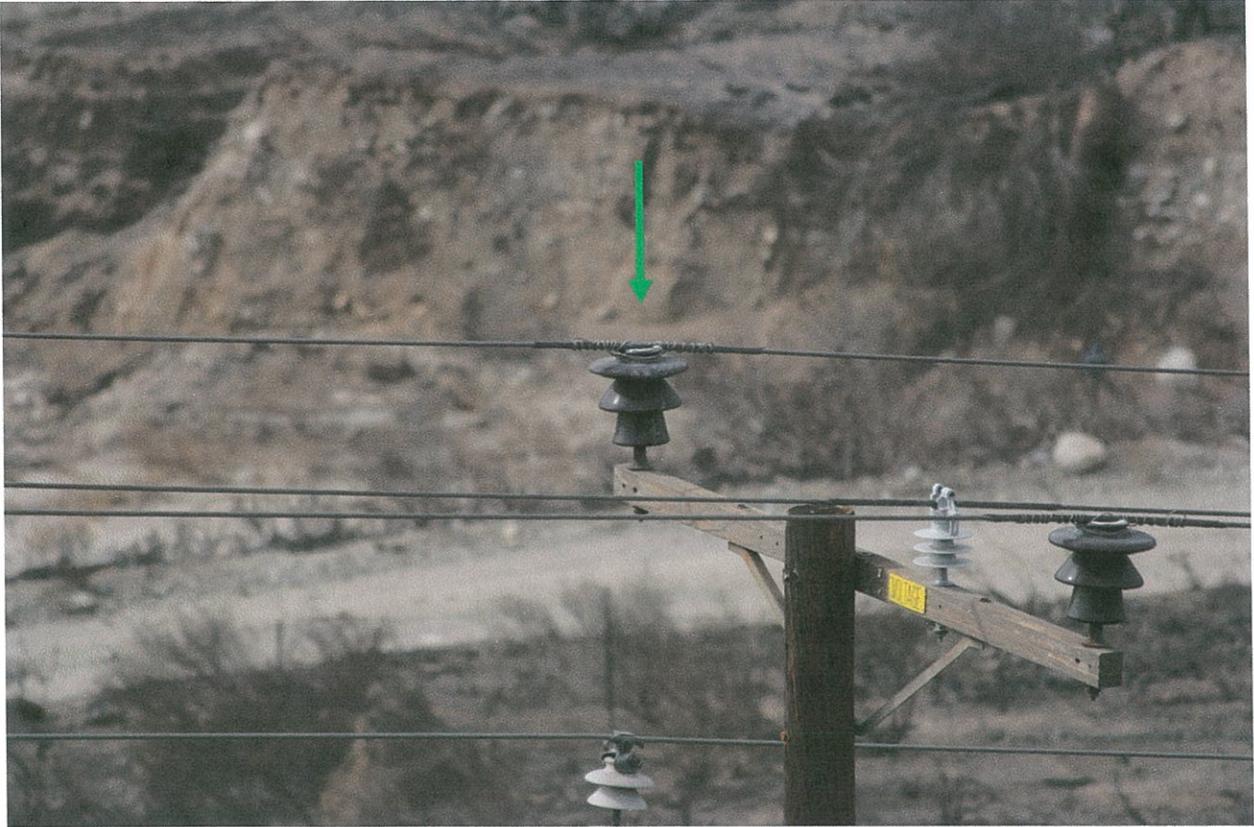
Picture # 15

The brown porcelain insulator shows evidence of scrapes against the side facing the center conductor. There is also evidence of contact on top of the conductor on the southwest end insulator, as well as the appearance of "flash burn" discoloration on the insulator and on the aluminum tie wire wrapped around the insulator's collar. This would indicate the contact area that resulted in the arcing (Photo I.D. # 5-20, 11-04-07).

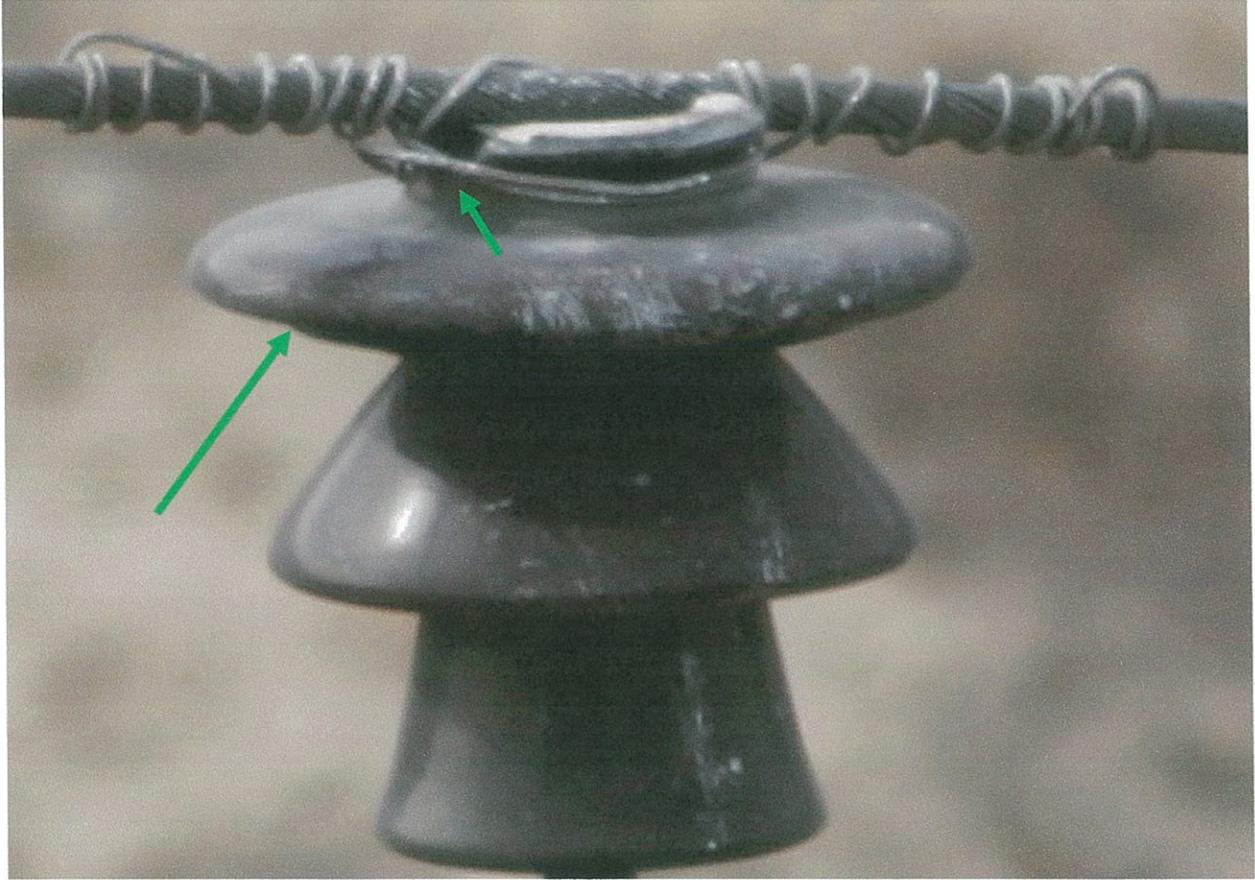
Picture # 15A

Enlarged view of the photo subject area shown in the image on 43 showing contact marks and “flash burn” discoloration.

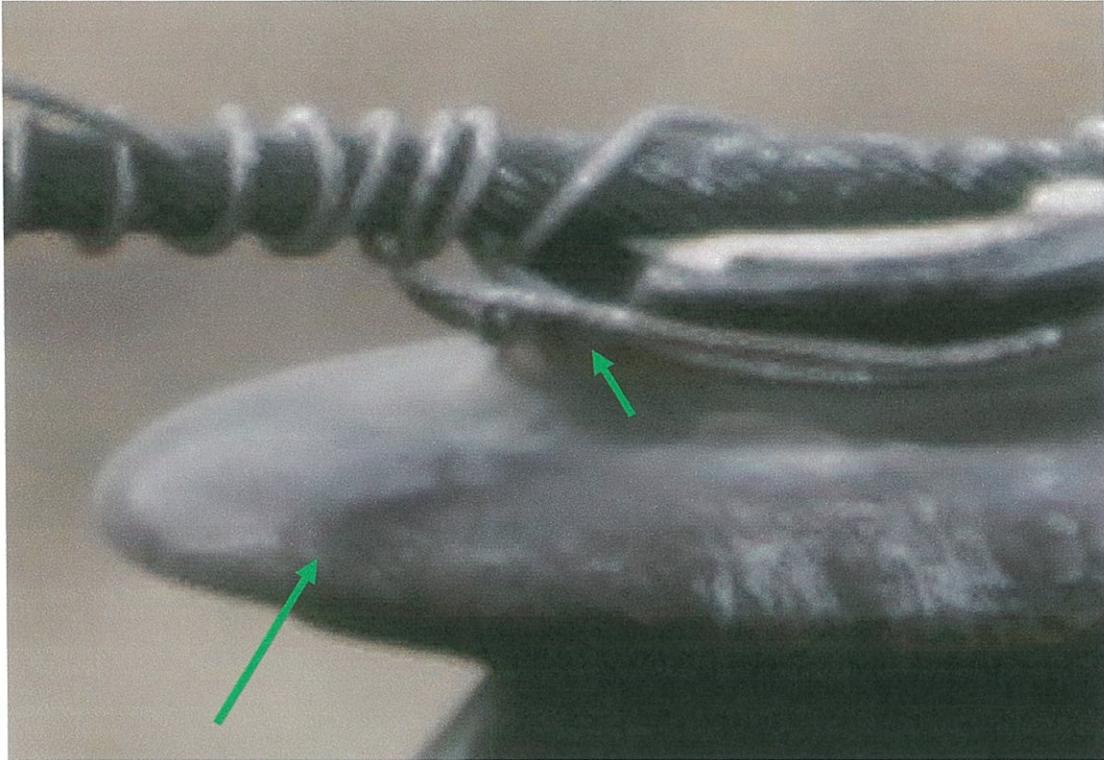
Picture # 15B

Enlarged view of the photo subject area shown in the image on 43 showing contact marks and "flash burn" discoloration.

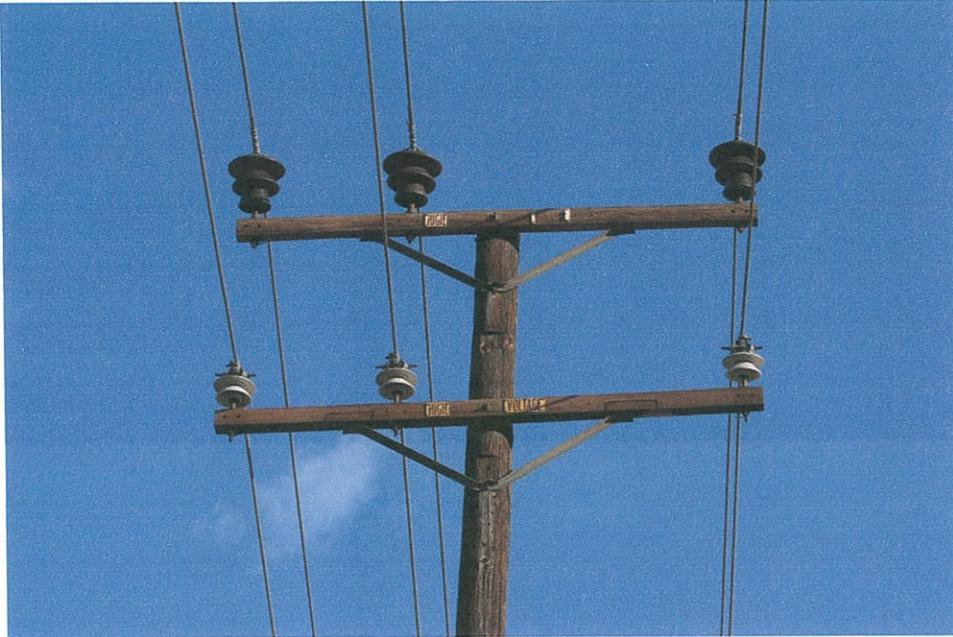
Picture # 16

Looking east at the power pole located two poles southeast of the subject power pole. The lower cross arm V-brace is missing one nut (Photo I.D. # 8-12).

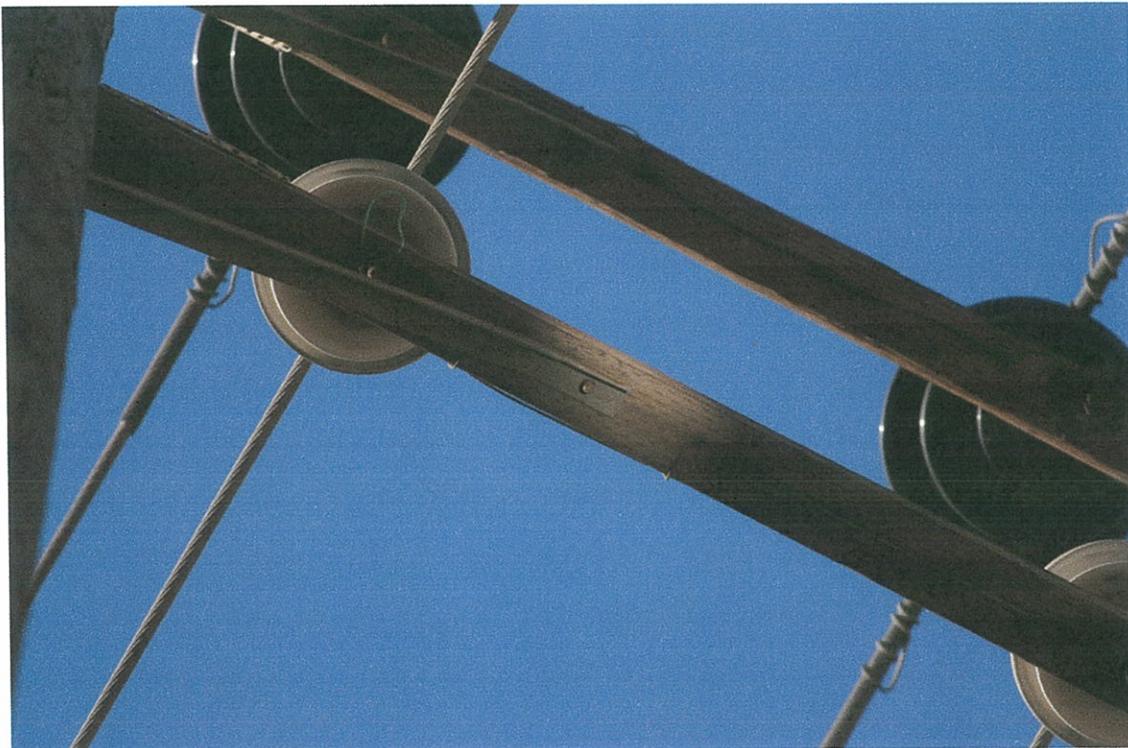
Picture # 17

Looking west at the same power pole in the above image showing the missing nut on the lower cross arm (Photo I.D. # 8-4).

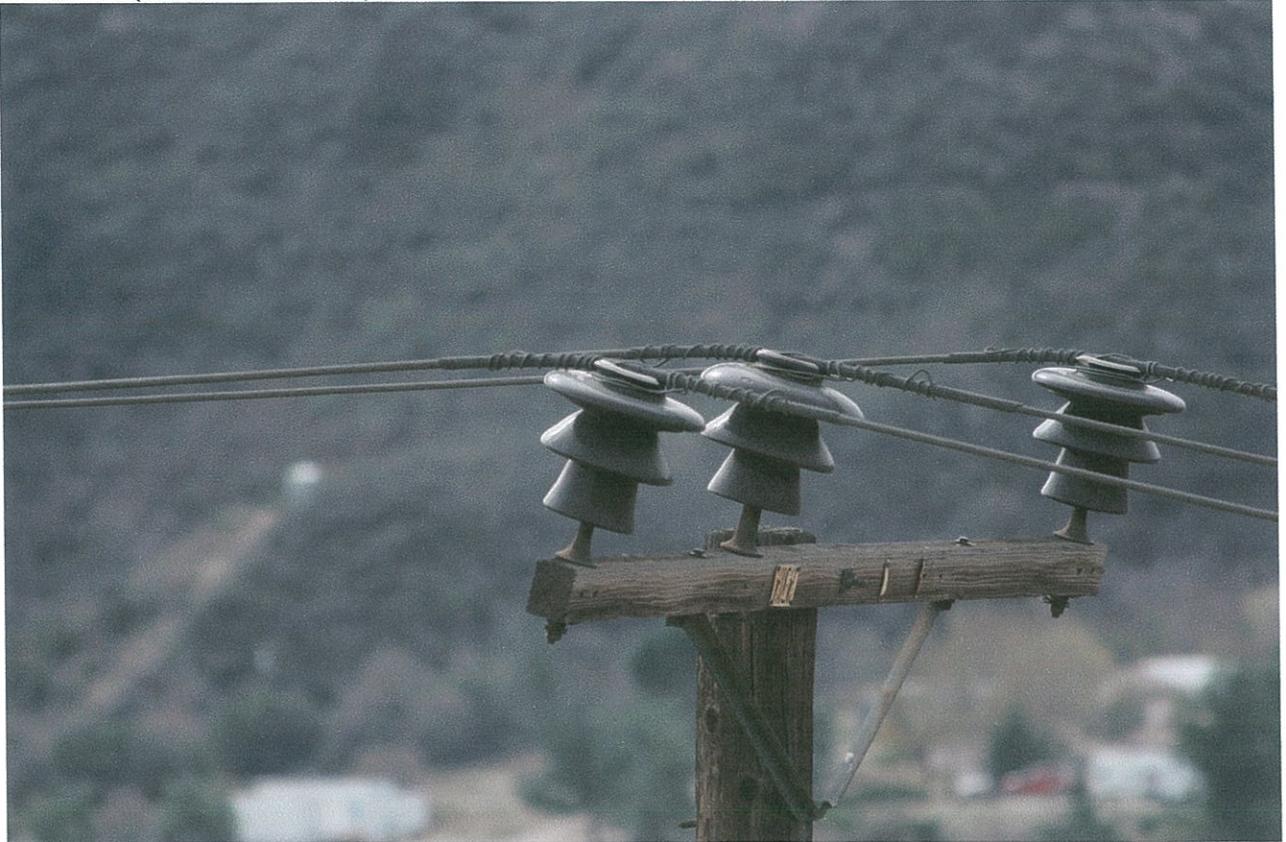
Picture # 18

Side view of same cross arm and insulators shown on page 46 indicate the tension of the conductor appears to pull on the tops of the insulators resulting in twisting of the upper cross arm (Photo I.D. # 5-32).
