DEPARTMENT OF FORESTRY
AND FIRE PROTECTION

INVESTIGATION REPORT

Case Name: Cajon

Date: October 22, 2007

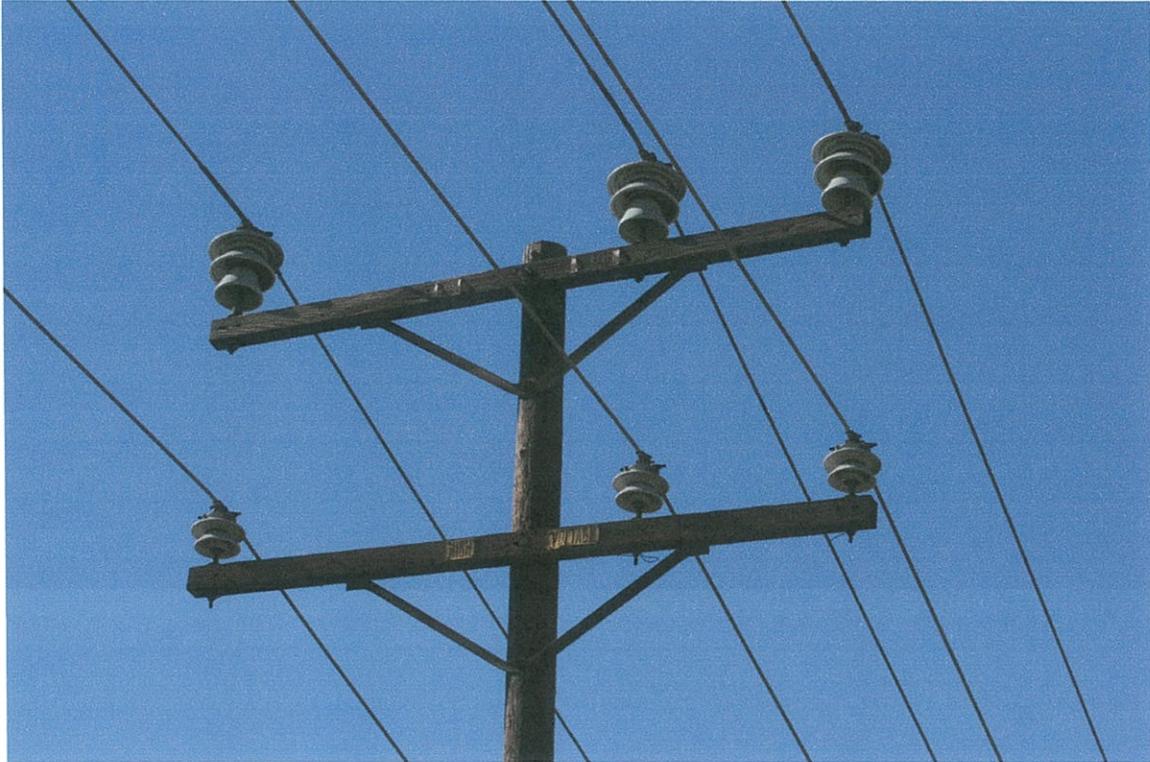
Picture # 19

Looking west at the power pole located three poles southeast of the subject pole. It is missing both nuts that secure the V-brace to the lower cross arm (Photo I.D. # 9-3)

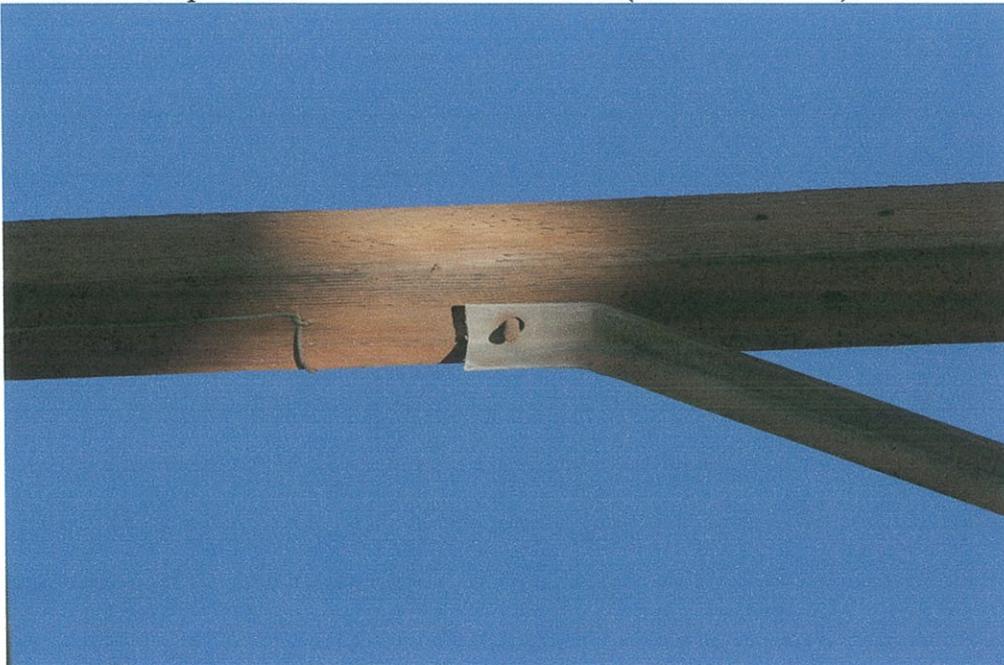
Picture # 20

Showing the missing nut from the carriage bolt on the lower cross arm's southwest end; located on the pole shown above in Picture # 19 (Photo I.D. # 9-6)

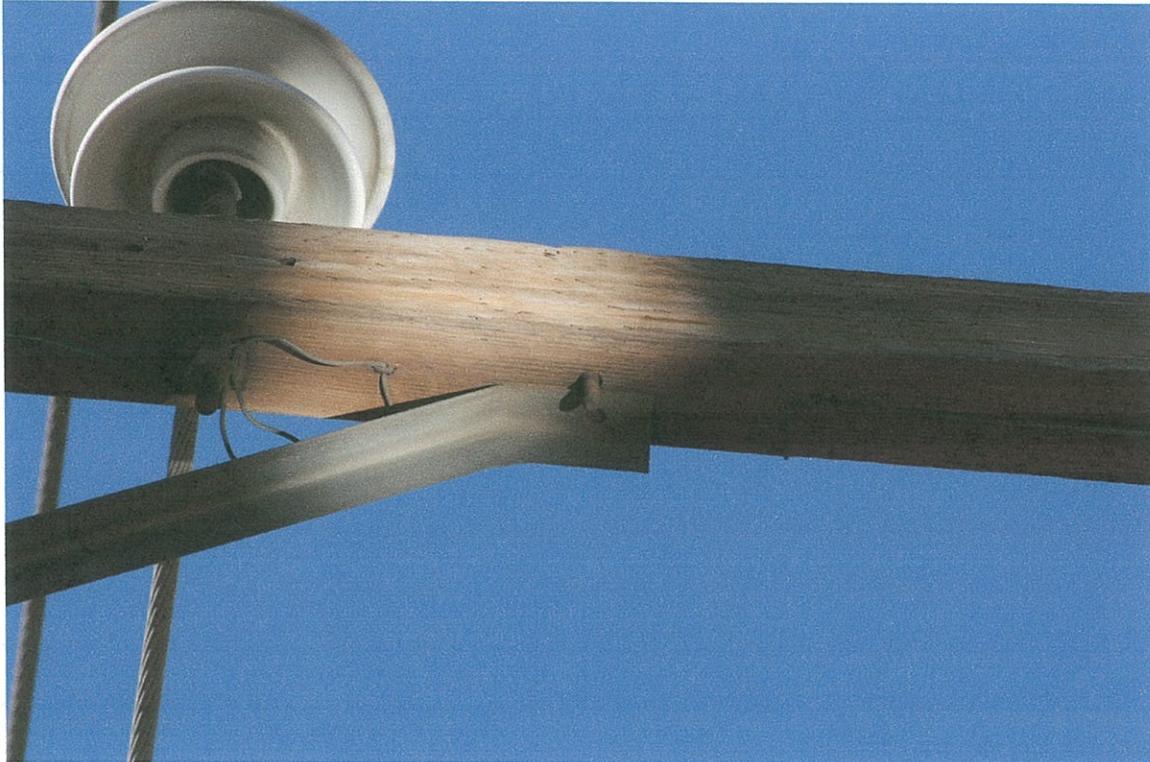
Picture # 21

Showing the missing nut from the carriage bolt and it's location on the outside of the V-brace on the lower cross arm's northeast end; located on the pole shown above in Picture # 19 (Photo I.D. # 9-4)

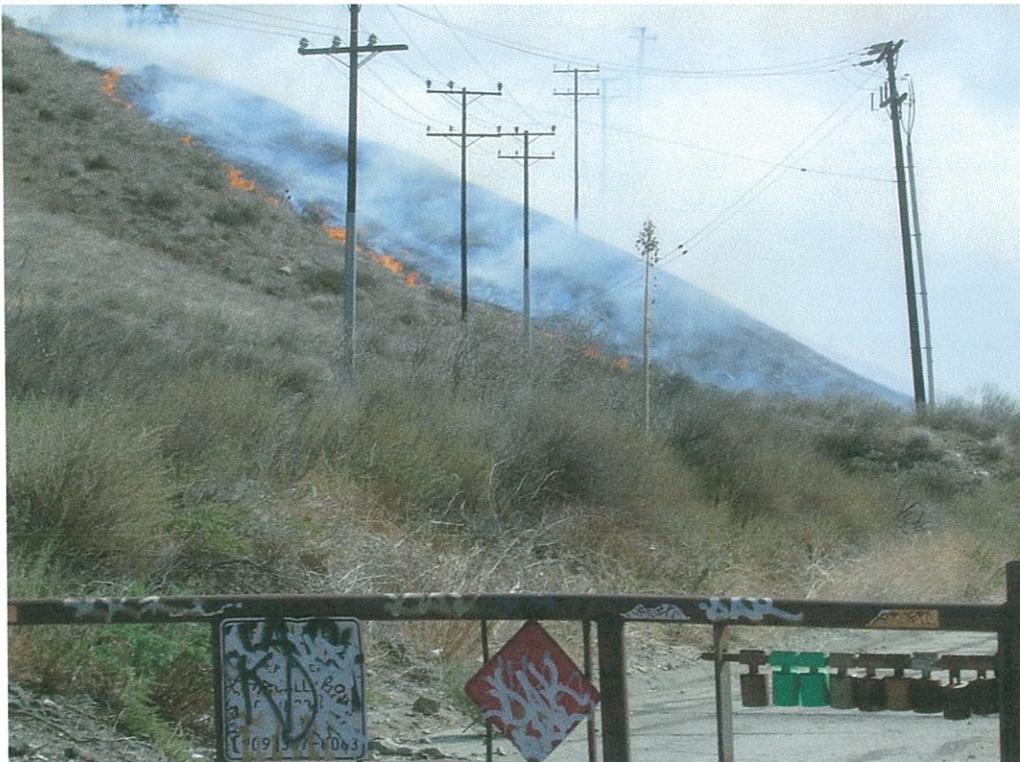
DSCN3053

Photograph taken by W-8 CAMPBELL several minutes after the fire started. He was facing the northeast while located at the intersection of Cajon Boulevard and Kenwood Avenue. The fire was burning near the base of the subject pole on the northeast/east/southeast side of it. (Photo I.D DSCN3053, Evidence Log I.D. # 1E)
