## OVERVIEW OF THE SPYGLASS ACCIDENT

### Spyglass Ridge Road

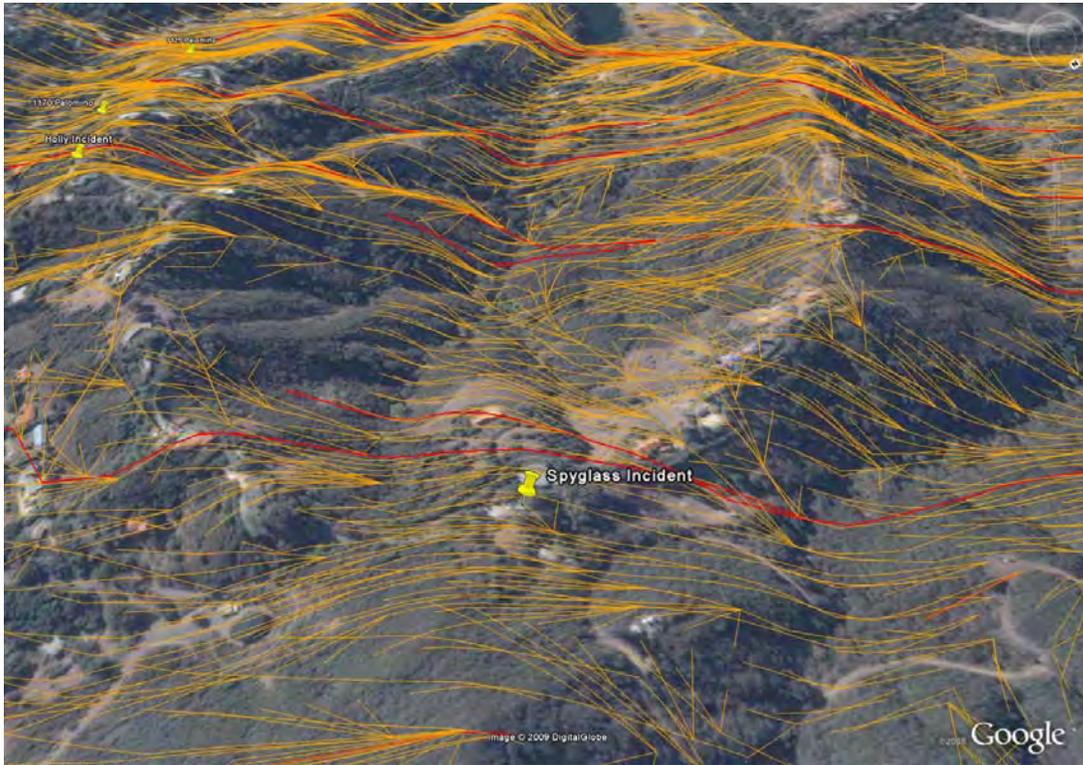
The location of the residence as it sits at the top of three drainages, with heavy fuel loading and numerous structures and out buildings caused the fire behavior to greatly increase.

The orientation of the structures and vegetation caused the fire to funnel up the driveway which was also the escape route back to VNC E-54.

Fire path at 1495 Spyglass Ridge Road

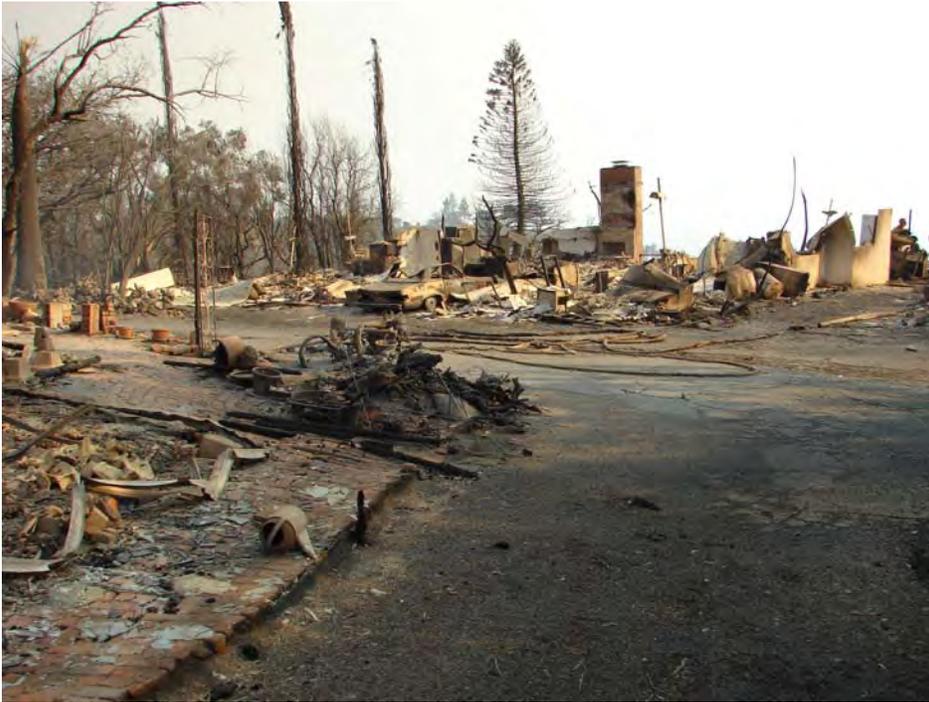
1495 Spyglass Ridge Accident site

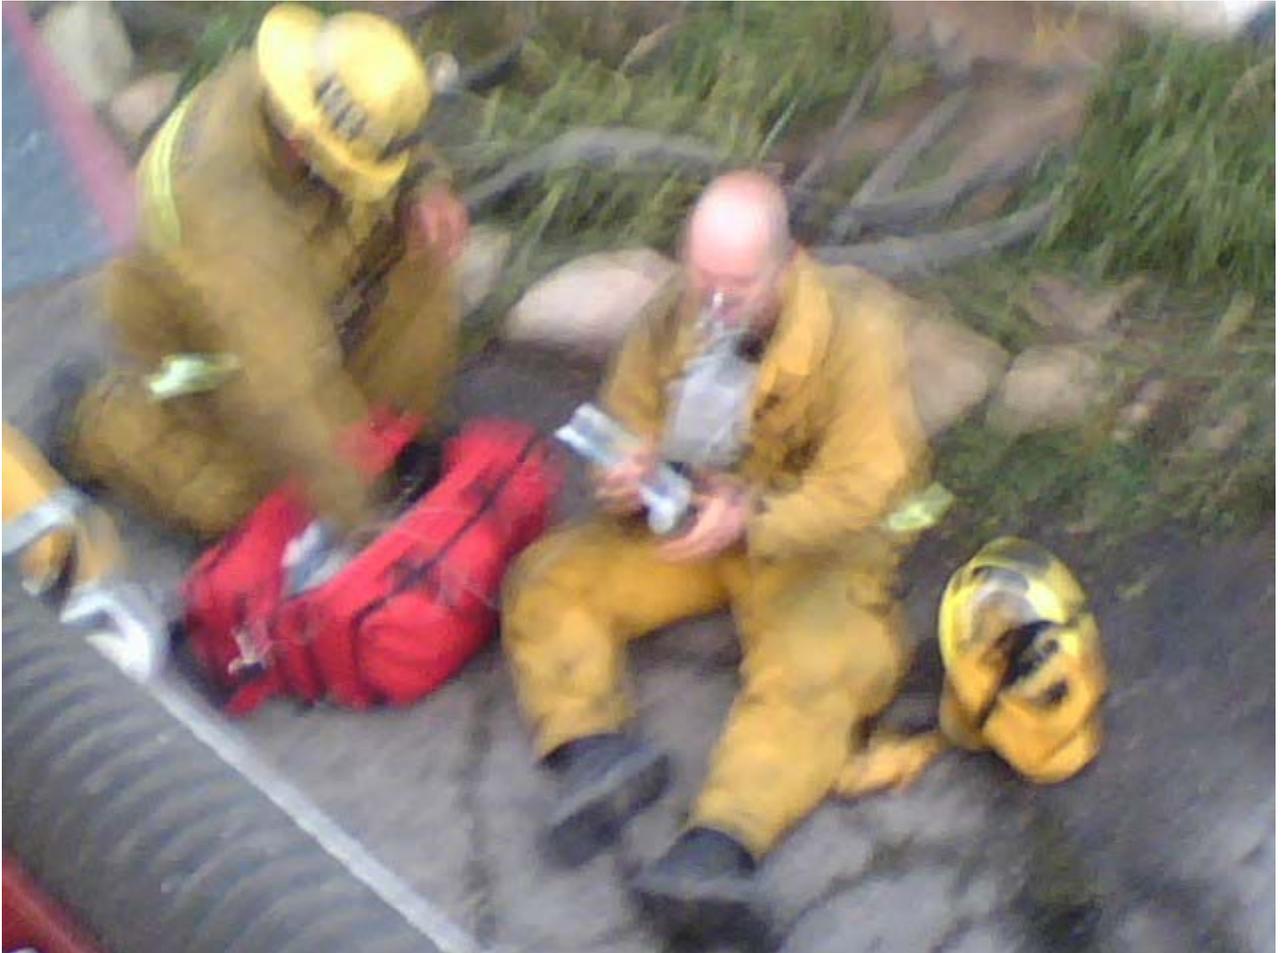
Firefighter at 1433 Mission accident site receiving breathing treatment.

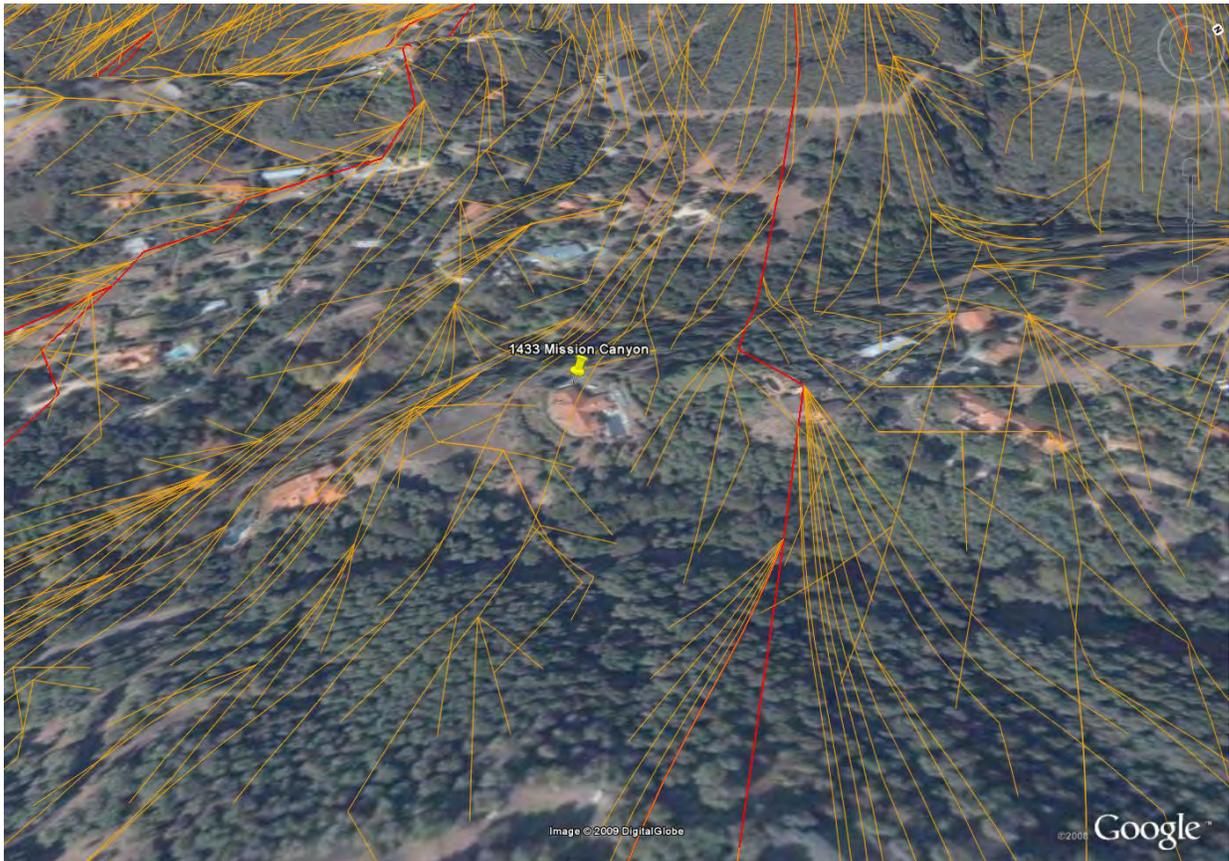
Fire path at 1433 Mission Canyon

Fire was coming from the northwest, from top to bottom in the photo

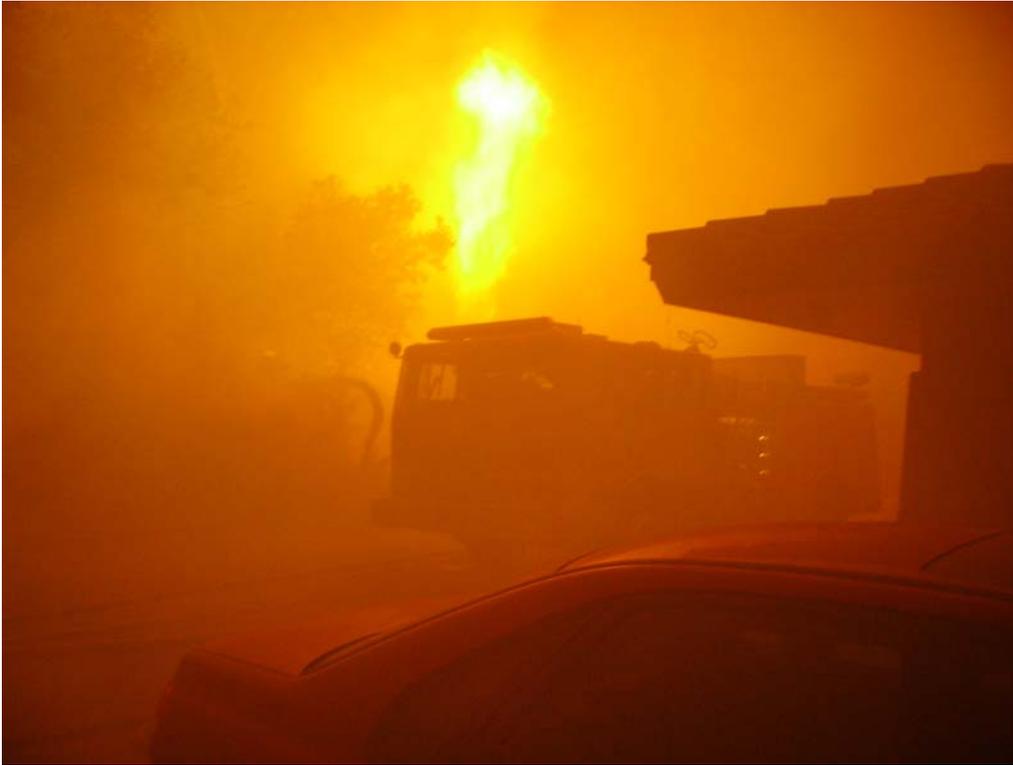
Propane tank venting at the 1433 Mission Canyon accident site

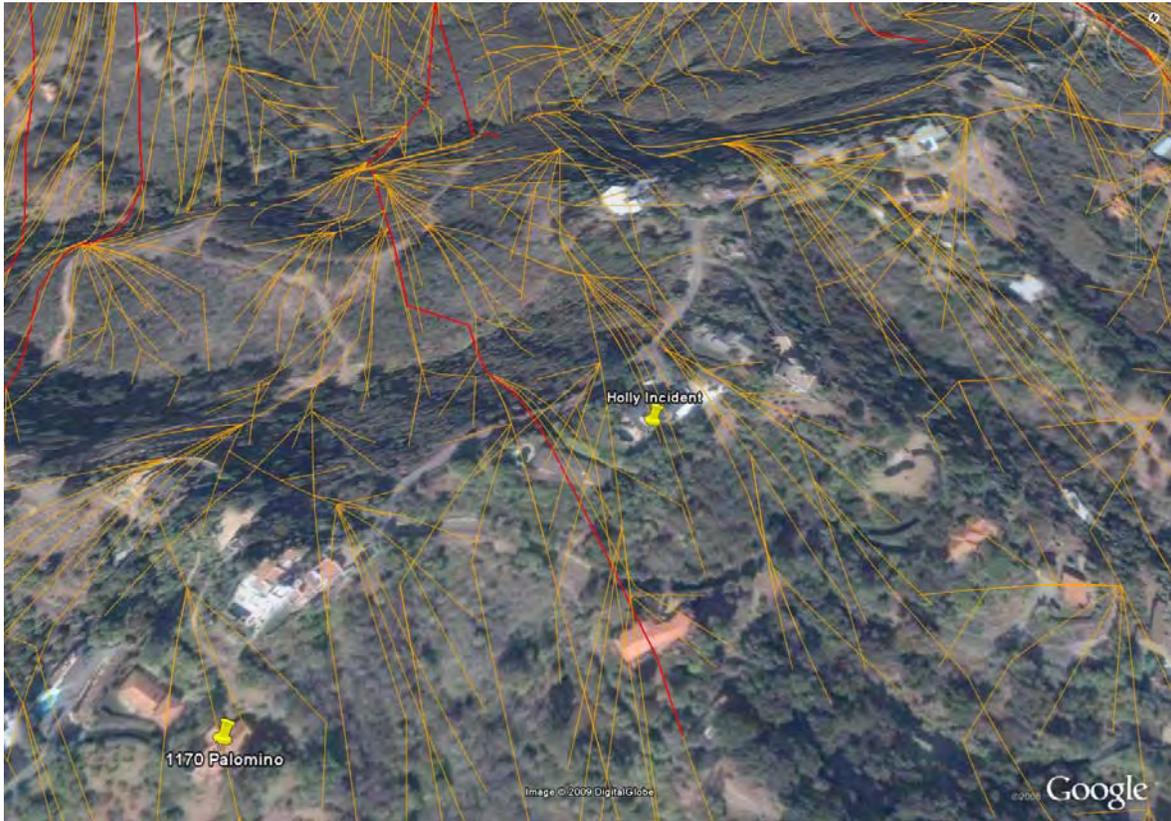
Fire path at Holly accident site.

Fire came from the northwest, from top to bottom in the photo.

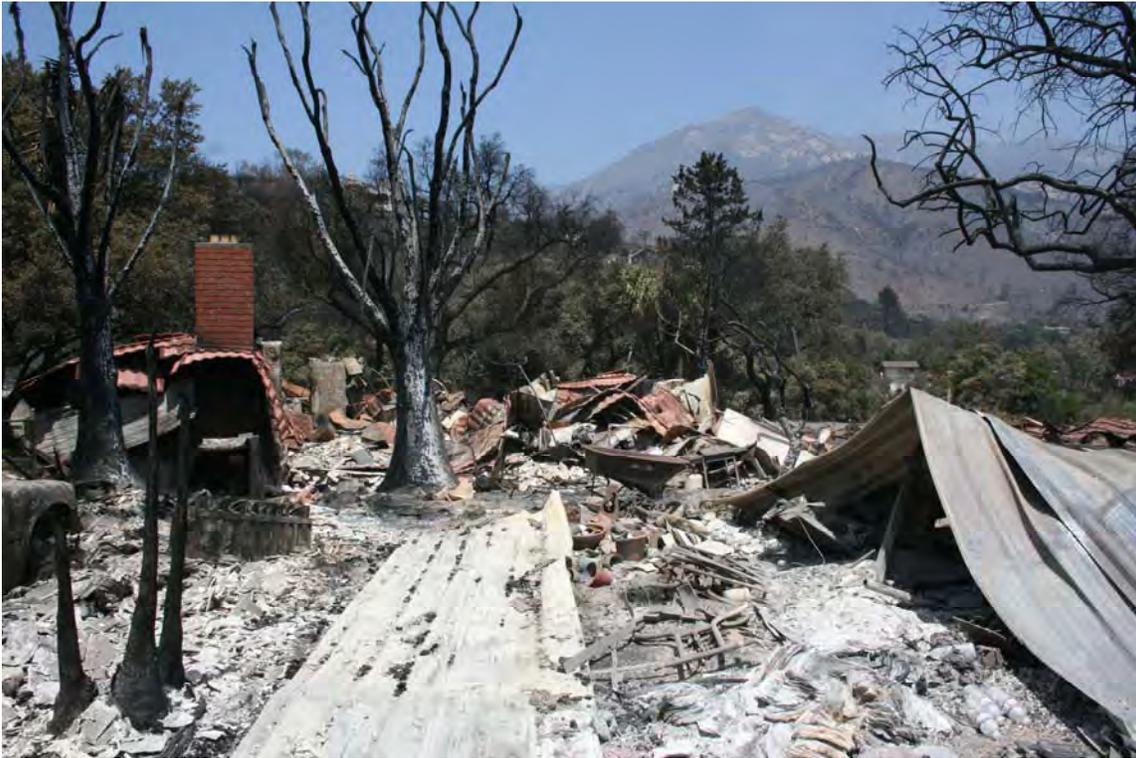
The residence at 1165 Tunnel #G failed its LE-100 inspections in 2008. The inspection program for 2009 had not started. This residence was not destroyed during the fire but the residences at 1255 and 1165 #A Tunnel were destroyed.

1165 Tunnel #G all outbuildings were destroyed.

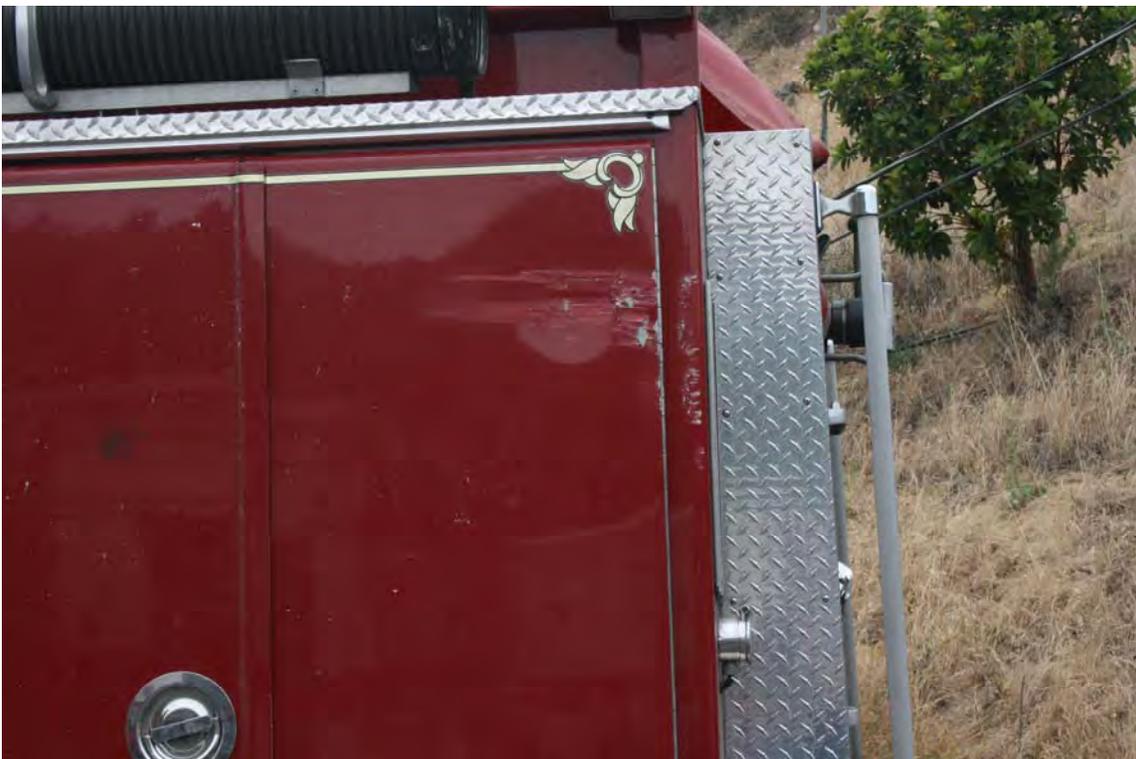
SPA E-81 received damage to the left rear upper compartment door and the body had scraping damage consistent with striking a concrete wall. The chrome bezel around the left rear stop, turn signal and back up light assemblies had scrape damage.

Santa Paula City E-81, damage from hitting block column.

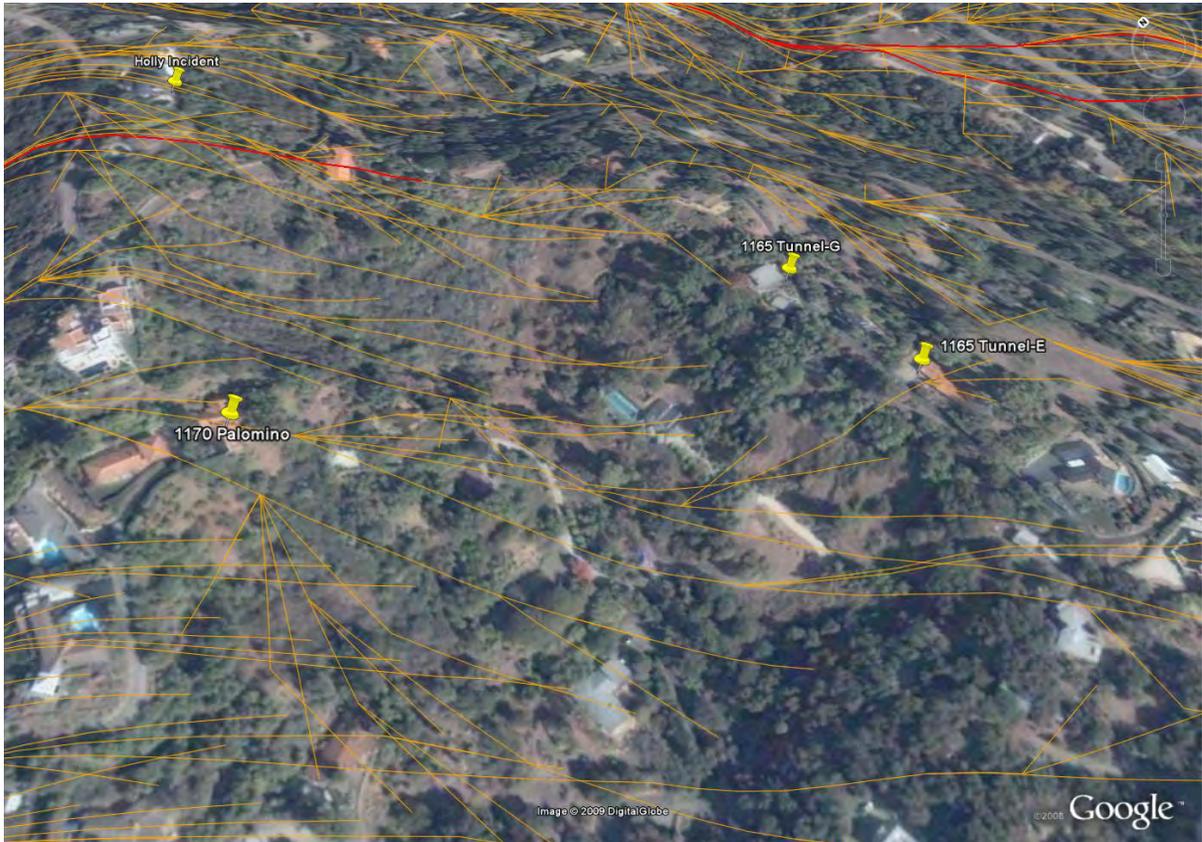
Fires path at 1165 Tunnel # E & #G

The fire came from the northwest which would be from left to right on this photo.

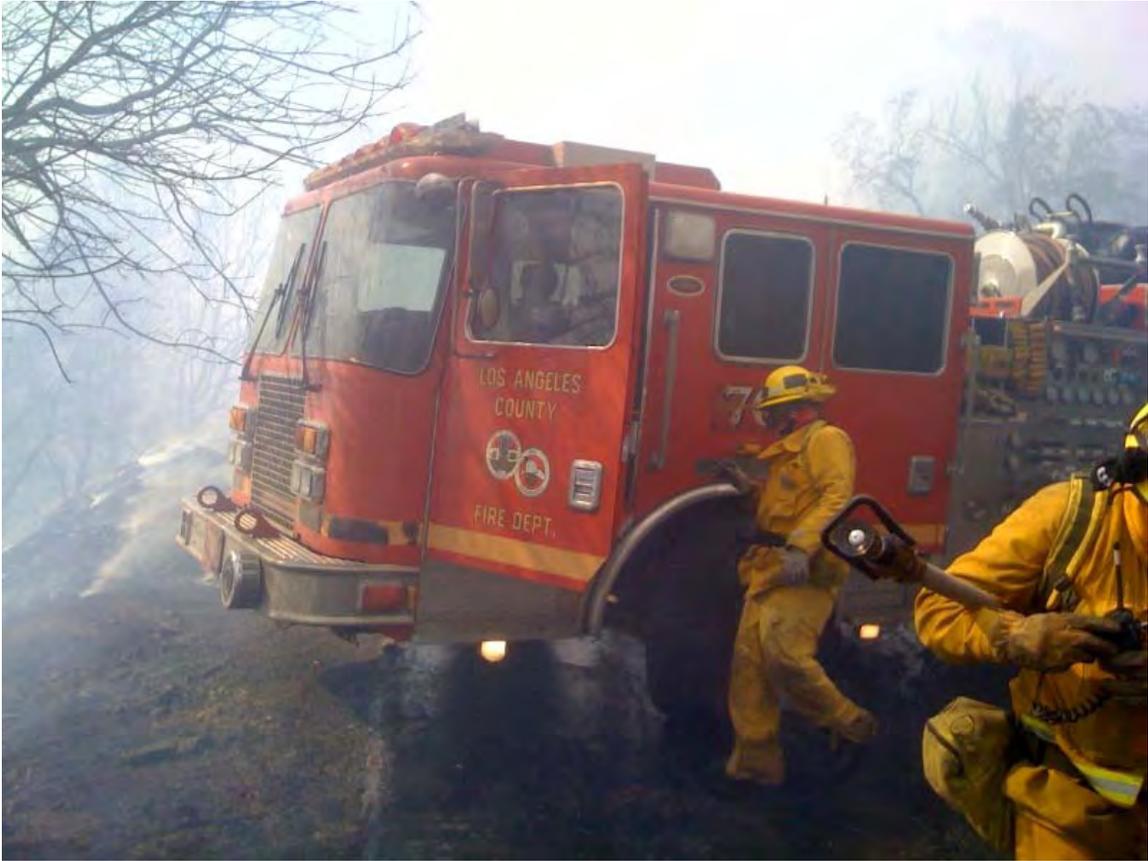
LAC E-70 had moderate fire damage to the complete front side of the vehicle, including cracks to both front windshields and the cab mounted light bar destroyed. Left side tires were damaged. The motor had stalled on the incident, and the crew discovered the air cleaner had burned.

LAC E-70 was equipped with an ember screen on the motor air intake. During the firefight, a burning ember went into the front air intake, burning the air filter which caused the motor to stall.

LAC E-70 at the Palomino residence

All engines should be inspected annually to make sure they have an ember screen to prevent the air filter from burning.

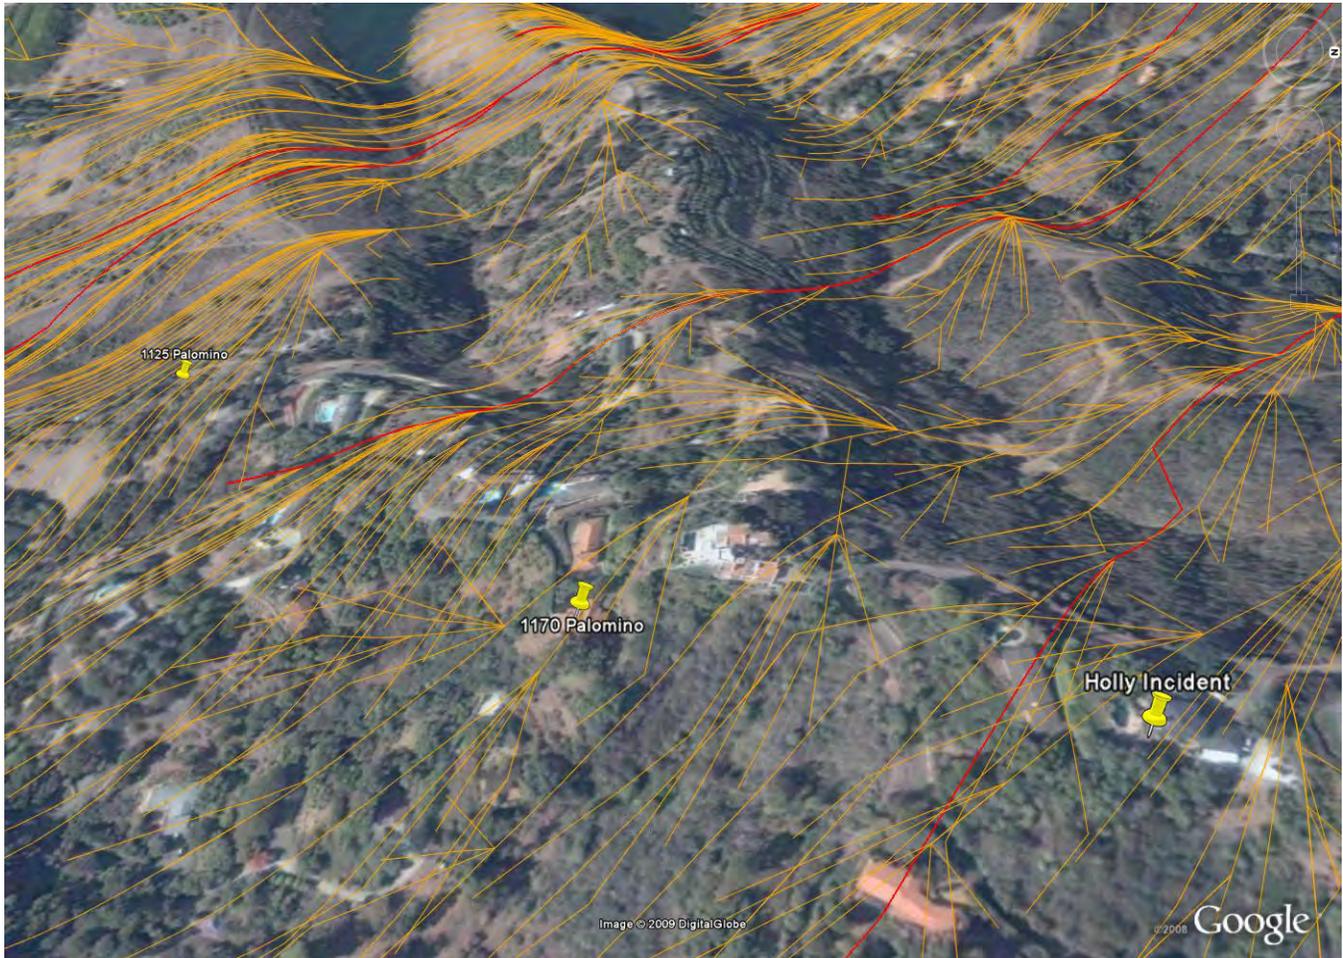
Fire path at 1125 Palomino Road

Fire came from the northwest which is the top right to bottom left in the photo.
