Excavation of the Franklin House Foundation  
Along San Diego Avenue  
Old Town San Diego State Historic Park

Jim Woodward and Dan Foster

January 1982

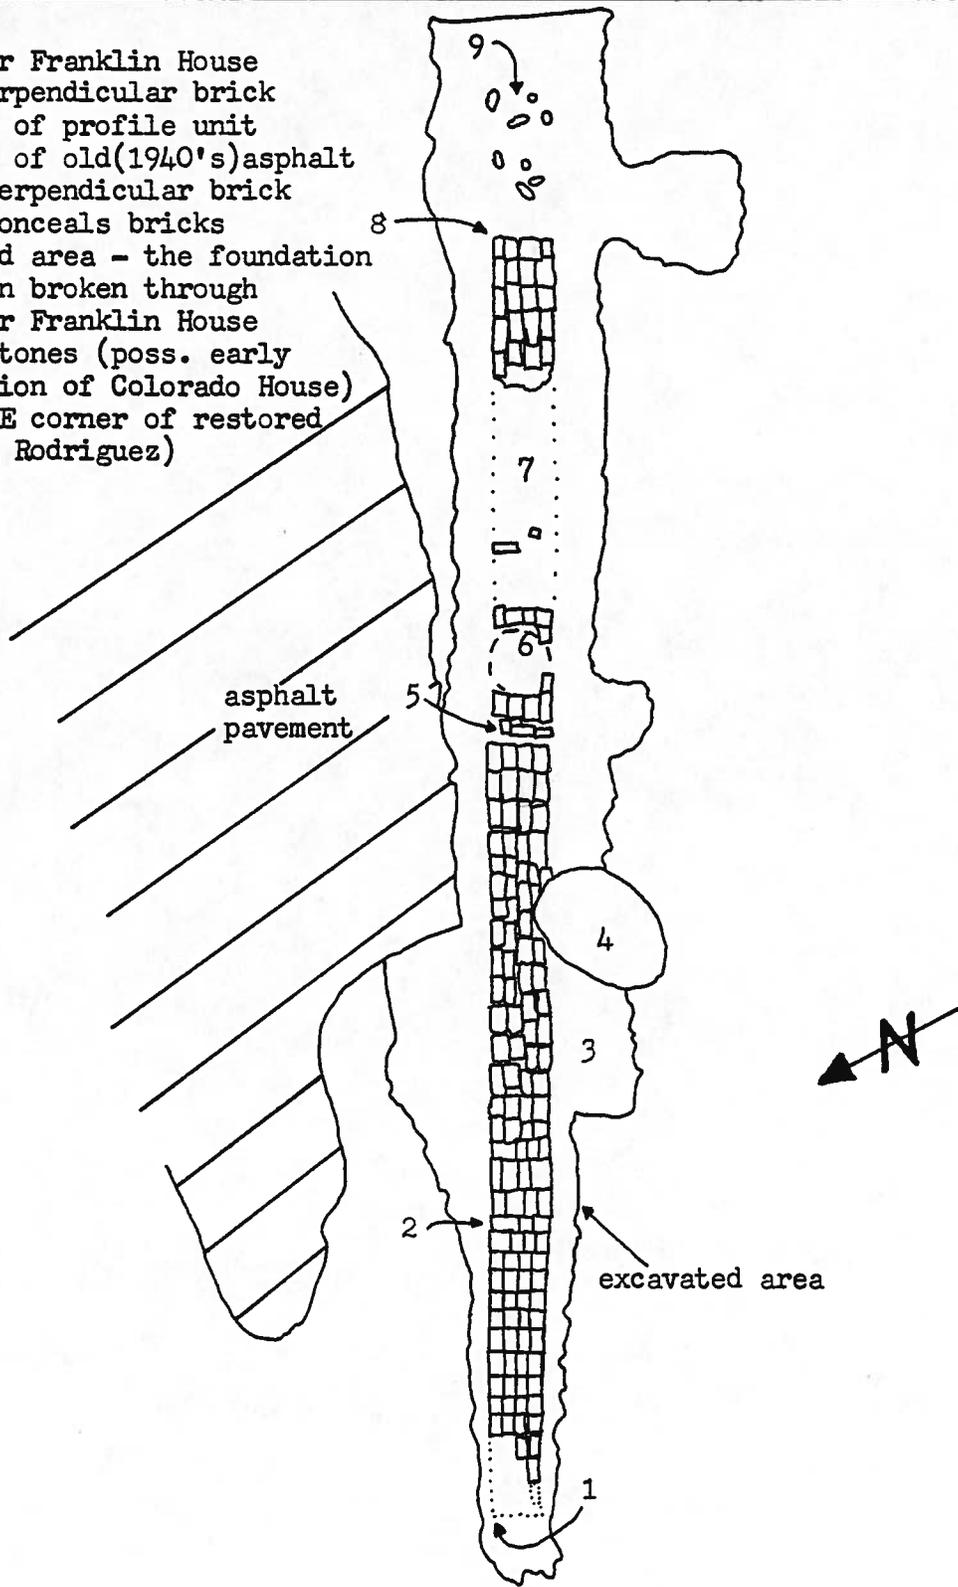
FIGURE 1  
 NORTH FOUNDATION WALL  
 FRANKLIN HOUSE EXCAVATION  
 March 18, 1981  
 D.Foster  
 J.Woodward

The first and most obvious feature encountered is a mortared brick foundation wall. This wall is 30' 9" long, 16" wide, and 16" - 20" thick. It is made of locally manufactured bricks, 4 courses wide and 4 to 5 courses high. The wall is nearly continuous. Only the western end and a portion near the eastern end is disturbed. The bricks vary in size and color and lack any makers mark. Some bricks show evidence of having been burned as they exhibit a bluish tint and fractured edges. Some may have been re-used from an earlier structure. Fire scars were observed on the surfaces of bricks which were subsequently mortared together. The bricks are mortared end to end except in two places where a single course is mortared end to side (see Fig. 1). These vertically aligned bricks probably mark the placement of internal walls, and are apparently aligned with the position of the veranda support posts farther out in the street. (See the Henfield photo of 1867 in Engstrand and Brandes 1976:4.) Beneath the brick wall was found a thin layer of mortar or lime.

\* see photographs for a more accurate view of brick arrangement

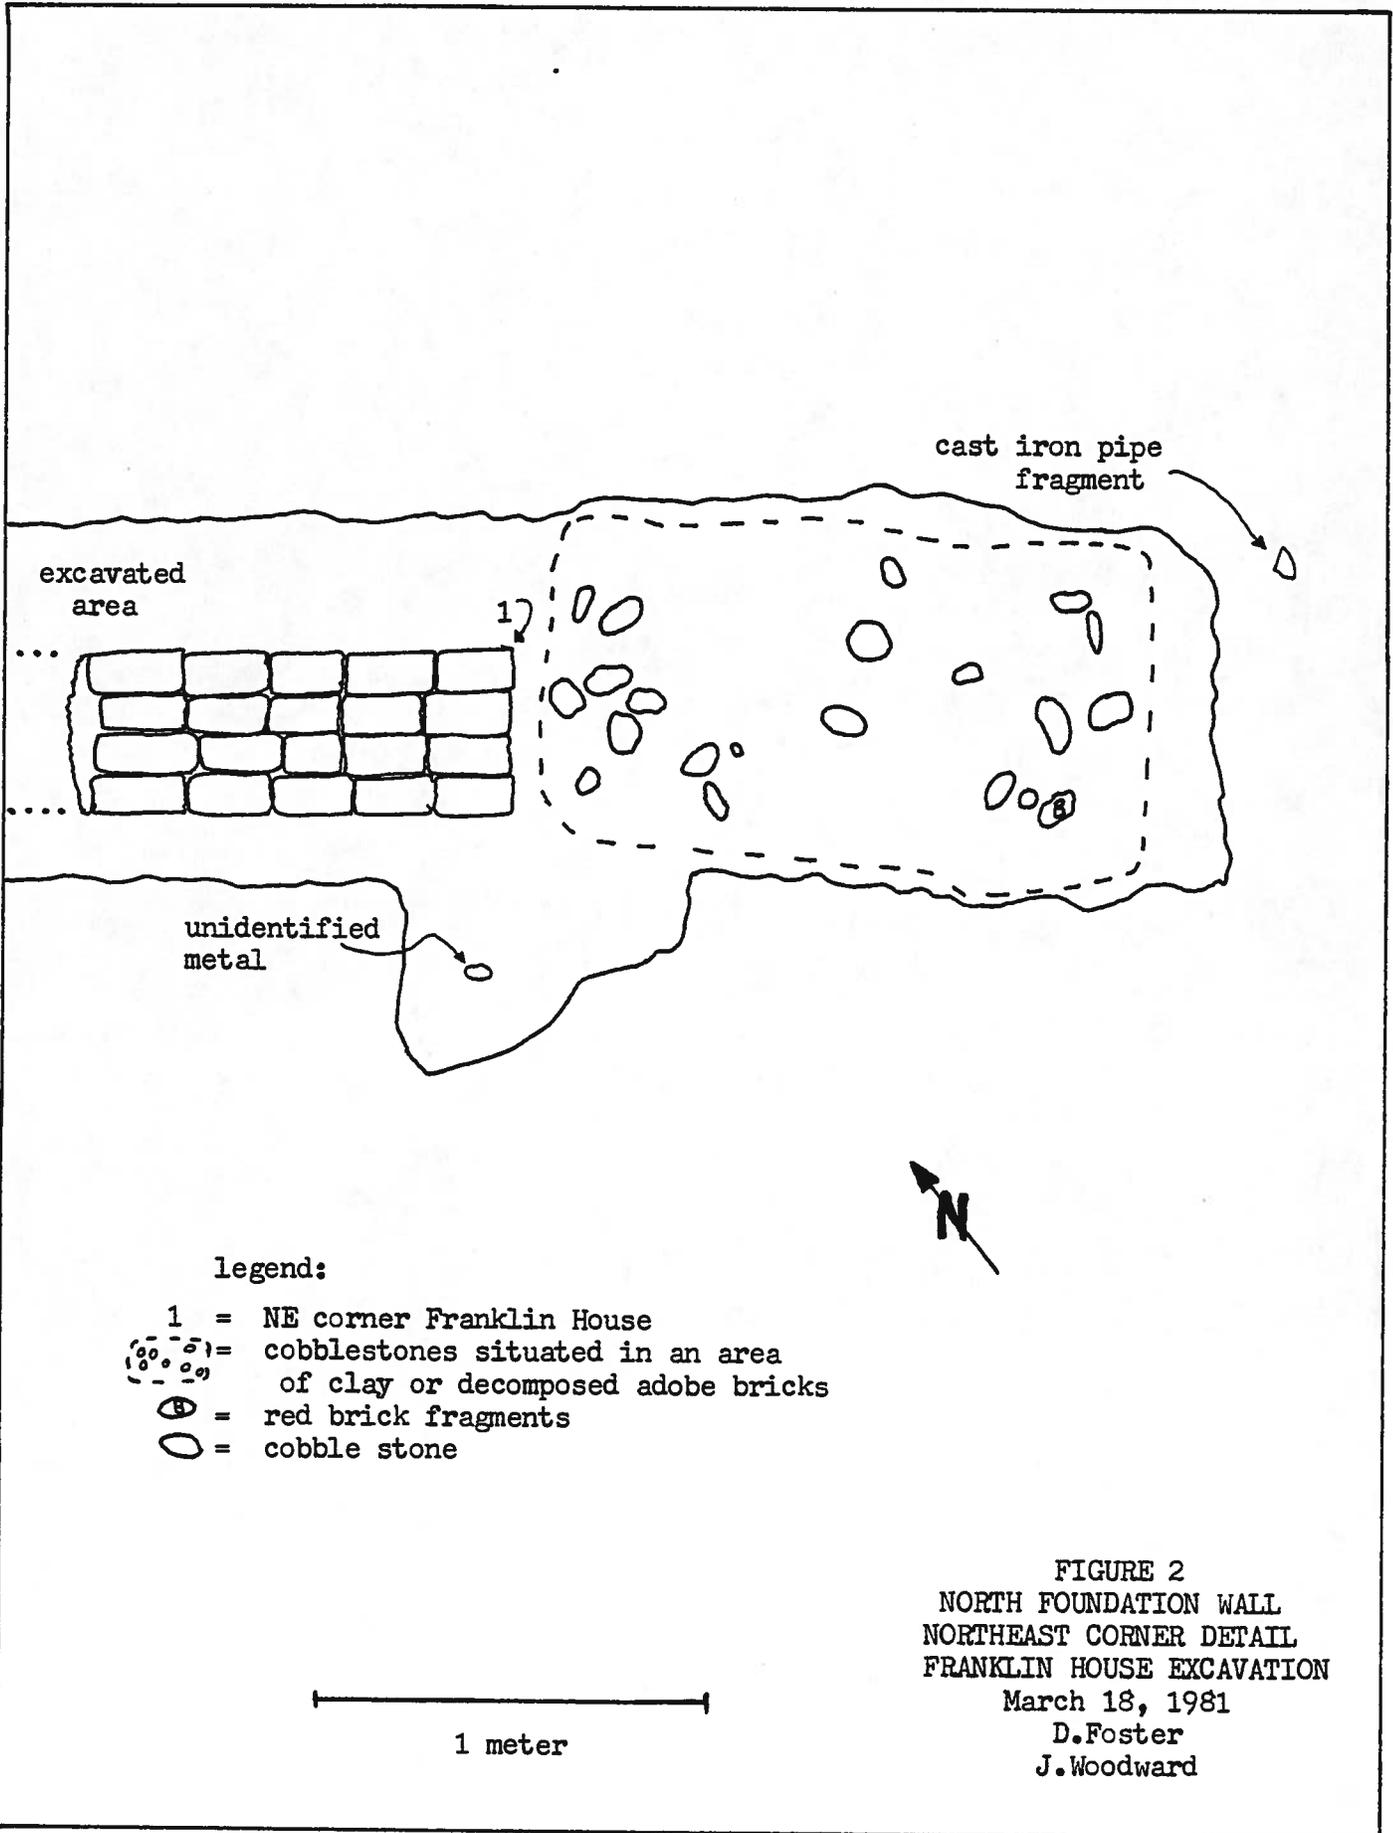
FIGURE 2  
NORTH FOUNDATION WALL  
NORTHEAST CORNER DETAIL  
FRANKLIN HOUSE EXCAVATION  
March 18, 1981  
D. Foster  
J. Woodward

The second feature discovered is located just east of the eastern end of the brick wall. It was anticipated that a foundation corner would be located in this area and that a perpendicular brick wall representing the eastern wall of the Franklin House would extend from the corner. The E-W wall simply terminated however, and no perpendicular wall was located. As the area was excavated, unmodified waterworn cobbles were found (see Fig. 2). These stones ranged from fist-sized to much larger and were not in any obvious alignment, however as a group, they occur in the same projected alignment as the two structures to the west (the Franklin House and the Casa de Juan Rodriguez). These cobbles were all situated in a soil matrix that is very high in clay content. This type of soil was quite different from that above or adjacent to the brick wall, and also seemed to be present only in association with the cobbles. It is very likely that the cobbles represent a disturbed early foundation and the clay soil is a result of decomposed adobe bricks. In this light, the feature may represent the NE corner of the Colorado House.

- 1 = NE corner Franklin House
- (○) = cobbles situated in an area  
of clay or decomposed adobe bricks
- (R) = red brick fragments
- (○) = cobble stone

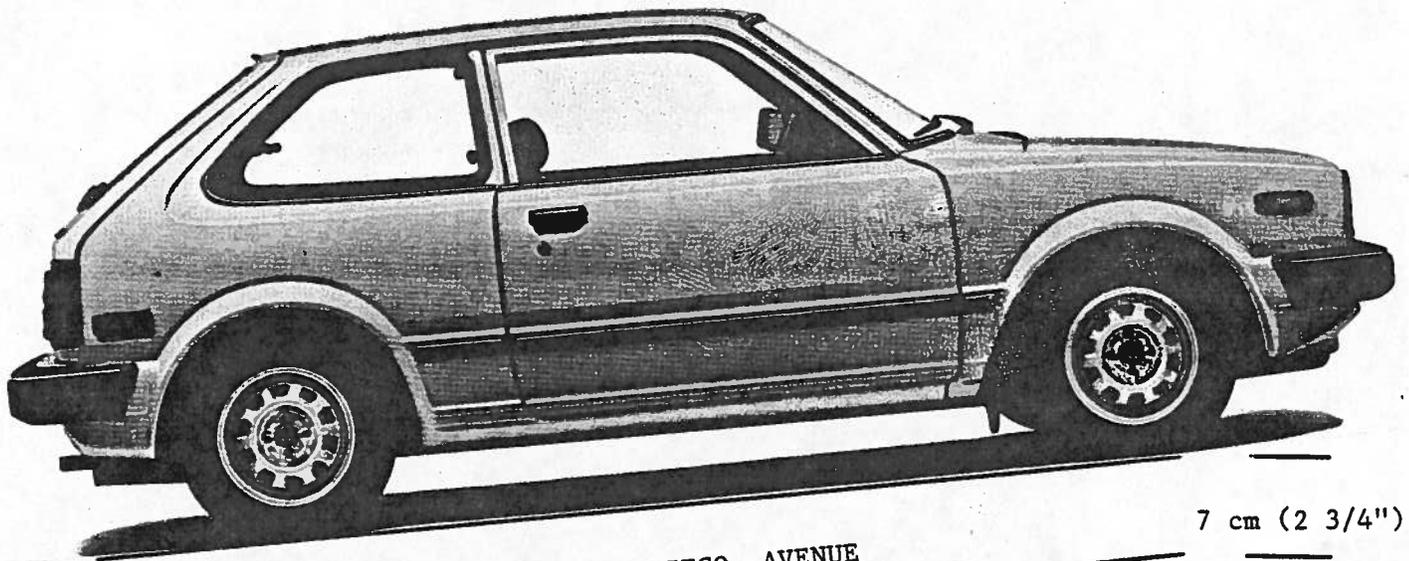
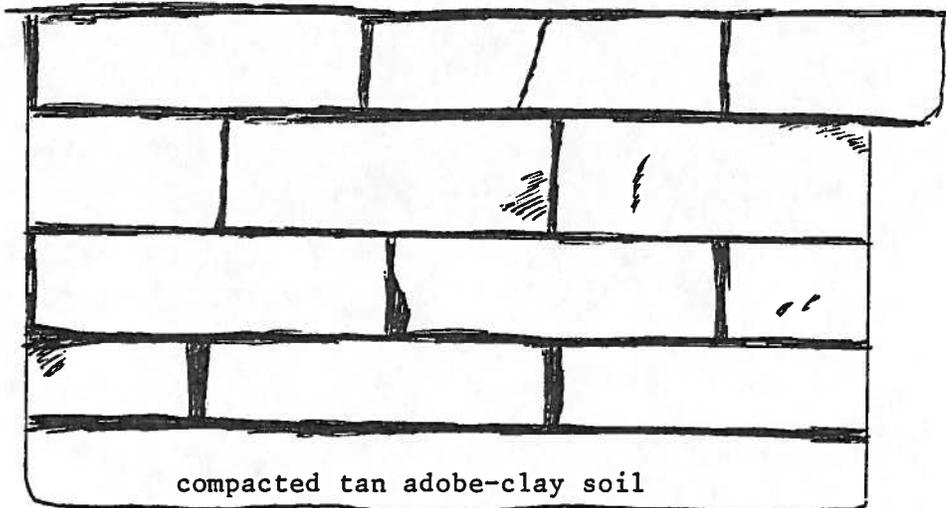
Figure 3  
Profile View of the Brick Foundation  
Franklin House, Old Town San Diego

wall. Approximately 3.5 inches southwest of the brick wall and 8 inches below the upper course of bricks, two large cobble stones were located and left in place (see attached photographs). There were also several (10-12) smaller cobbles above, below, and adjacent to them. Between the cobbles and the foundation was a mixture of reddish soil, brick fragments, charcoal and some plaster fragments. This soil was very similar to the clay soil found in the feature previously described. It was the same color as the surrounding soil, but was of a more even texture and lacked any brick or mortar rubble. The adobe soil was found four inches below the upper course of bricks and a thin layer of ash, plaster and charcoal rests on top of the adobe. Southwest of the two large cobbles appears to be pieces of melted adobe, perhaps from a wall. This feature may represent remnants of the earlier Exchange Hotel, an adobe structure built on this site previous to the three-story brick and wood Franklin House (Zink 1955).

Note: scattered charcoal adheres to the bricks and mortar.
