First Ten-Year Update to the California Department of Forestry and Fire Protection Management Plan for Historic Buildings and Archaeological Sites

prepared by:
The California Department of Forestry and Fire Protection (CAL FIRE)¹
P.O. Box 944246
Sacramento, CA 94244-2460

June 7, 2012

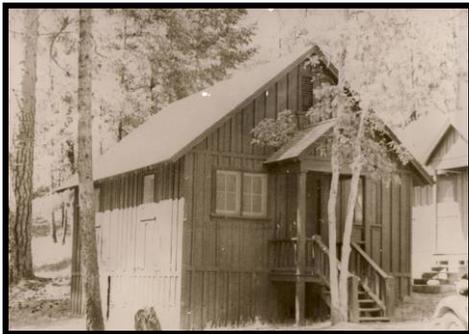
The CCC Camp Fawn Lodge Paymaster's Office as it appeared in 1935. Note two-stem oak tree.

The facility is now scheduled for replacement. The initial proposal included demolition of all buildings at the existing site to be replaced with new construction. These include the 1935 Paymaster's Office (Figure 21 and front cover) and 1935 Kitchen/Messhall (the warehouse was removed about 20 years ago).

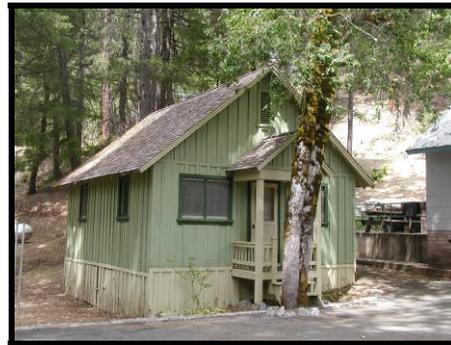
The CCC Camp Fawn Lodge Paymaster's Office as it looked in 2010. Note same oak tree.

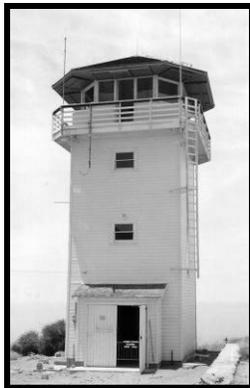
Boucher Hill Lookout Tower as it appeared in 1948.

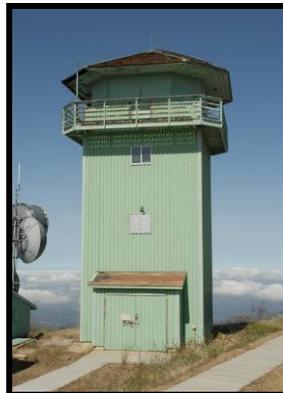
Boucher Hill Lookout Tower as it appeared in 2008.

#21	Boucher Hill Lookout	Restore exterior of lookout and transfer to DPR	Restoration completed, transfer to DPR is imminent.
#22	Cuyamaca FS – Combination Barracks/Garage	Transfer ownership and management to DPR after replacement Fire Station is built nearby.	New CAL FIRE FS is under construction. Transfer to DPR expected to be completed by 2013.

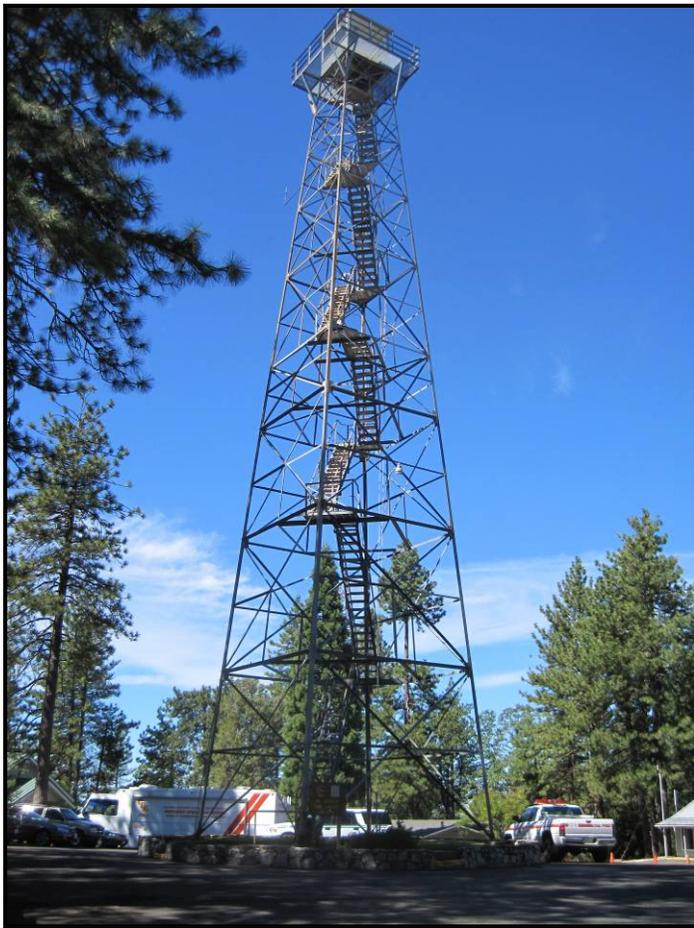
Description: This impressive historical structure is CAL FIRE’s tallest fire lookout at 100 feet in height (Figure 2). It forms the centerpiece of the Amador-El Dorado Unit Headquarters complex and stands as a monument and constant reminder that modern wild land fire suppression has an important historical past. It is a battered, open steel (X-brace) tower that measures 22’ x 22’ at the base and is 100 feet tall. It has a concrete pier foundation, and a 49 square foot metal observation cab. A steel stairway with 131 wooden steps extends up the inside of the tower to a wooden trap door. There is a plaque placed at the base of the tower that indicates it was constructed on August 10, 1949. This steel tower replaced an 80 foot high wooden tower that was originally built here about 1933. The original tower was named in honor of Ray E. Danaher, who was a member of the State Board of Forestry and a co-owner of the Mich-Cal Lumber Company. The latter donated the materials for the original wooden tower. The current metal tower was manufactured by the Aermotor Company and is a variation of their model L-1400 series fire lookouts. The metal observation cab was modified circa 1960 and a surrounding catwalk added at that time. The 2001 Management Plan described the structure as being in good condition and a good candidate for preservation because it is located at a secure CAL FIRE facility and is easily accessible by the public (Foster and Thornton 2001: 38). The 1991 inventory assessment of CAL FIRE lookouts indicates the tower is open to visitors during fire season working hours (Thornton 1993: 208).

Figure 2. Building #1. View of the 1949 Mount Danaher FLS Lookout which continues to be preserved *in situ* by CAL FIRE. Photo taken in 2010.

Management Issues: The Mount Danaher Lookout is still in good condition, probably pretty much the same as it was when examined and formally recorded by Mark Thornton in 1991. As discussed below, the steps have been repaired and the windows replaced in 2009 due to management concerns related to a

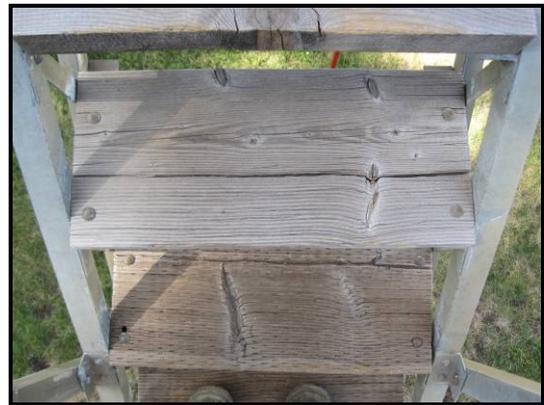
Since the Mount Danaher Lookout is constructed largely out of galvanized steel it does not require a great deal of management relating to its maintenance as a historic structure. As with any structure, however, things can and do happen that occasionally require some sort of repair or other maintenance. Two events over the course of the past ten years have necessitated specific repairs. The first of these events was the realization that the practice of inmates climbing the wooden steps to hang fire hoses from the tower frame was wearing heavily on the wooden steps that lead up to the cab. (This lookout is apparently somewhat unusual in having wooden steps incorporated into an otherwise all-metal structure. Once the Unit Chief became aware of the situation, he ordered that the worn steps be replaced. This was done by purchasing pressure-treated 2x8 inch wooden planks, cutting them to the appropriate length, and then individually replacing the heavily worn steps. The lookout contains 131 wooden steps, one quarter of which were replaced during this repair. The replacement steps are readily visible since pressure-treated wood is different in appearance from the original boards and the replaced steps (Figure 3). In addition, some of the attachment bolts were replaced because the original nuts were frozen and had to be cut to remove them. The replacement bolts are modern hexagonal head bolts that are quite different from the original flat head bolts.

Figure 3. Building #1. View of Mount Danaher Lookout step replacement project. 2010 photo.

The management problems with this structure have been described above. The continued use of the wooden steps (as well as normal weathering processes) will predictably lead to their eventual demise. The decision to replace some of the steps was a logical and effective solution to this problem. The use of unmatched materials is unfortunate, but is not a great problem since this does not affect the overall character of the lookout. The identified damage to the structure due to the wind event, (as well as potential for damage to other buildings in the facility), was unexpected. This prompted the decision to remove the shutters and replace the windows. Again, these were prompt and logical solutions to an obvious management problem. Ideally, the decision to replace the windows would have considered the historic appearance of the structure and replaced the original windows with modern ones of identical outward appearance. Since we don't know what the originals looked like, we can't be sure that the new ones are any different in appearance. There is no need for climate control or other issues that one might consider in replacing old windows with modern ones, although the use of tempered glass is certainly an improvement. The loss of the storm windows is also unfortunate, but these were presenting a hazard and their removal makes sense in this context. Since these can be arranged into different configurations, their presence or absence does not affect the overall appearance of the lookout or its historical significance.

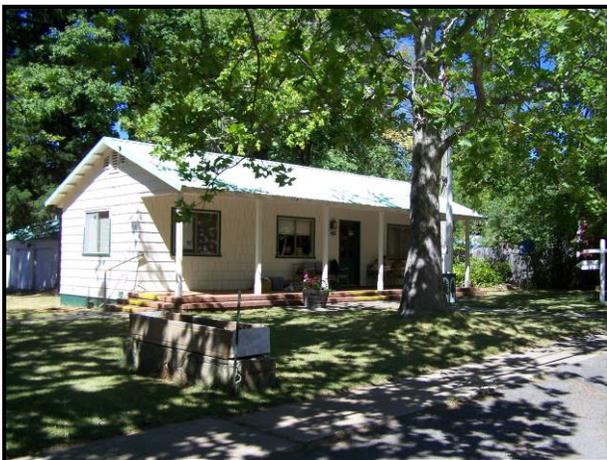
Figure 4. Building #2. View of 1937 Stirling City FS Office taken in 2010. Ownership transfer completed – preserved *in situ* by Stirling City Historical Society, with support from CAL FIRE.

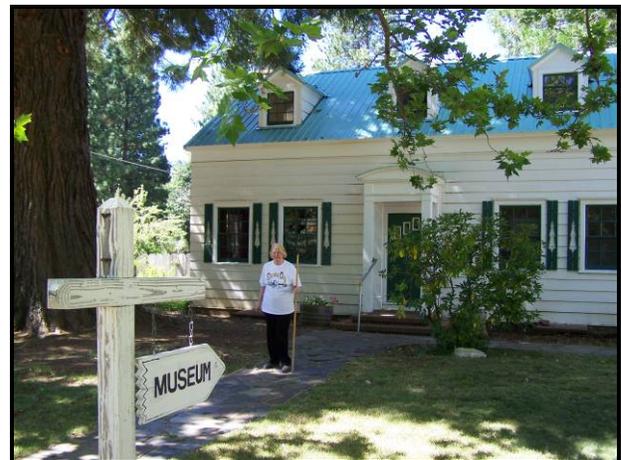
Figure 5. Building #3. View of 1937 Stirling City FS, Ranger's Residence taken in 2010. Ownership transfer completed – preserved *in situ* by Stirling City Historical Society, with support from CAL FIRE.

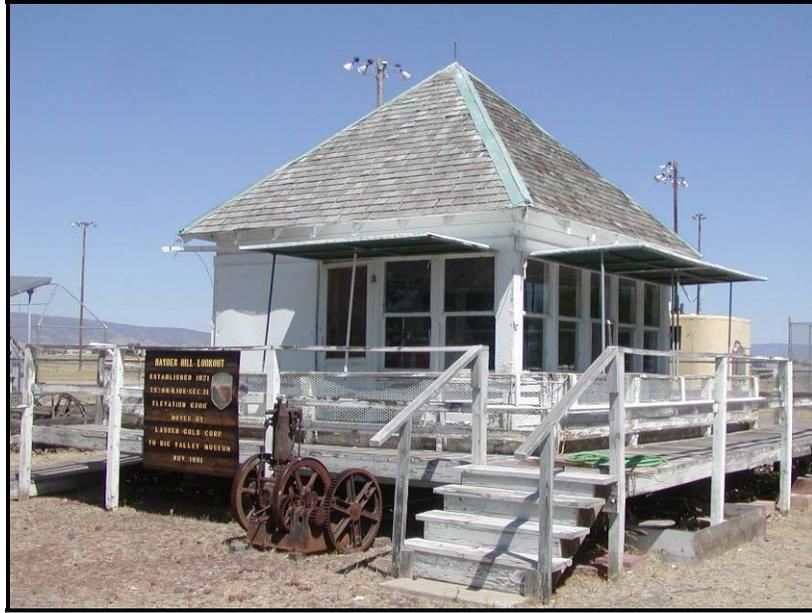
Description: Built in 1940, the Hayden Hill Lookout as one of the last lookouts built by the Emergency Conservation Works (ECW) program of the 1930s. It consists of a 14' X 14'(base) X 9' (high) non-battered enclosed timber tower built on a concrete slab foundation. Prior to its relocation, the property was considered eligible for listing on the National Register of Historic Places (NRHP) as one of the few remaining CCC-era lookouts in the CDF fire detection system that retains a high degree of historical integrity.

Figure 6. Building #4. View of 1940 Hayden Hill Lookout (Cab) as it appeared in 2010. As discussed in the original Plan, this lookout cab was relocated to the Big Valley Historical Museum in Bieber to be maintained and interpreted by the Museum with support from CAL FIRE.

Tasks for CAL FIRE from 2011-2021: The 2001 Management Plan committed CAL FIRE to assist the museum in conducting needed maintenance and repairs to this historic lookout. The CAL FIRE Unit shall continue to provide this assistance to the extent possible. To date, the museum has fabricated shutters for

the windows to prevent further sun damage to the interior. Discussions have taken place among the Museum's Board of Directors concerning the need to repaint the exterior of the structure as part of necessary, on-going maintenance of it. The CAL-FIRE Lassen, Modoc, Plumas Unit has offered to provide assistance to the museum staff when requested to do so.

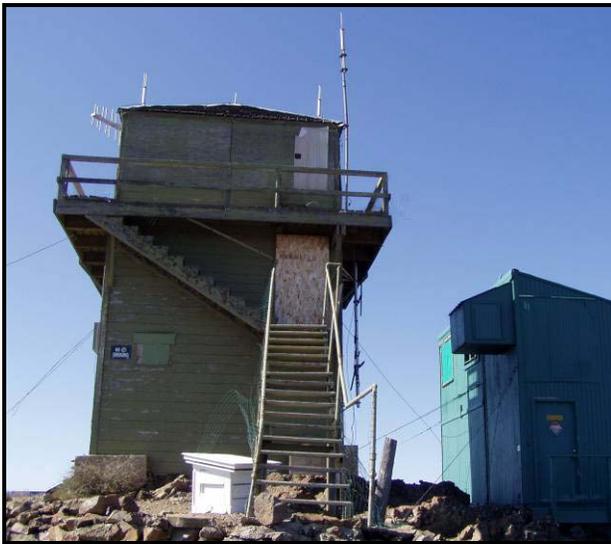
Description: The lookout consists of a 15-foot tall non-enclosed timber tower built in 1934 that has been determined eligible for listing on the NRHP (Figure 7). Due to not having been maintained for some time, the upper cab is now unsafe to enter.

The high elevation of the site and difficulty of access during winter months has significantly impacted the condition of the tower. Guy wires to the tower are sagging on one side and taut on the other, possibly indicating structural failure. The staircase is comprised of a mixture of cracked and splintered boards. The hand rail is loose and falling apart and the cat walk is separating from the main structure. Up until 2007 CAL FIRE, which was still using the structure as a lookout at that time, continued to conduct maintenance of the facility, including painting, light carpentry and cleaning. However, at this time the LNF is not doing regular maintenance of the building, which is deemed unsafe for use and would require extensive repair and upgrades, including changes to the facility access to meet standard safety compliance requirements. Because it has been determined eligible for listing on the NRHP, repairs to the building would have to be done in conformance with the Secretary of the Interior's Standards and Guidelines for Rehabilitation (36 CFR Part 61).

Figure 7. Building #5. View of 1934 Dyer Mountain Lookout in 2008. This Lookout has been de-listed from CAL FIRE's Management Plan due to its highly deteriorated condition.

Tasks for CAL FIRE from 2011-2021: CAL FIRE shall continue negotiating with the USFS in a search for feasible ways to improve the condition of the lookout. While doing so, CAL FIRE shall also pursue various options to upgrade the communications site, including the option of relocating it to another vault and tower. Consequently, due to the situation described above, CAL FIRE has now removed the Dyer Mountain Lookout from its list of historic buildings to be preserved and maintained and, in its place, has added the Fredonyer Peak Lookout (which the State owns and controls).

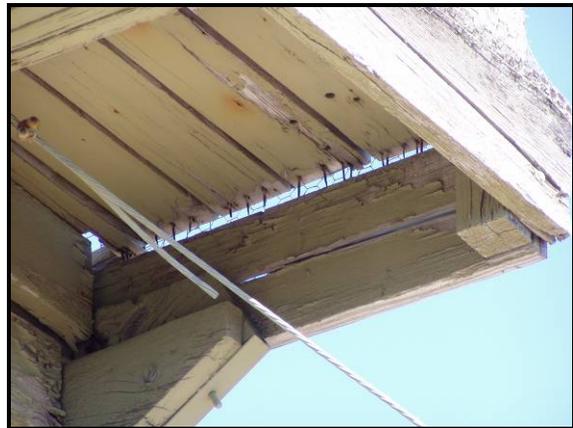
Although funding for staffing the lookout was discontinued years ago, this facility has continued to serve an important function since it houses State and Federal radio equipment. However, on-going deterioration of the lookout building is affecting its use as a communications site. For example, a radio mast, lashed to the tower catwalk, is separating from the structure and, consequently, no longer provides adequate support for the mast. As well, rain water leaking into the tower threatens to ruin the radio equipment stored inside.

The Dyer Mountain Lookout is presently in a terribly unsafe condition. Without substantial public funding to make repairs necessary to restore it to working order, the USFS may well find it has no feasible options to demolition of the lookout one day in the not too distant future.

Figure 8. Building #5. Another view of Dyer Mountain FLS taken in 2008 showing unsafe condition of the catwalk. LNF has not been able to locate funds or resources to keep up with needed repairs and maintenance, and eventual demolition by LNF may be inevitable.

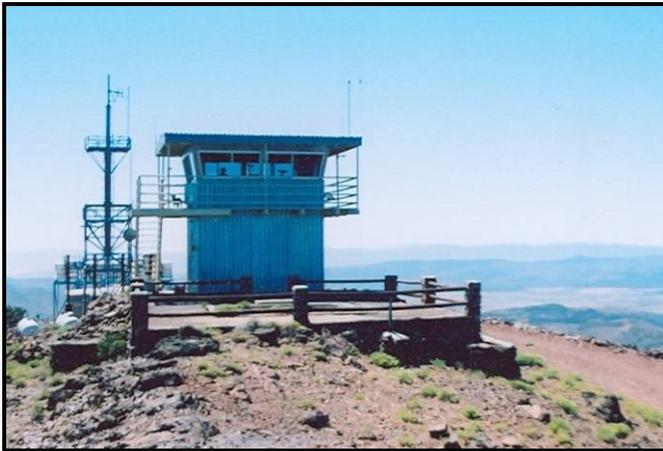
Description: This lookout consists of a 14' X 14' X 10 (tall) non-battered enclosed steel (H-brace) tower with a concrete slab foundation supporting a 196 square foot wood frame cab (Figure 9). The first floor serves as a utility room housing bathroom facilities and a 1750-gallon water storage tank. There are no windows in the first floor room which has plywood paneling and corrugated aluminum siding. Constructed in 1972, the lookout may be determined eligible for inclusion on the NRHP when it becomes old enough (i.e., 50 years of age) to qualify for listing (in 2022). Archaeological features representing the remains of the previous lookout that was erected at this location in 1942 and are visible on the north side of the present lookout include ruins of the former tower (foundation remains, rock retaining walls).

Management Issues: The lookout is owned by CAL FIRE and continues to function as a lookout during severe fire conditions through use by the Bureau of Land Management (BLM). The lookout, which has been continuously maintained and is in relatively good condition, is periodically visited by interested members of the public who walk or drive to it over seasonal roads. CAL FIRE has now decided to add this lookout to its list of 29 buildings to be managed and preserved, to offset the de-listing of the Dyer Mountain Lookout which, as explained above, was a poor selection to our list because the Department does not own the property and does not control how the lookout is managed. The Fredonyer Peak

Figure 9. Building #6. View of 1972 Fredonyer Peak Lookout in 2009. This lookout was added to the list of buildings to be saved in CAL FIRE's Plan to compensate for de-listing Dyer Mountain. This lookout will be used, maintained, repaired and preserved *in situ* by CAL FIRE.

Tasks for CAL FIRE from 2011-2021: CAL FIRE shall continue to protect, repair, and maintain this lookout as a functioning facility and one which can be visited by the public. This is now one of the historic buildings CAL FIRE shall commit for long-term preservation and management, in exchange for the de-listing of the Dyer Mountain Lookout.

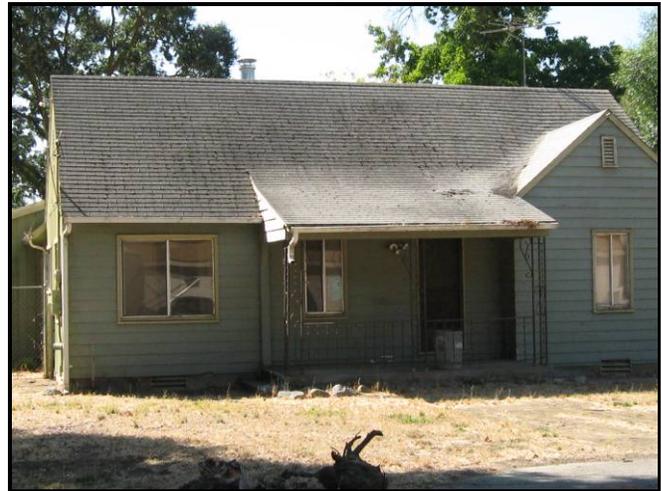
Figure 10. Building #7. View of 1921 State Ranger's Residence at L.A. Moran Reforestation Center in 2010.

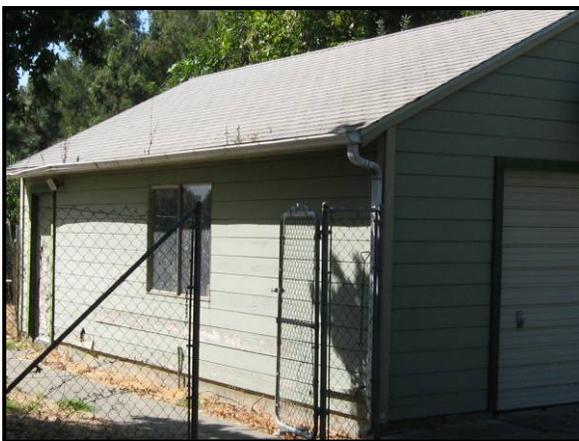
Figure 11. Building #8. View of 1940 Residence Garage at L.A. Moran Reforestation Center. Photo taken in 2010.

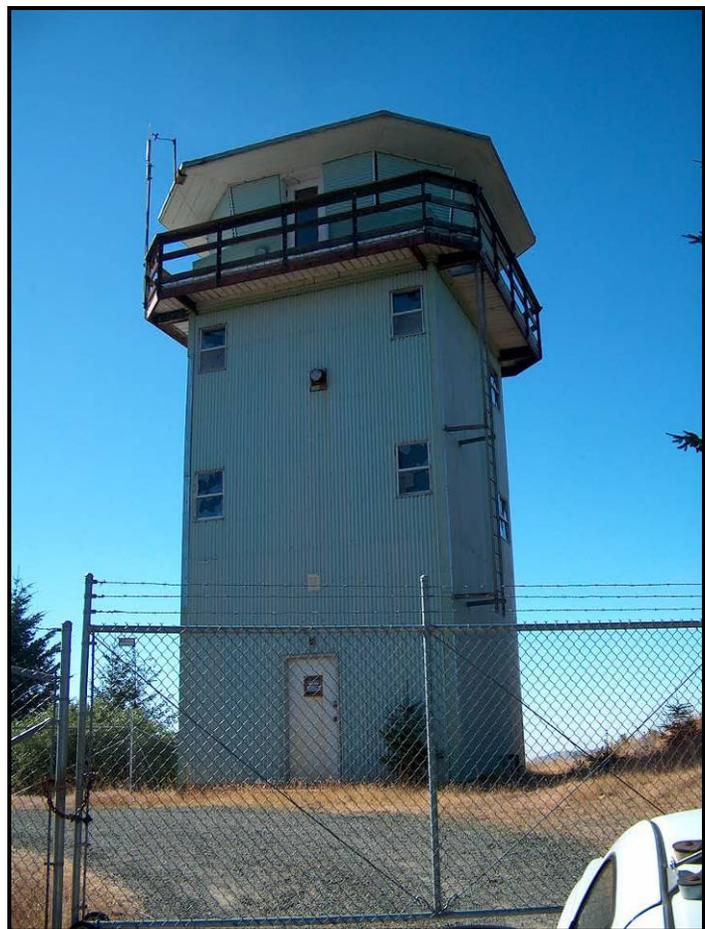
Description: This lookout, built in 1965, is a 16'X16'X29' (tall) enclosed steel-braced with a concrete slab foundation and corrugated metal siding over wood framing (Figure 12). It has an asphalt-composition roof and boxed eaves. The entry to the ground floor room is by way of a metal door on the tower's north wall. This lower room contains a 300 gallon water storage tank and pressure system. The second floor rooms contain a flush toilet and sink while the cab above it has built-in cabinets and a propane stove. The lookout is enclosed within cyclone fencing and barbed wire with a padlocked gate.

Management Issues: Although the Lookout is currently un-staffed and has been for several years, the structure is in relatively good condition. The only apparent exterior damage is all the window panes on the tower (below the cab) are broken. The interior has been protected by the installation of Plexiglas sheets which seal the windows. Corrugated metal material similar to the lookout's siding covers all of the windows around the octagonal cab. These window coverings are hinged and can be lifted and secured to allow a full view of the surrounding lands. The windows within the cab are intact. The access road to the lookout consists of approximately one mile of paved road which leads to approximately 4 miles of rock-surfaced access road (known as Signal Ridge Road) and is well-maintained. The lookout was effectively utilized by CAL FIRE staff as an observation point during the 2008 Mendocino Unit Lightning Complex. Management actions thus far have been to accomplish on-going maintenance of the exterior and interior by painting as needed and repairing or replacing doors and stair treads. However, the bathroom facility and windows require repairs and, in time, the roof will need to be replaced.

Figure 12. Building #9. View of 1965 Cold Springs FLS, Lookout in 2010.

CAL FIRE maintains the power lines to the lookout starting from the approximately 3.5 mile point on Signal Ridge Road trending south through mountainous terrain for over ¼-mile to the lookout. The wooden poles supporting the transmission wires, which deliver electricity to CAL FIRE's communication vault and to the lookout, need to be replaced. As funds become available CAL FIRE intends to replace the power poles, repair the broken windows and replace the roof.

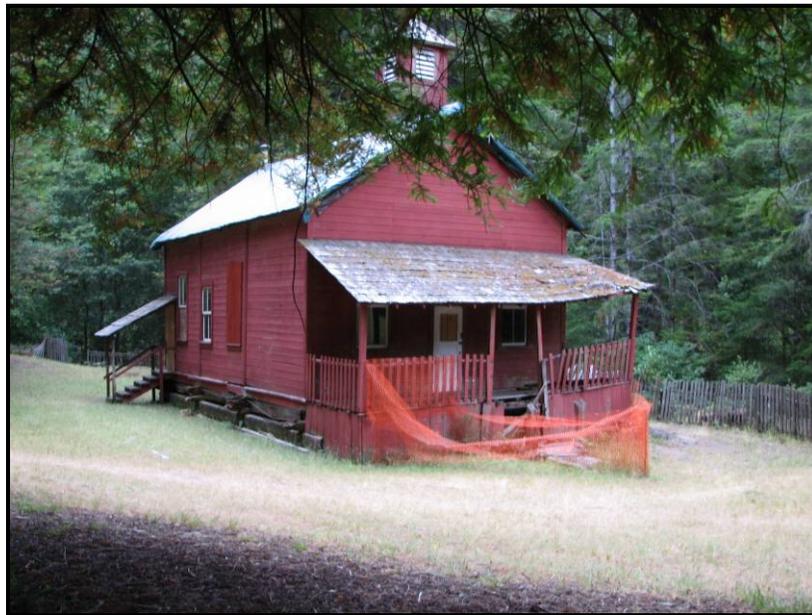
Description: This schoolhouse, known formally as the Caspar Woods Schoolhouse, was built in 1915 for children of loggers working for the Caspar Lumber Company (Holmes 1986) (Figure 13). It was built in three sections and rested on wooden skids so it could be pulled by steam donkey and transported by rail car when the logging camp was moved further inland within the redwood forest. The property now comprising Jackson Demonstration State Forest (JDSF) was acquired by the State of California from the Caspar Lumber Company in 1947 and named after the founder of the Caspar Lumber Company, Jacob Green Jackson.

Management Issues: Although the schoolhouse is not currently used for any operational purpose, due to its proximity to Highway 20 and the Camp 20 day-use area, it is occasionally visited by the public. The interior of the building has been closed to the public for safety and security reasons for over ten years. Due to chronic lack of funding during that time the exterior of the building has seriously deteriorated. The front porch, an addition to the original schoolhouse building sometime after placement at its present location (the Camp 20 rest area on State Highway 20), is falling apart and about to collapse (Figures 14 and 15). The wooden skids that comprise the foundation continue to deteriorate and the wooden shingle roof, which began leaking nearly a decade ago, has been covered with a large heavy tarp.

Figure 13. Building #10. View of 1915 Caspar Woods Schoolhouse at Jackson Demonstration State Forest. Photo taken in 2010.

3. Stabilize the building by placing it on a concrete foundation and trimming the exterior to look the same as the existing redwood skids while retaining the building's historic appearance, as prescribed in the Dreyfuss stabilization Plan (Dreyfuss 2000).

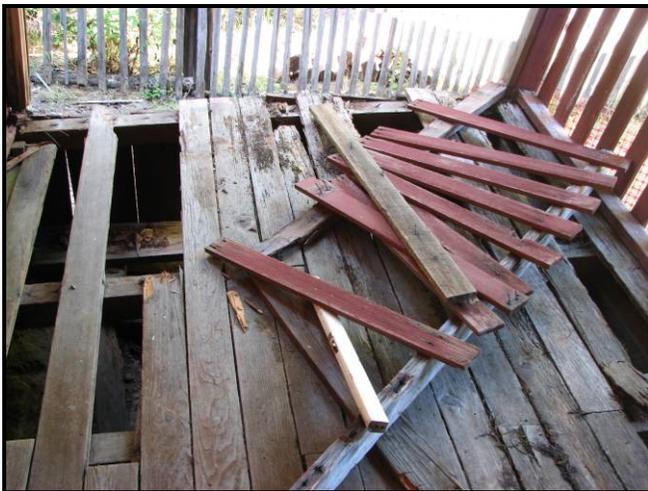
Figure 14. Building #10. View of Caspar Woods Schoolhouse taken in 2010 showing badly deteriorated condition of the porch.

As stated in that report, Phase I (Stabilization) "...consists of those tasks required immediately to preserve the schoolhouse from serious deterioration." However, funds to conduct the needed work have, to date, not materialized. Consequently, in the over ten years since Dreyfuss' report was written, "serious deterioration" of the structure has inexorably continued. Among the tasks requiring immediate attention are repairs to the foundation and the roof. The foundation and roof repairs will necessitate temporary removal of the front porch of the building.

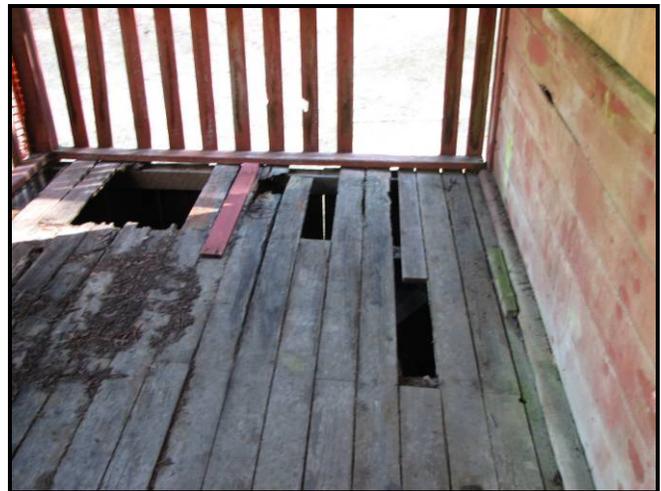
Figure 15. Building #10. View of the Caspar Woods Schoolhouse porch. Although initially CAL FIRE intended to reuse any original materials during porch reconstruction, it appears that no such materials are sound enough for reuse.

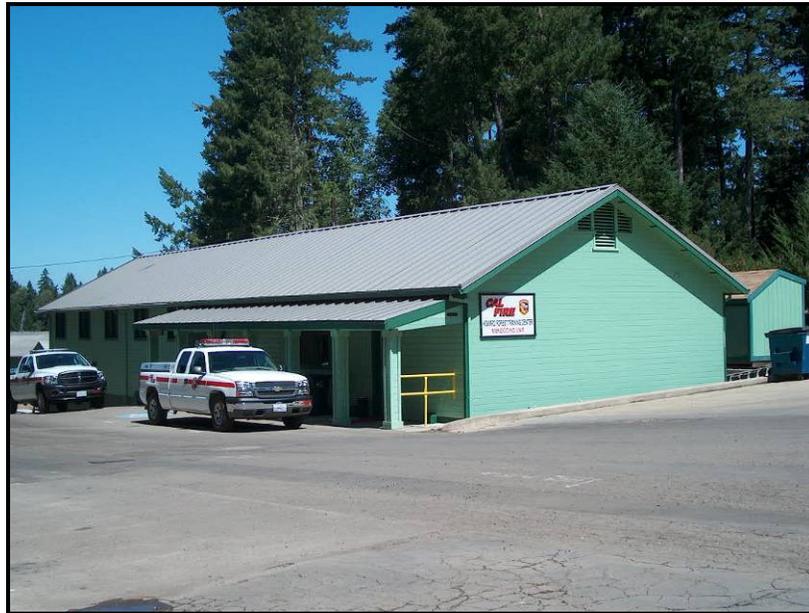
Figure 16. Building #11. View of the 1938 Warehouse/4-Bay Garage and Mendocino Unit Headquarters, which, as discussed in the original Plan, was reconstructed to function as a classroom. This photo was taken in 2010.

Description: This extensive compound contains a number of historic buildings including a 1937 equipment garage, a 1938 warehouse, a 1939 office, a 1940 residence garage, a 1940 gas and oil house, 1942 residence, and a World War II Army Surplus barracks. The 1938 warehouse was selected as the one historic building within this compound to be managed for long-term preservation. It is the only 27' X 97' combination warehouse and garage in CAL FIRE's collection of buildings that predates 1946, and, up until circa 2000 had experienced few alterations (Figure 16). This building was determined potentially eligible for listing on the NRHP as a separate property (Thornton 1994:83-96). In 2000-2001, the Unit completed a substantial reconstruction of the warehouse converting it to a training center offering training opportunities at the local and regional level.

Tasks for CAL FIRE from 2011-2021: Continue to use, repair, maintain and preserve the building, giving consideration to maintaining the historical appearance of the compound.

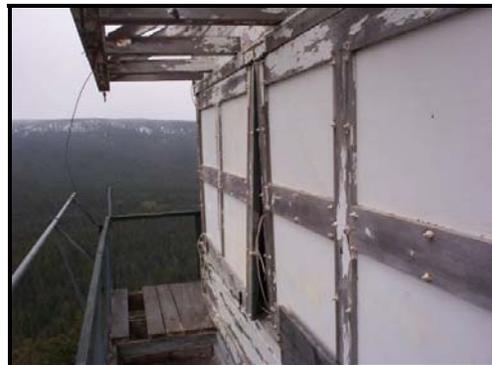
Figure 19. Building #12. View of 1936 Digger Butte FLS, taken in 2006, showing its deteriorated condition.

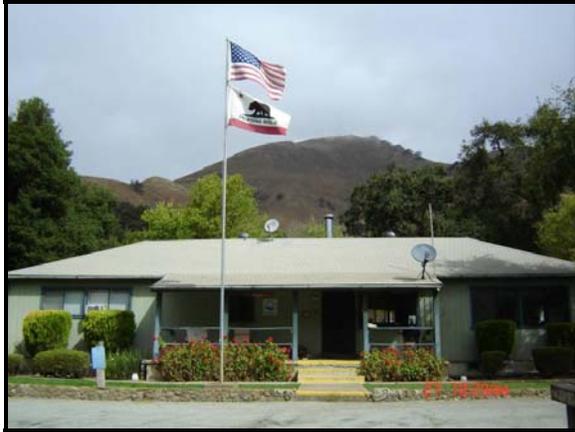
Description: The 2,157 square foot combination barracks at this station was constructed circa 1942. The single story wood frame building has a concrete perimeter foundation, plywood panel siding, 1/1 aluminum frame sliding windows, boxed eaves, and asphalt composition shingles over a hip roof with gable rear wings (Figure 20). The building has a symmetrical "U" floor Plan. An extended shed roof centered on the south elevation covers a 7' X 28'5" concrete front porch. The porch roof is supported by five chamfered wood posts. A side entry is on the east elevation of the right rear wing. Inset in the "U" at the corner junction of the left rear wing with the front wing is a rear entry. An extended shed roof from the north slope of the front wing covers this rear entry. To the east is a north wall utility door. Existing

Figure 20. Building #14. View of the 1942 Combination Barracks at Pacheco FS. Photo taken in 2010.

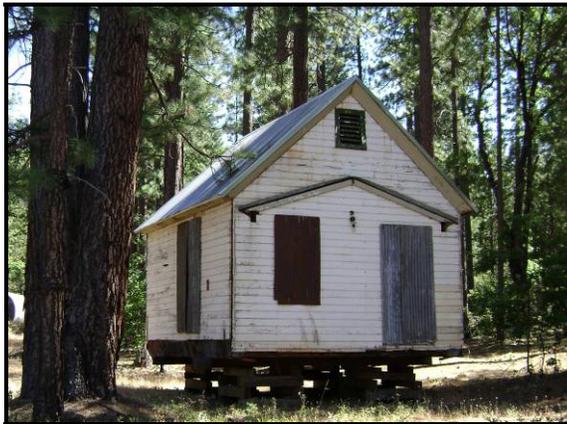
Figure 22. Building #16. View of the 1935 CCC Office that was located at Whitmore FS. Photo taken in 2010. This building has been de-listed and replaced with another 1935 CCC Office at Fawn Lodge FS.

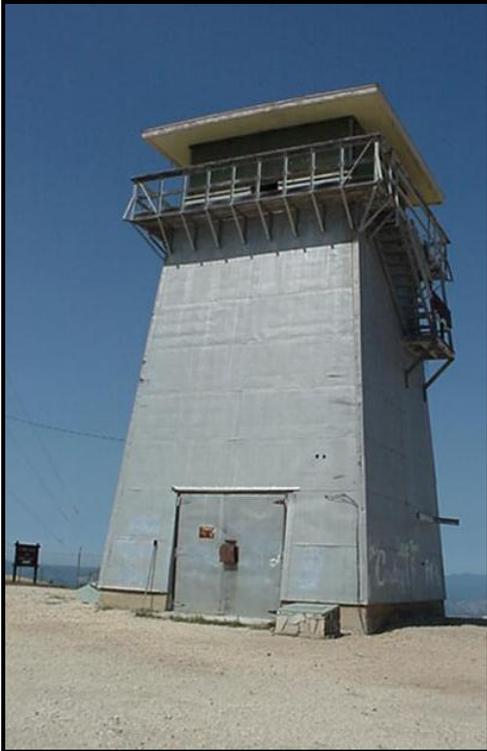
Figure 24. Building #18. View of 1944 Calandra FLS, Lookout. Photo taken in 2003.

#18	Calandra Lookout	Original Plan called for exploring possibility of relocating the lookout to San Luis Obispo County Fairgrounds. That Plan has failed.	Calandra will remain on CAL FIRE's list of buildings to be saved. The Department will attempt to make necessary repairs and maintenance as available funds permit. Assistance will be sought from the BLM and the Forest Fire Lookout Association.

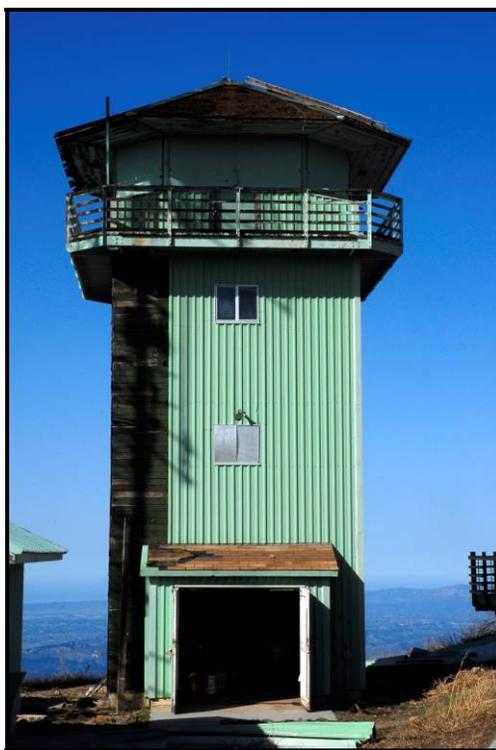
Figure 28. Building #21. View of 1948 Boucher Hill FLS with damaged roof and siding after fire and windstorm. Photo taken in 2010.

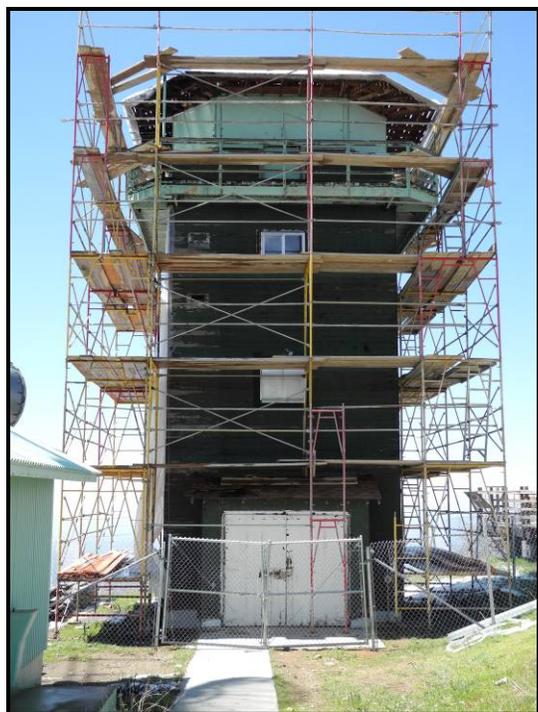
Figure 29. Building #21. View of Boucher Hill FLS as it appeared during exterior restoration by CAL FIRE in 2011.

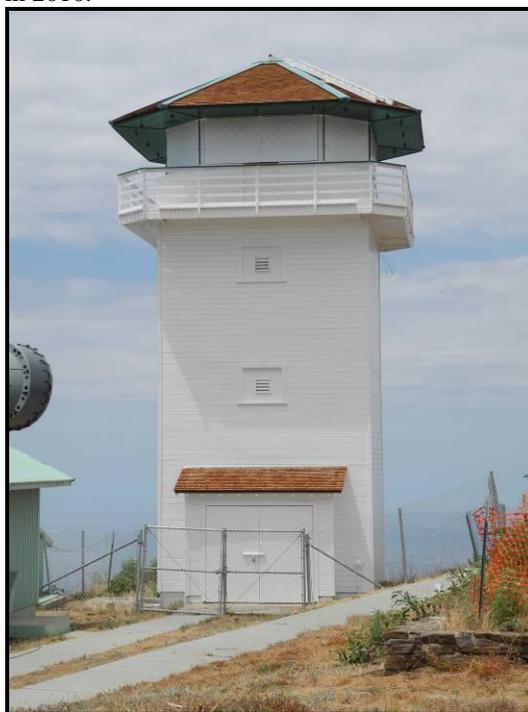
Figure 30. Building #21. View of Boucher Hill Lookout after completion of the CAL FIRE/DGS restoration. Photo taken in 2011.

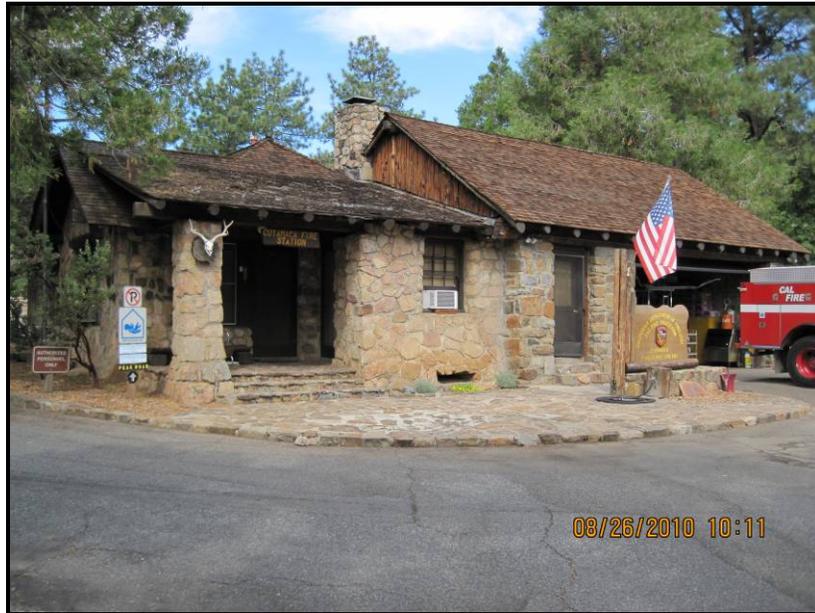
Figure 31. Building #22. View of 1934 Combination Barracks at Cuyamaca FS in Cuyamaca Rancho State Park. Photo taken in 2010.

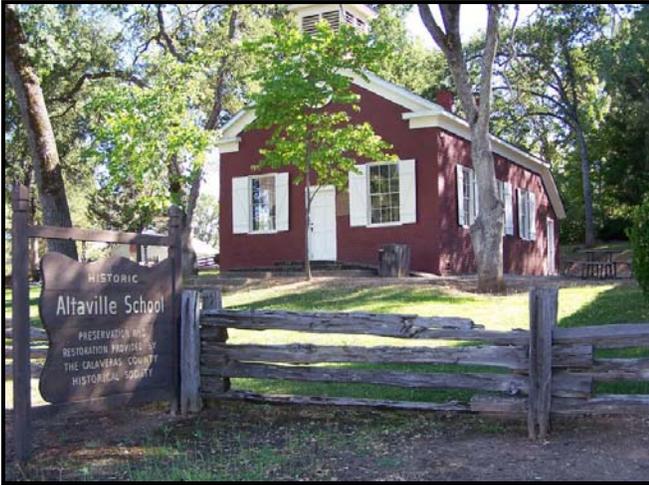
Description: The Altaville School was built in the 1858 and served as an elementary school until its closure in 1950. The school was situated within a parcel of land that became the CDF (now CAL FIRE) Altaville FS. In 1983 a small (½ acre) parcel of State land in the front of the station was quit-claimed to the Calaveras County Historical Society. The historic school was moved to this location and restored where it sits today (Figure 33). The school's current location, right along State Highway 49, is one that provides the public with easy access to this popular tourist destination.

Figure 33. Building #23. View of the 1858 Altaville School at Altaville FS in 2010.

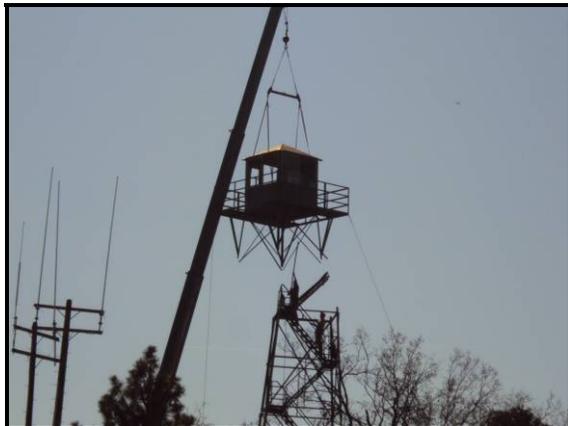
Figure 36. Building #25. View of 1930 Blue Ridge Lookout cab as it was being removed from the tower in 2010.

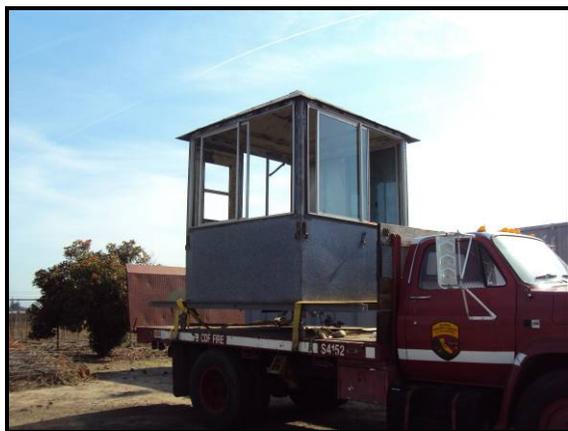
Figure 37. Building #25. View of Blue Ridge FLS, Lookout cab with catwalk removed. Photo taken in 2010.

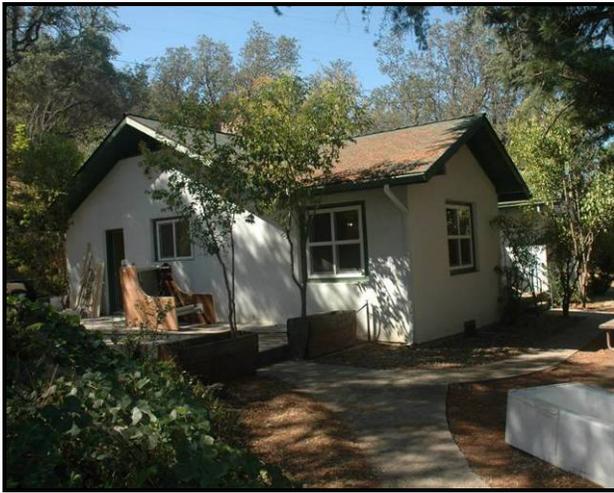
Description: The Hammond FS was built in the 1930s. Four of the historic buildings here have been targeted for long-term preservation by the Department, including a 1935 ranger's residence (Figure 38), a 1938 four-bay equipment garage (Figure 39), a circa 1943 combination barracks (Figure 40), and a circa 1943 gas and oil house (Figure 41).

Figure 38. Building #26. View of 1935 Ranger's Residence at Hammond FS. Photo taken in 2010.

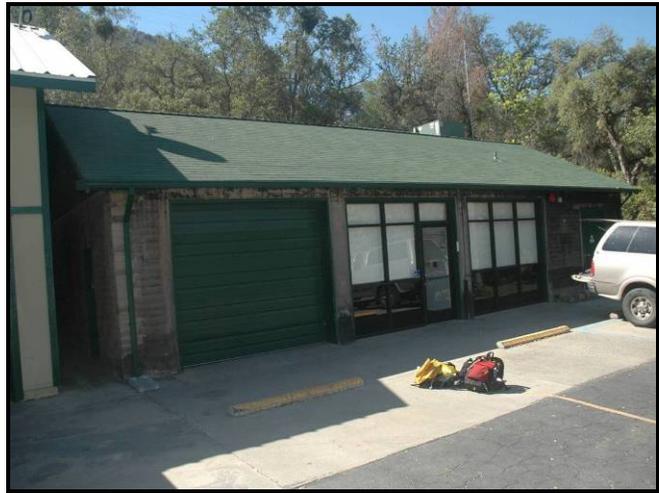
Figure 39. Building #27. View of 1938 Truck Garage at Hammond FS. Photo taken in 2010.

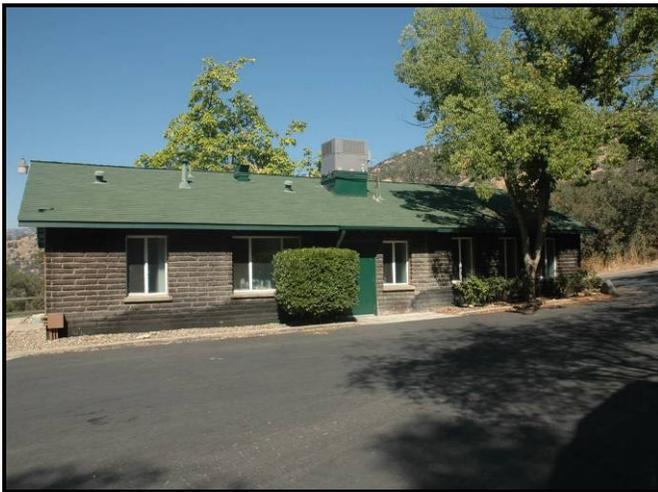
Figure 40. Building #28. View of circa 1943 Combination Barracks at Hammond FS. Photo taken in 2010.

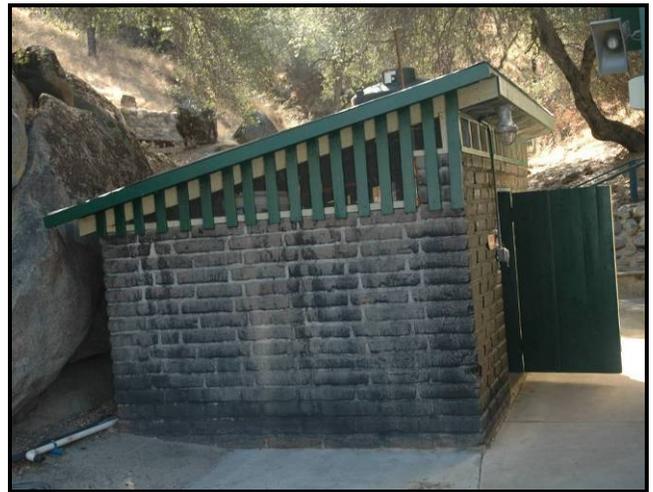
Figure 41. Building #29. View of 1943 Gas and Oil House at Hammond FS. Photo taken in 2010.

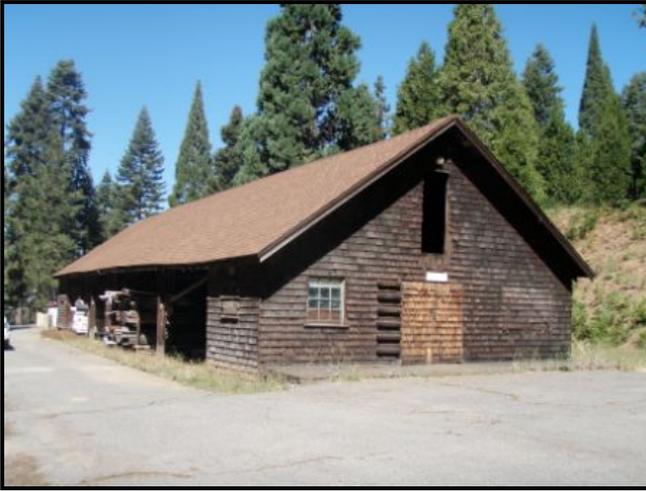
Description: The warehouse, in continuous use since its construction in 1948, is used to store equipment, construction materials, signage, supplies, hardware and other miscellaneous materials used for various purposes throughout the forest (Figure 42). With the exception of some minor weathering and damage by local wildlife, the warehouse is in good condition.

Figure 42. Building #30. View of 1948 Warehouse at Mountain Home DSF. Photo taken in 2010.

#30	Mountain Home DSF Warehouse	CAL FIRE shall continue to use, protect, repair and maintain this building.	CAL FIRE shall continue to use, protect, repair and maintain this building.

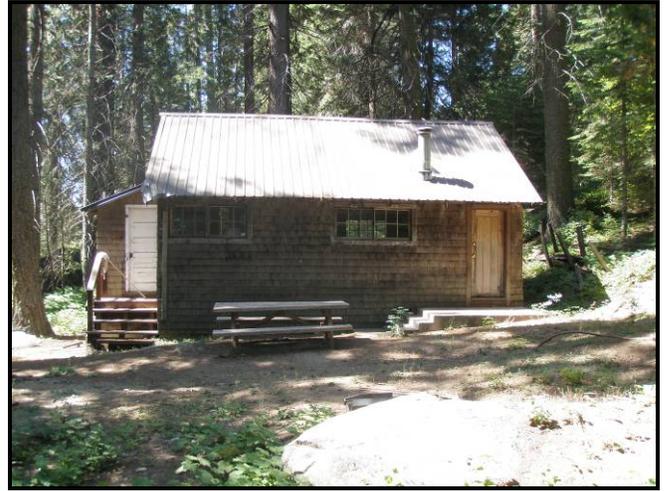
Description: The cabin, built in circa 1944, is not available for public use and has been most recently used by Department employees for a nominal rental fee, but has not been used for at least the last two years (Figure 43).

Figure 43. Building #31. View of circa 1944 Cabin at Mountain Home DSF. Photo taken in 2010.

#31	Mountain Home DSF Cabin	CAL FIRE shall continue to use, protect, repair and maintain this building.	CAL FIRE shall continue to use, protect, repair and maintain this building.

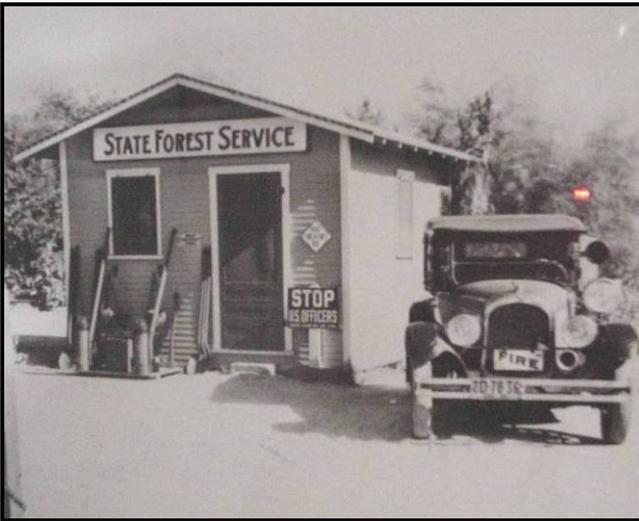
Description: This historic CDF Fire Station office was built in circa 1921 and represents one of the last buildings in CAL FIRE's collection dating to the 1920s. It is in good condition, has had a recent exterior paint job and the roof is less than 15 years old (Figures 44 and 45). The floor and walls are sound and the windows are intact and functional. There is some water damage to the celotex ceiling from rain in 1992-1993 prior to the new roof, but this damage is minor. The building is currently used for storage and display of Department related memorabilia, especially personal items and documents from the life of Charles Van Fleet, the first Ranger of the San Jacinto area who served in San Jacinto from 1927 to 1965. Historical items include fire reports, journals, work camp rosters, photographs, clothing, hand tools, safety

Figure 44. Building #32. View of circa 1921 Ranger's Office at San Jacinto FS. Photo taken in 1920s or 1930s.

#32	San Jacinto FS Office (old)	CAL FIRE shall continue to use, protect, repair and maintain this building.	CAL FIRE shall continue to use, protect, repair and maintain this building.

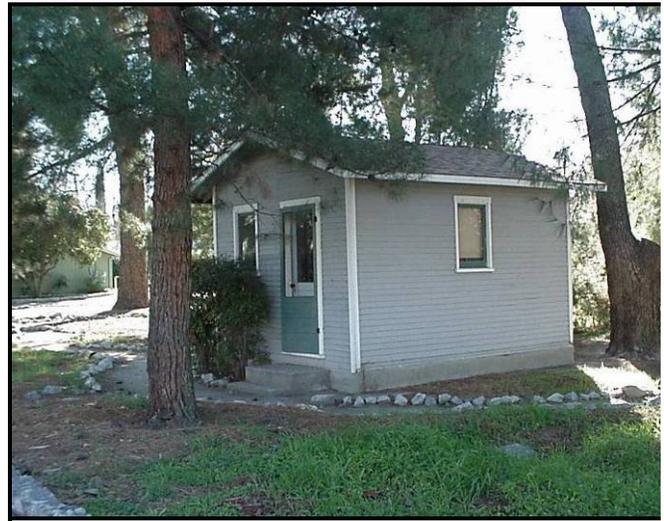
Figure 45. Building #32. View of San Jacinto FS, Office after it was moved in 1984 to the present day FS property and restored. Photo taken in 2002.

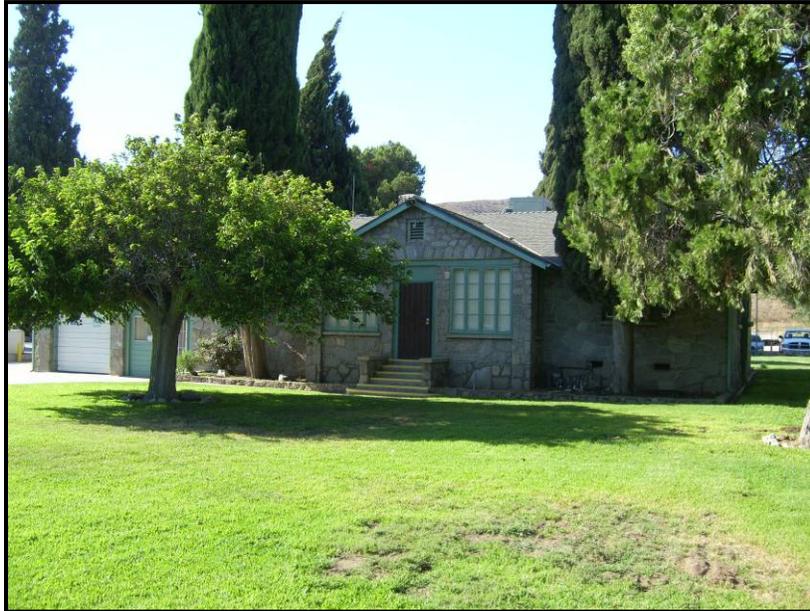
Figure 46. Building #33. View of 1940 Combination Barracks at West Riverside FS. Photo taken in 2010.

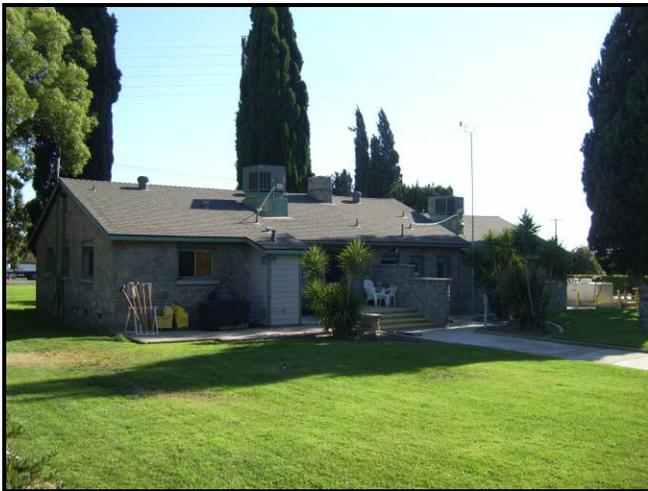
Figure 47. Building #33. View of West Riverside FS, Combination Barracks. Photo taken in 2010.

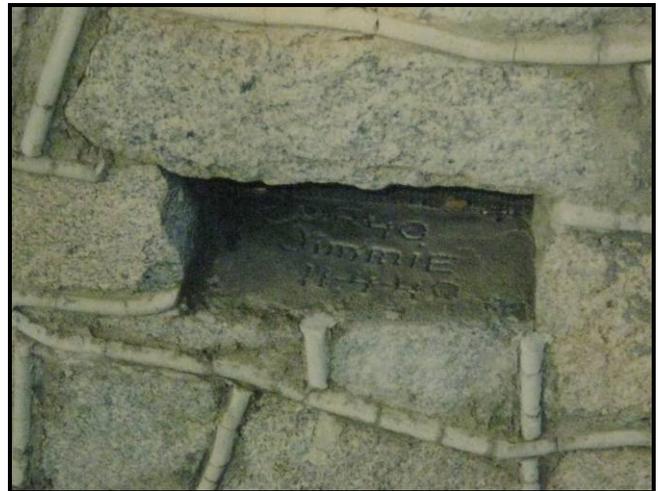
Figure 48. Building #33. View of West Riverside FS, Combination Barracks. During initial construction the original station employees etched their names into the foundation vents around the station. Photo taken in 1998.
