10- ATTACHMENT: Photographs

CALIFORNIA DEPARTMENT OF FORESTRY AND FIRE PROTECTION

Incident Name		CAJON	Incident #	CABDU011627	
Photo Number	Date Taken	Time Taken	Photographer	Photographer Position	Description
1-1	10/22/07	11:39 AM	Delgado	W/B 40th E/ O Kendall Dr	Enroute to Fire
1-2	10/22/07	11:40 AM	"	W/B 40th E/ O Kendall Dr	Smoke from Cajon Fire
1-3	10/22/07	11:42 AM	"	Northwest bound Kendall Dr at University PKWY	Smoke Column seen from 7 miles southeast of fire.
1-4	10/22/07	11:44 AM	"	Northwest bound Kendall Dr at about Pine Ave	Smoke Column seen from about 5 miles southeast of fire.
1-5	10/22/07	11:45 AM	"	Approaching Palm Ave from Kendall Dr	Vehicle Traffic
1-6	10/22/07	11:46 AM	"	Northbound Interstate 15 onramp from Palm Ave	Heavy smoke with heavy winds blowing to the south / southeast
1-7	10/22/07	11:51 AM	"	N/B I-15 (facing west) just east of Kenwood	H- Frame seen on left side ridge; fire already burned along southbound I-15 shoulder & center div.
1-8	10/22/07	11:55 AM	"	Cajon Blvd SE/ of Kenwood, SE/of metal gate, SW/of I-15	Heel of fire back-burning against wind

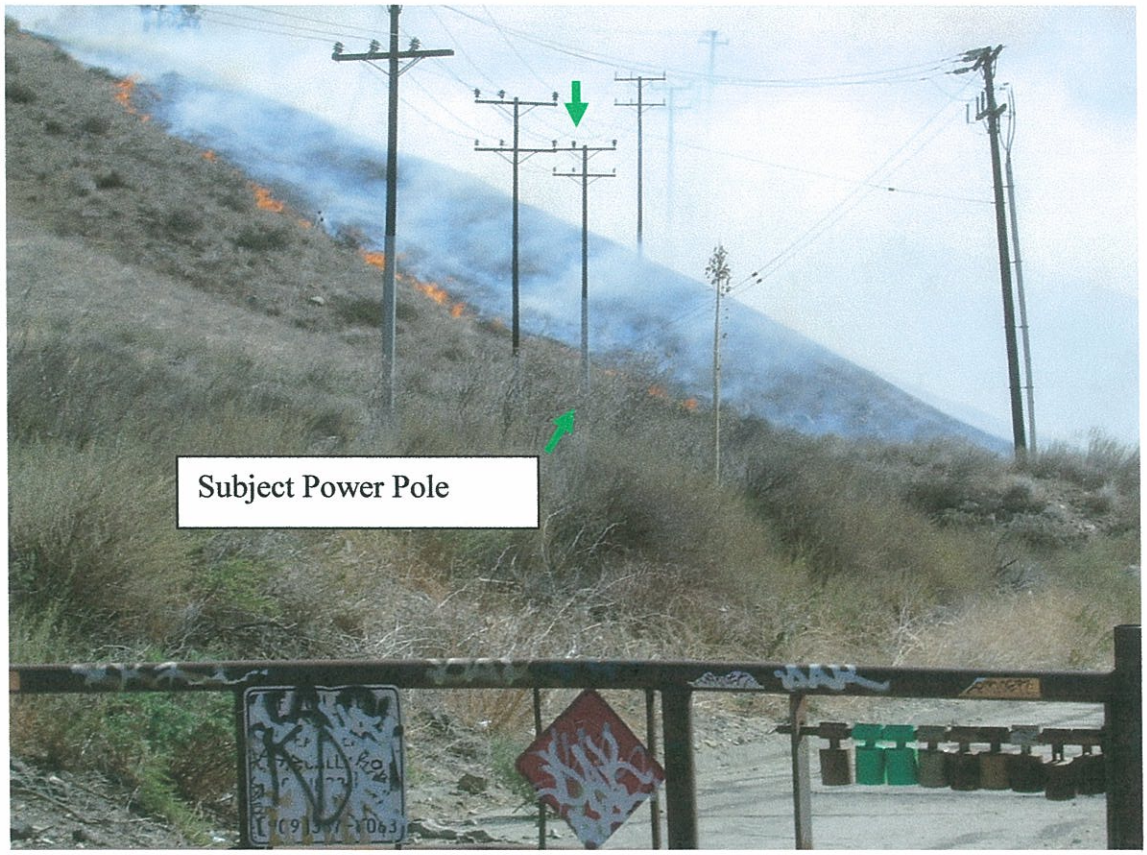
Picture # 2
Photograph taken by W-8 CAMPBELL several minutes after the fire started. He was facing the northeast while located at the intersection of Cajon Boulevard and Kenwood Avenue. The fire was burning near the base of the subject pole on the northeast/east/southeast side of it. (Photo I.D DSCN3053, Evidence Log I.D. # 1E)

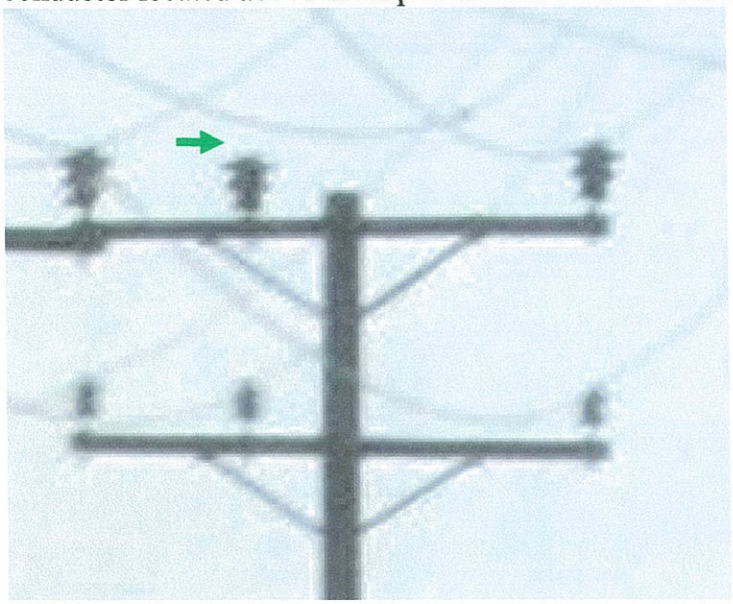
Picture # 3
An enlargement of the subject identified in the preceding photograph shows the conductor located above the top cross arm's center insulator is detached.

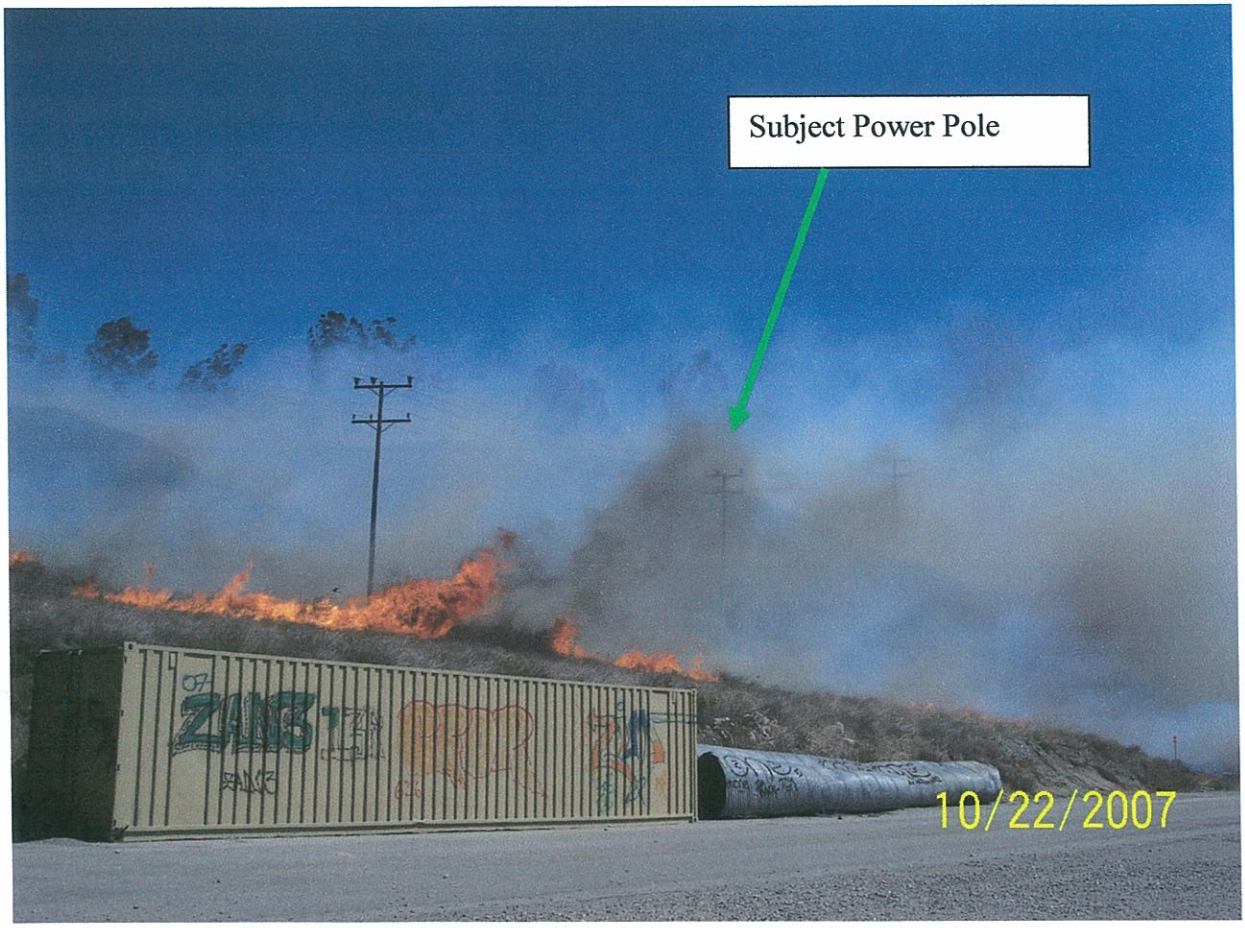
Picture # 5
W-5 HOLMES stated that when he saw the fire it was approximately 50 feet in diameter midway between Cajon Blvd and Interstate 15. Cajon Blvd is in the foreground with the metal storage container, and Interstate 15 is on the other side of the trees at the top left side of the photograph (Photo I.D. # 1-12 taken at 12:00 p.m.)

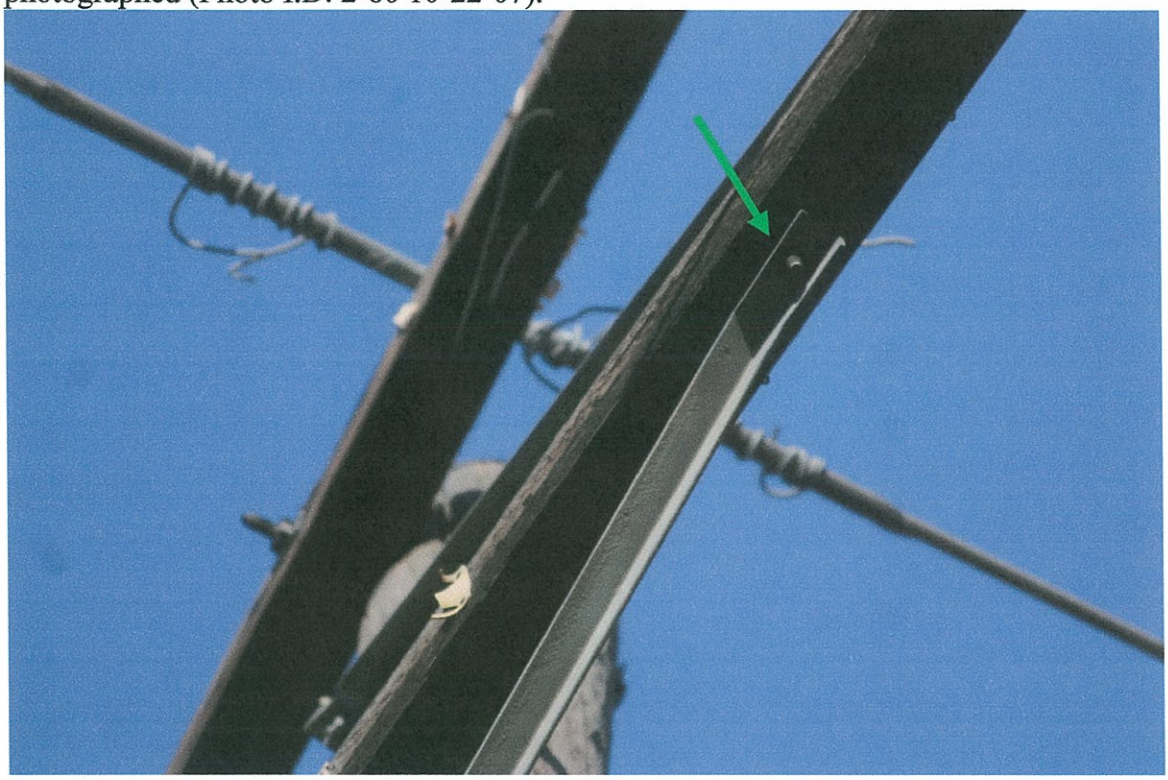
Picture # 7
The missing nuts securing the upper cross arm V-brace were not present resulting in its rotation. The nut missing from the lower cross arm on the southwest end was photographed (Photo I.D. 2-80 10-22-07).

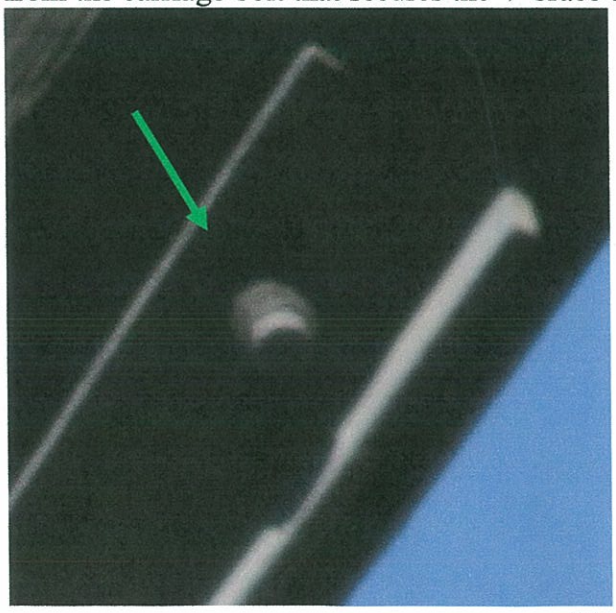
Picture # 7A
Enlarged view of the image above showing the area on lower cross arm missing the nut from the carriage bolt that secures the V-brace to the cross arm.

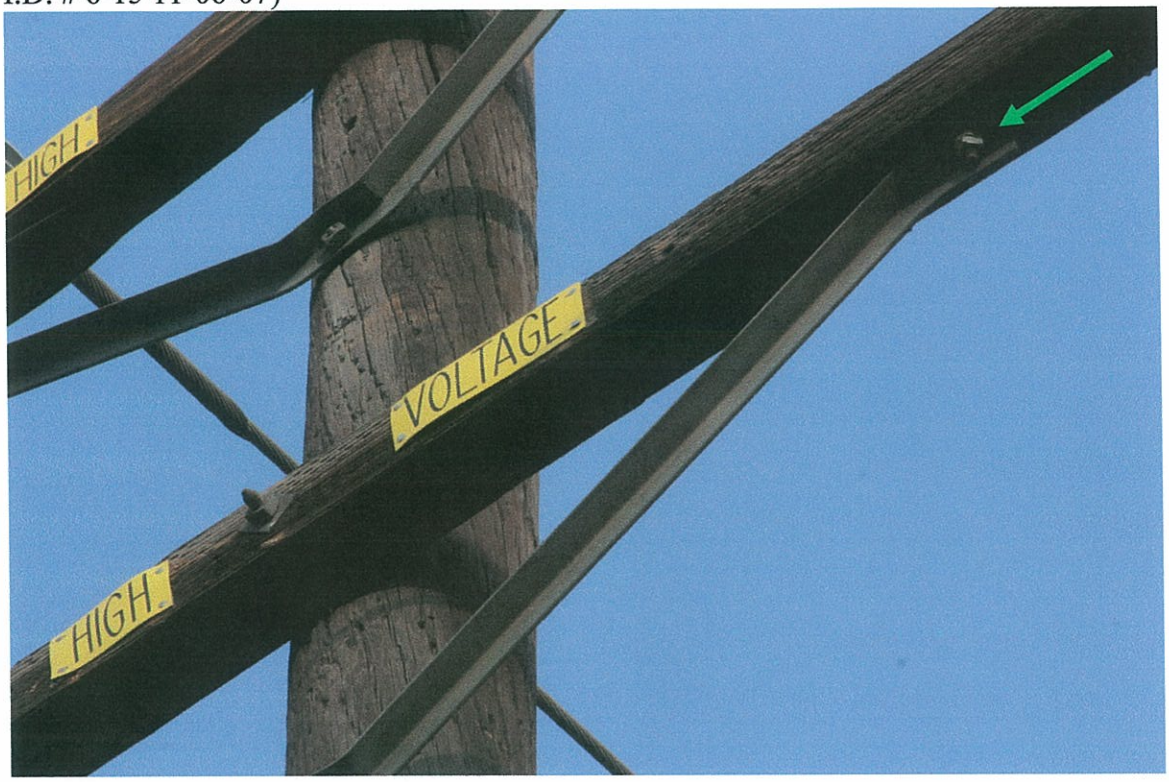
Picture # 10
View of lower cross arm after repairs had been made. Note the nut in place securing the lower cross arm V-bracket is similar in shape and size to the nut seen in the image (Photo I.D. # 6-15 11-06-07)

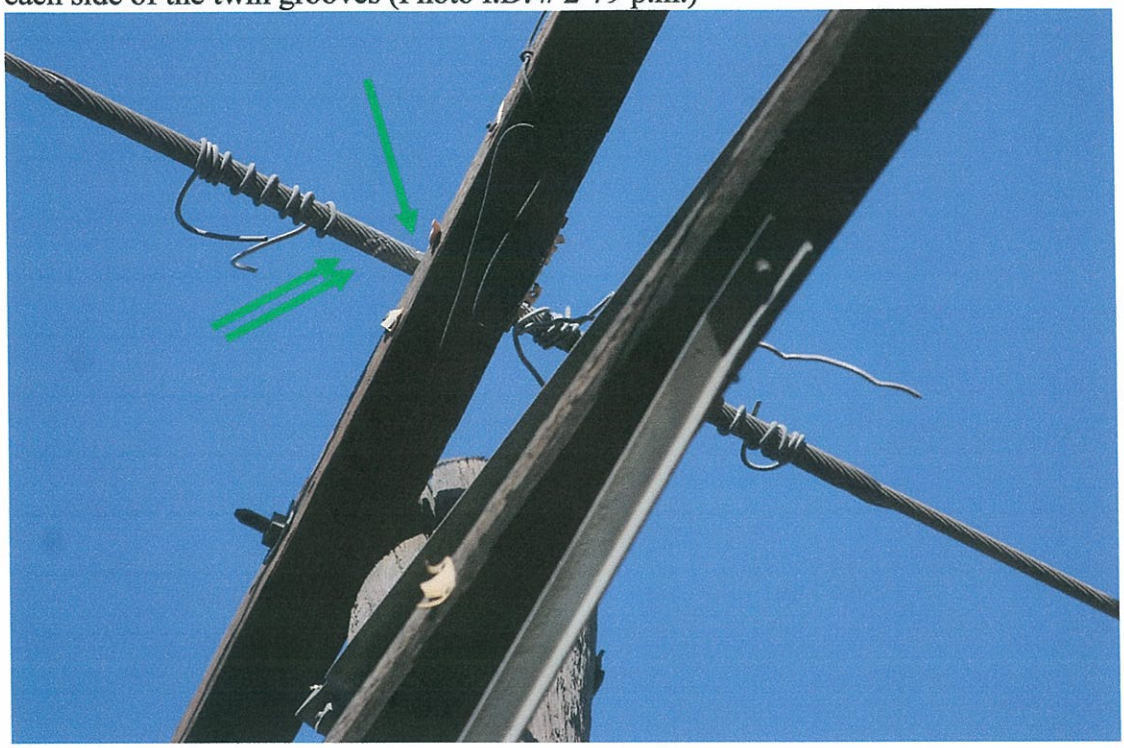
Picture # 11
Evidence of arcing against the center conductor that had detached from its insulator is visible in this image, which also shows the loose aluminum tie wires hanging free. The arcing was evident by the appearance of twin side-by-side grooves fused into the center conductor on both its underside and south-facing side. The aluminum tie wires are on each side of the twin grooves (Photo I.D. # 2-79 p.m.)

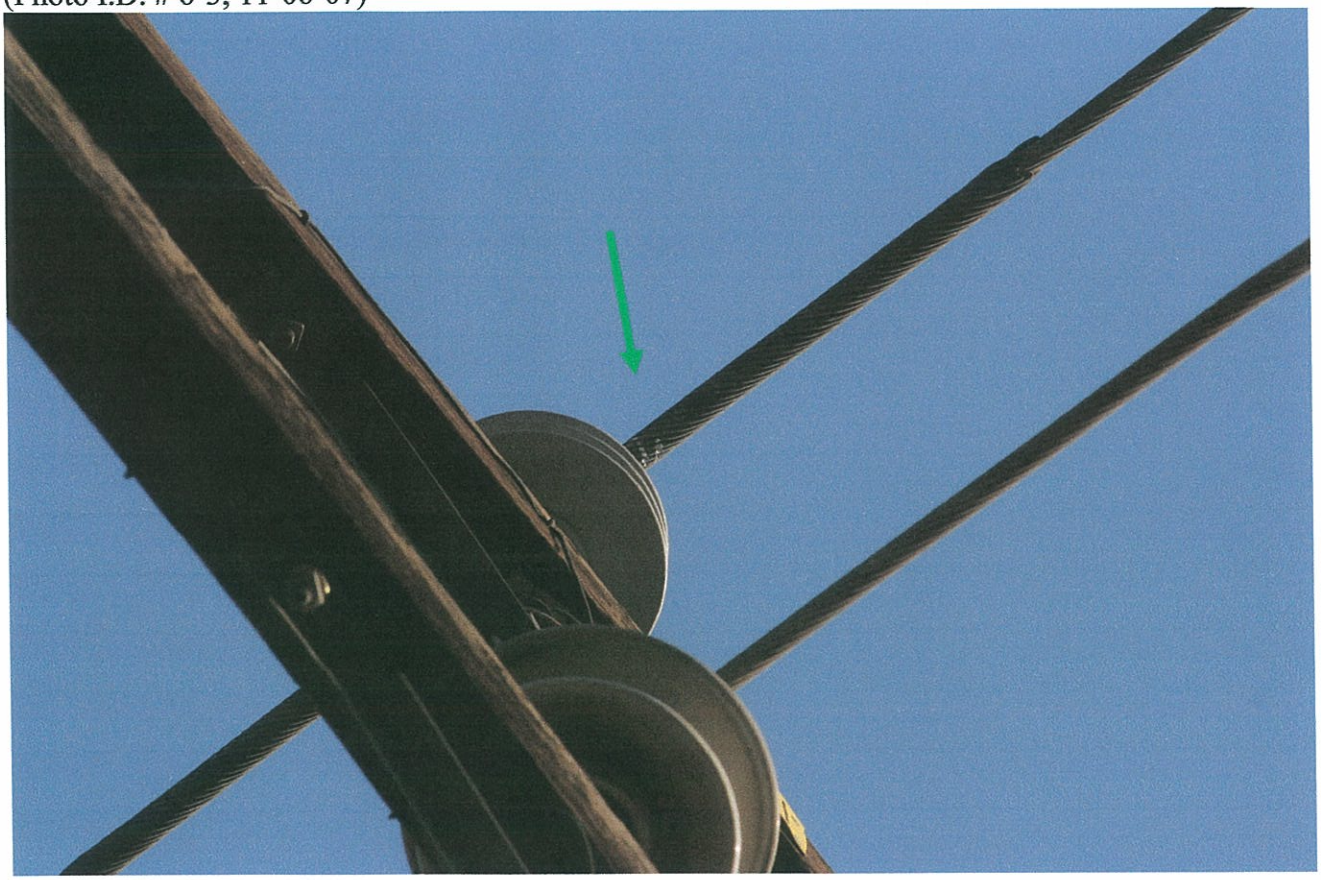
Picture # 13
On 10-23-07 at about 4:14 a.m. and new style insulator was installed in place of the insulator that originally secured the center conductor. The new insulator is shown in this image. Also shown from a different angle are the twin grooves photographed on 10-22-07. Note the aluminum tie wires are not present because the new insulator uses a clamping type system for holding the conductor in place. Also note there are no similar groove impression markings where the aluminum wire wrapping was located on 10-22-07; evidence the tie wires alone do not create grooves into the conductor
(Photo I.D. # 6-3, 11-06-07)

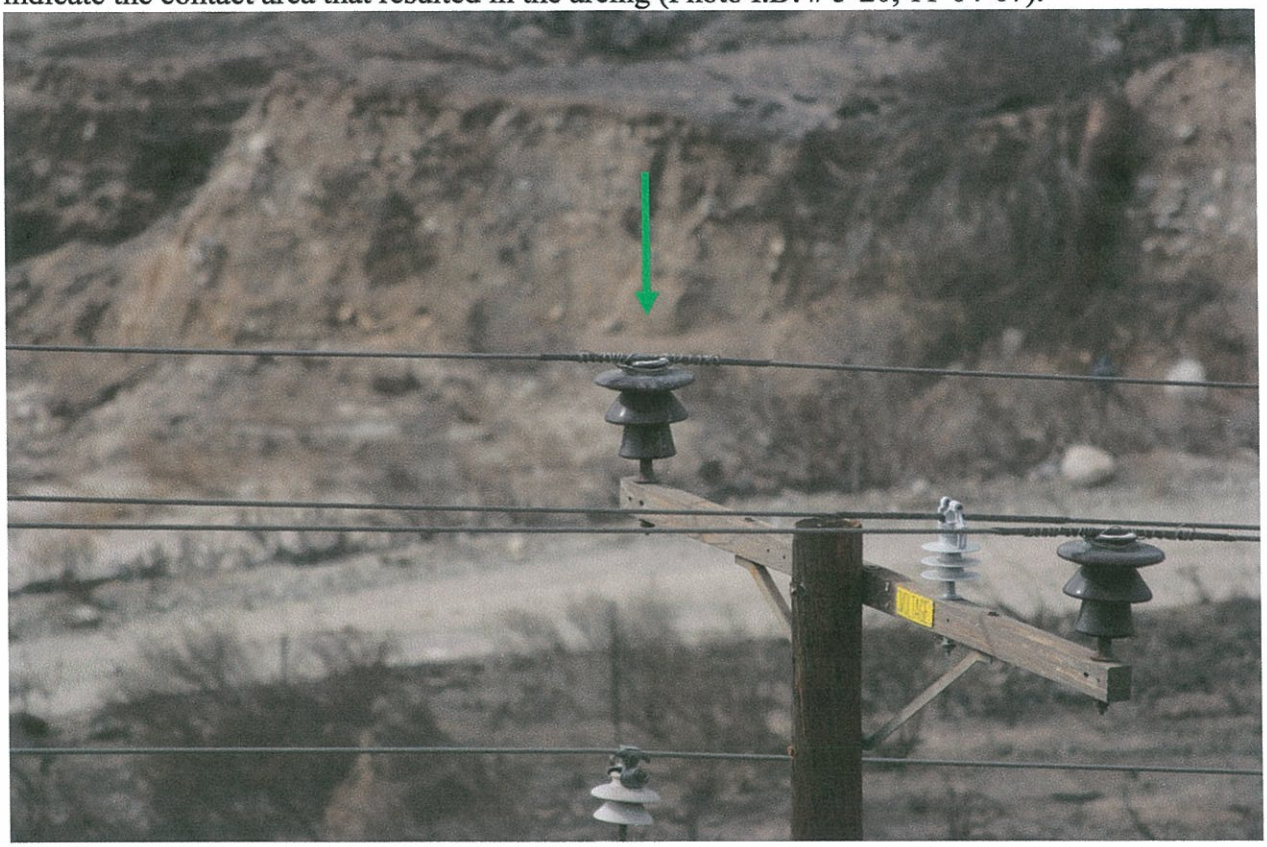
Picture # 15
The brown porcelain insulator shows evidence of scrapes against the side facing the center conductor. There is also evidence of contact on top of the conductor on the southwest end insulator, as well as the appearance of "flash burn" discoloration on the insulator and on the aluminum tie wire wrapped around the insulator's collar. This would indicate the contact area that resulted in the arcing (Photo I.D. # 5-20, 11-04-07).

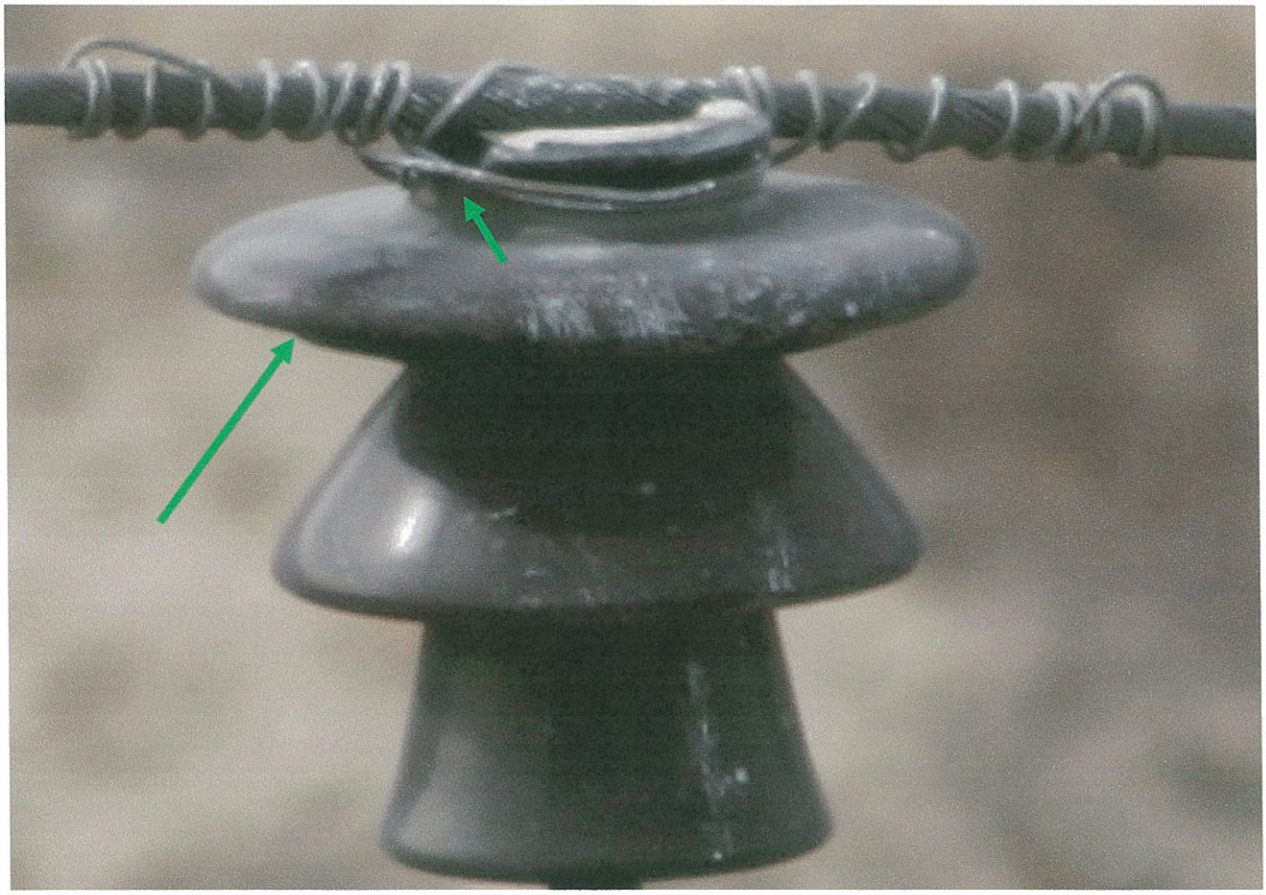
Picture # 15A
Enlarged view of the photo subject area shown in the image on 43 showing contact marks and "flash burn" discoloration.

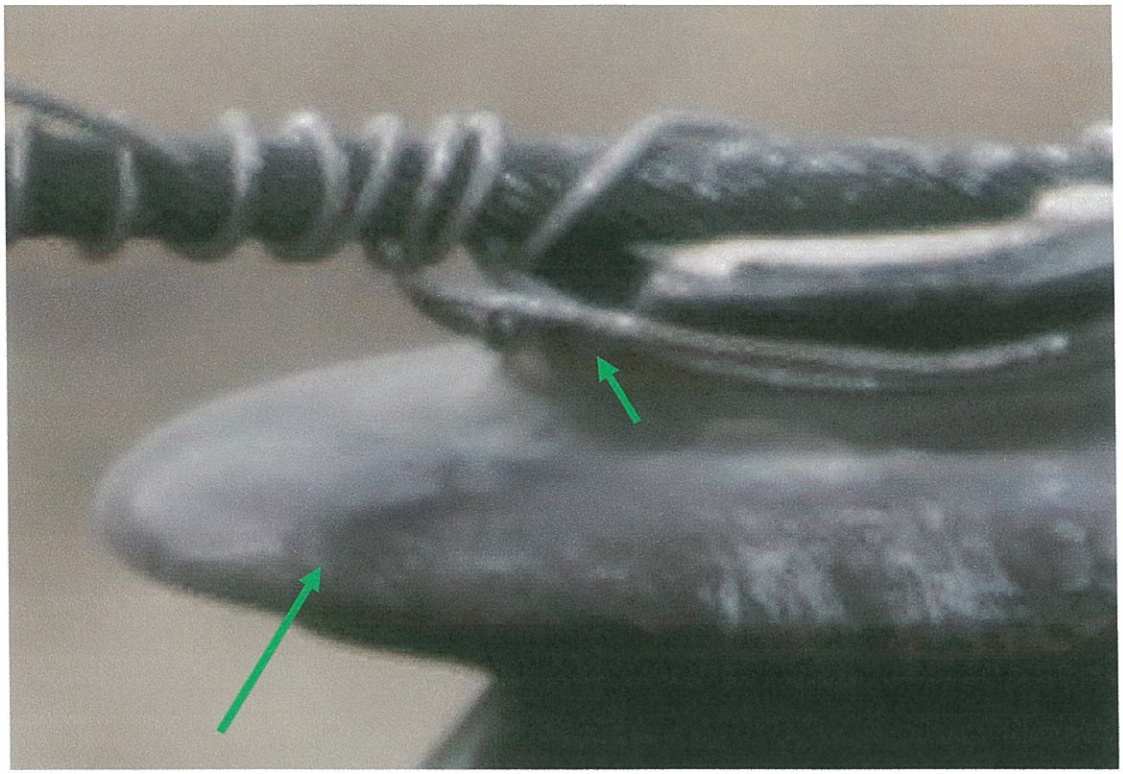
Picture # 15B
Enlarged view of the photo subject area shown in the image on 43 showing contact marks and "flash burn" discoloration.

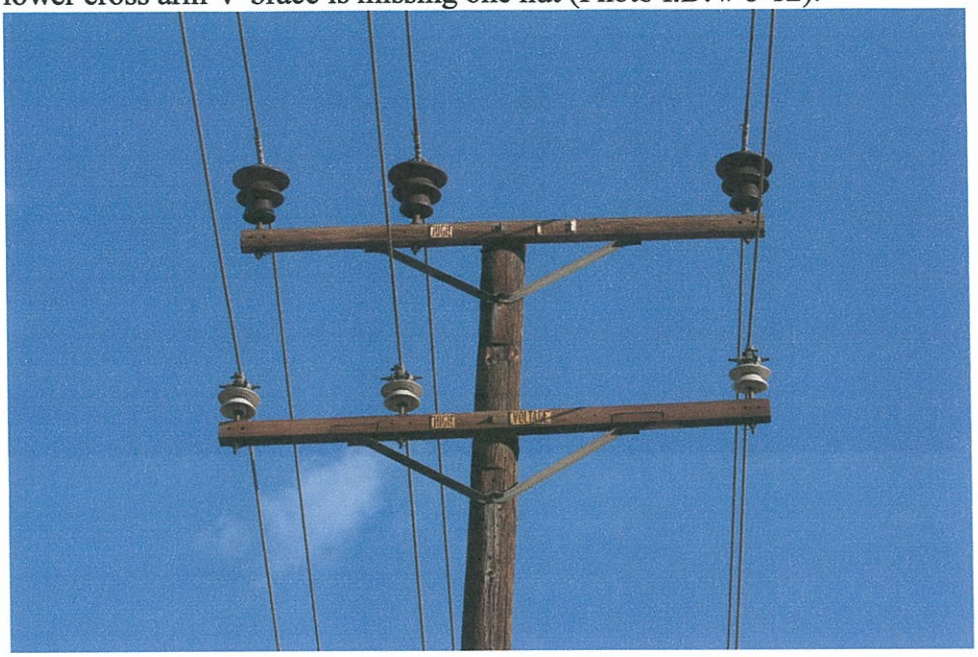
Picture # 16
Looking east at the power pole located two poles southeast of the subject power pole. The lower cross arm V-brace is missing one nut (Photo I.D. # 8-12).

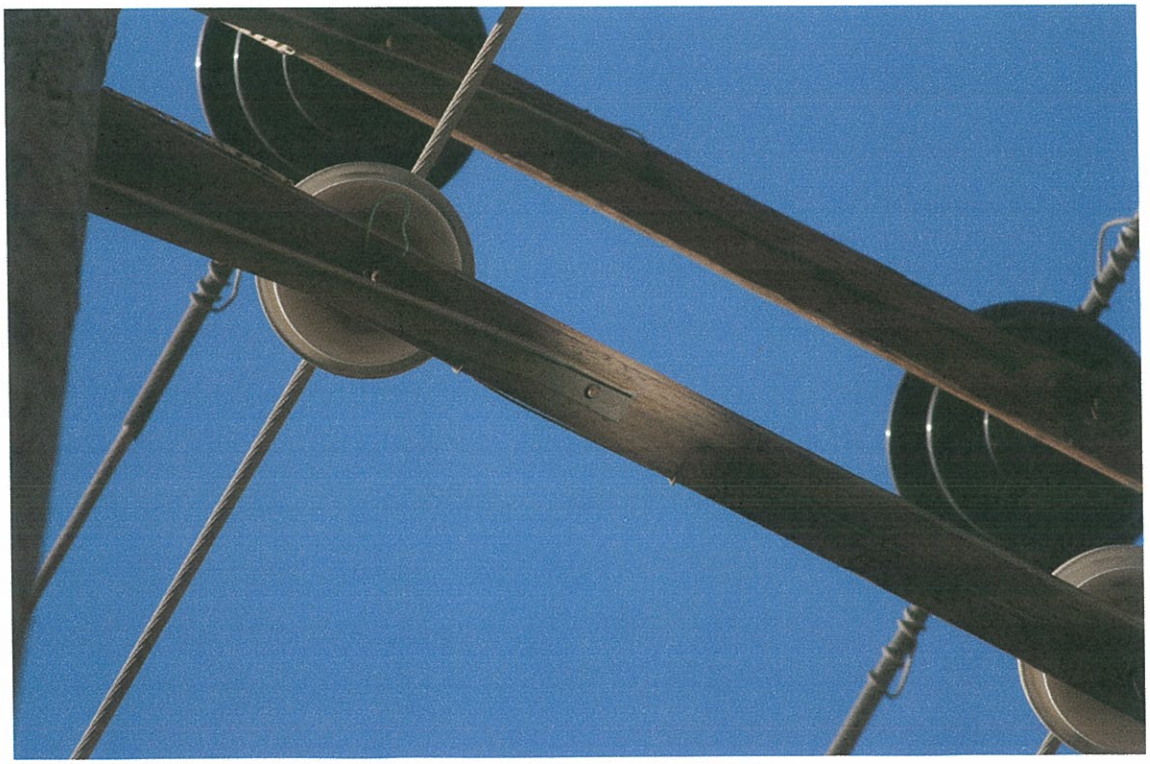
Picture # 17
Looking west at the same power pole in the above image showing the missing nut on the lower cross arm (Photo I.D. # 8-4).

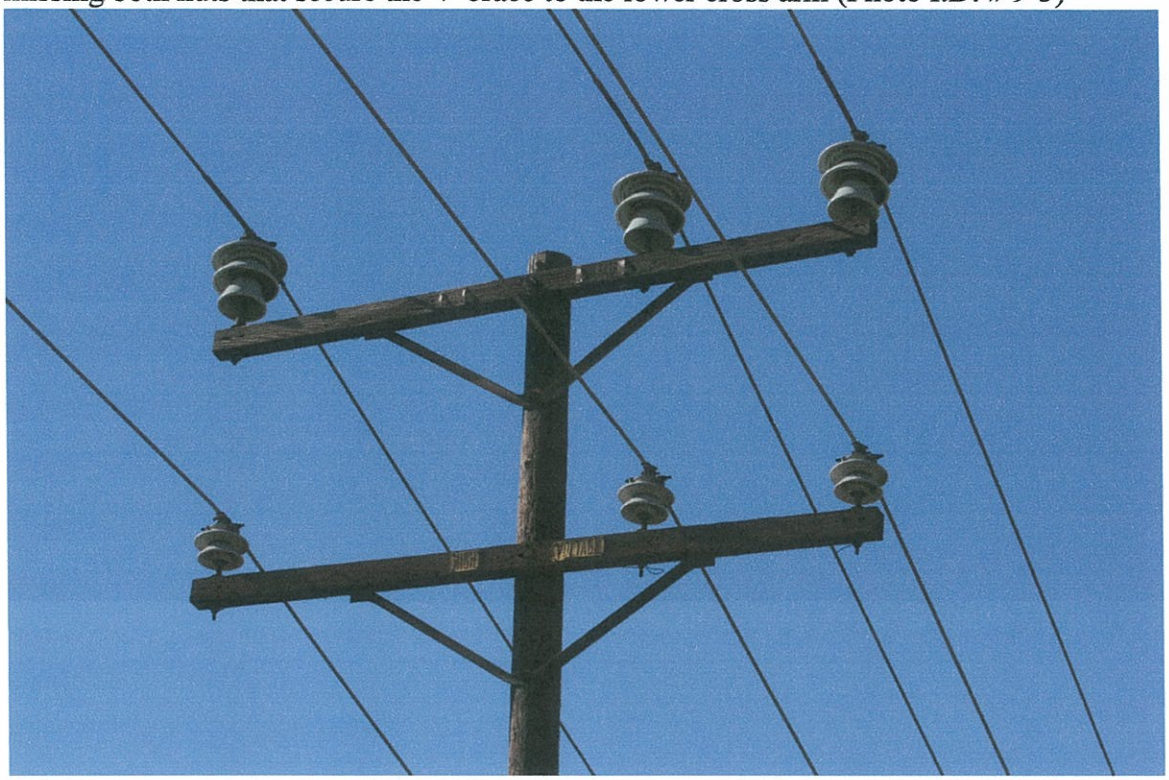
Picture # 19
Looking west at the power pole located three poles southeast of the subject pole. It is missing both nuts that secure the V-brace to the lower cross arm (Photo I.D. # 9-3)

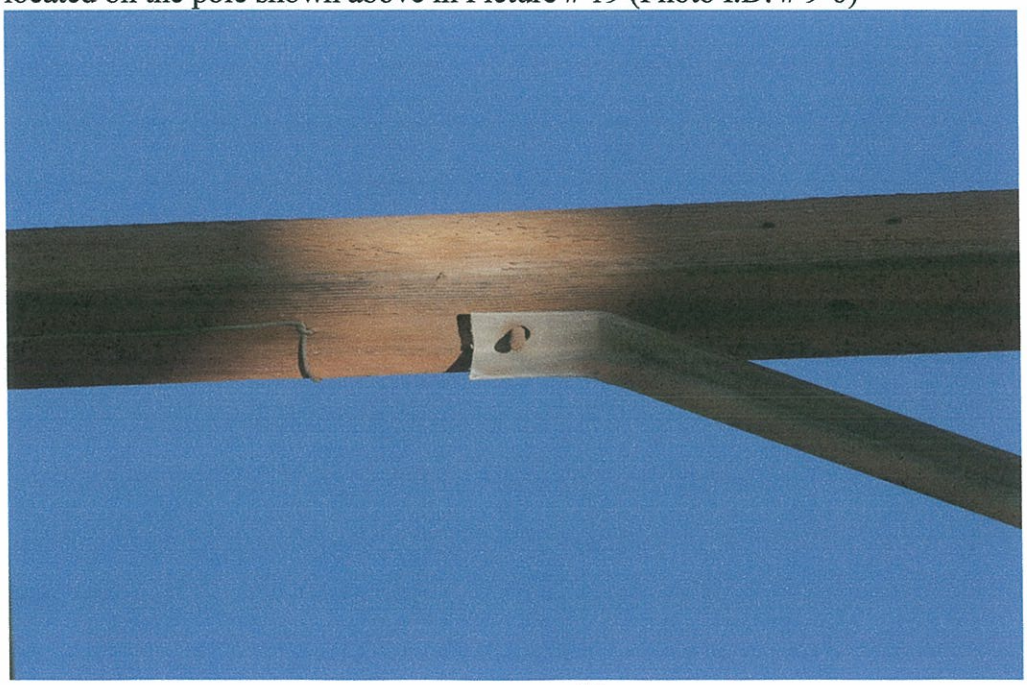
Picture # 20
Showing the missing nut from the carriage bolt on the lower cross arm's southwest end; located on the pole shown above in Picture # 19 (Photo I.D. # 9-6)
