Attachment A

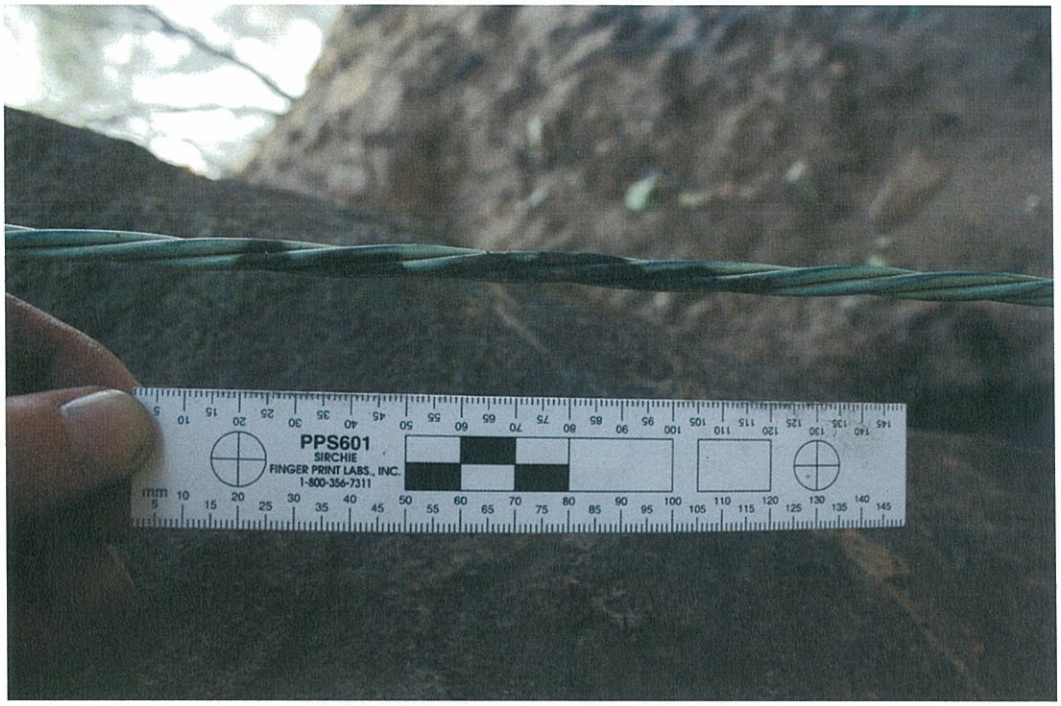
P-90 MG Close-up view of arcing on power line
