Excavation of the Franklin House Foundation  
Along San Diego Avenue  
Old Town San Diego State Historic Park

Jim Woodward and Dan Foster

January 1982

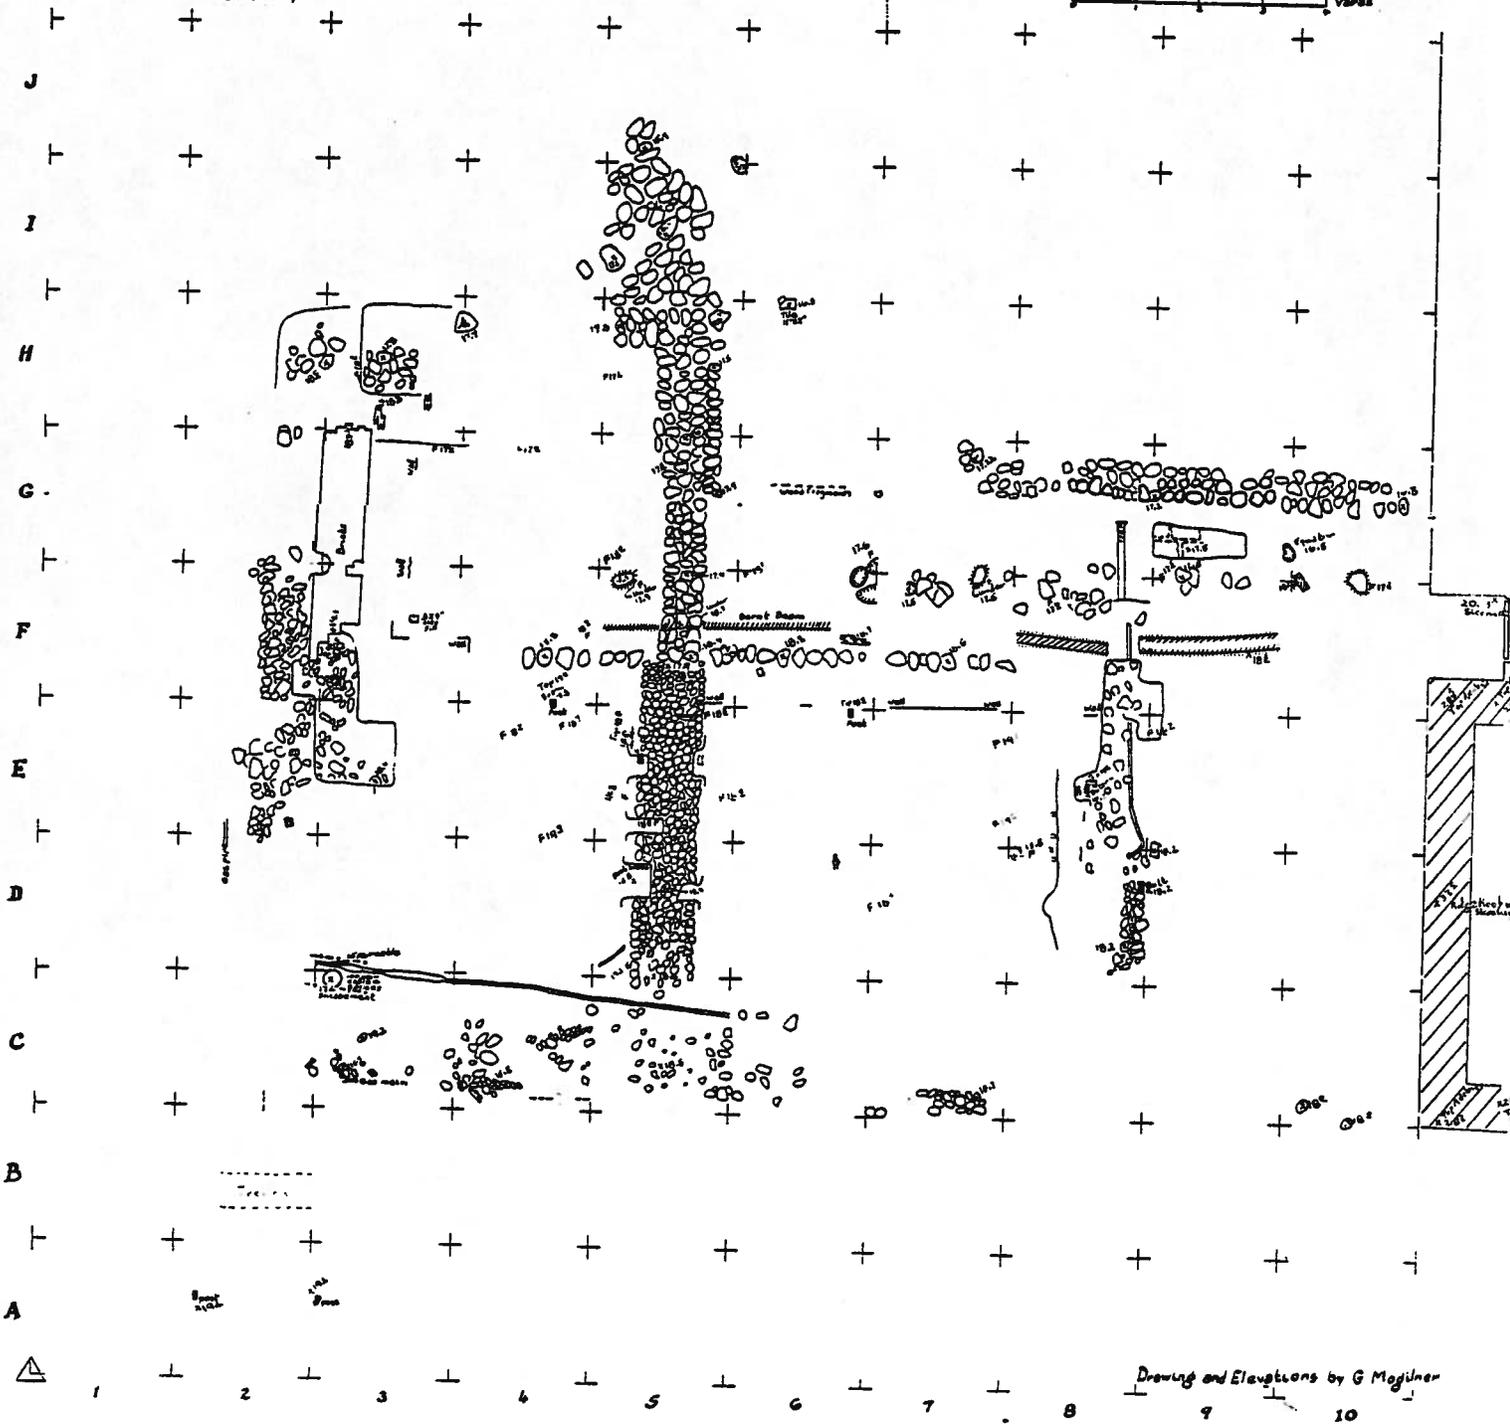
\*Elevations off by a systematic error\*

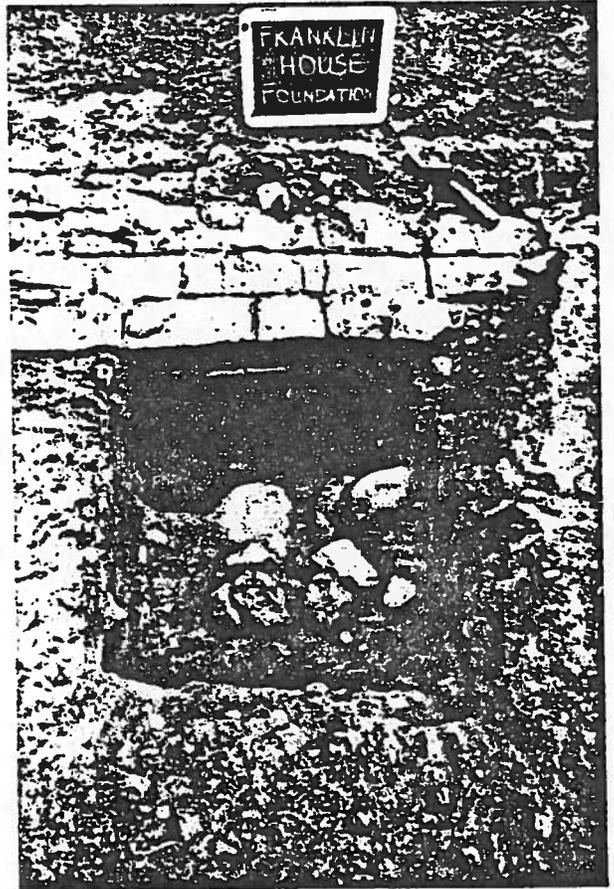
Wide angle views of foundations  
 top left: looking southeast  
 top right: foundation profile  
 and adjacent test pit  
 bottom right: detail of  
 four-brick-wide foundation.

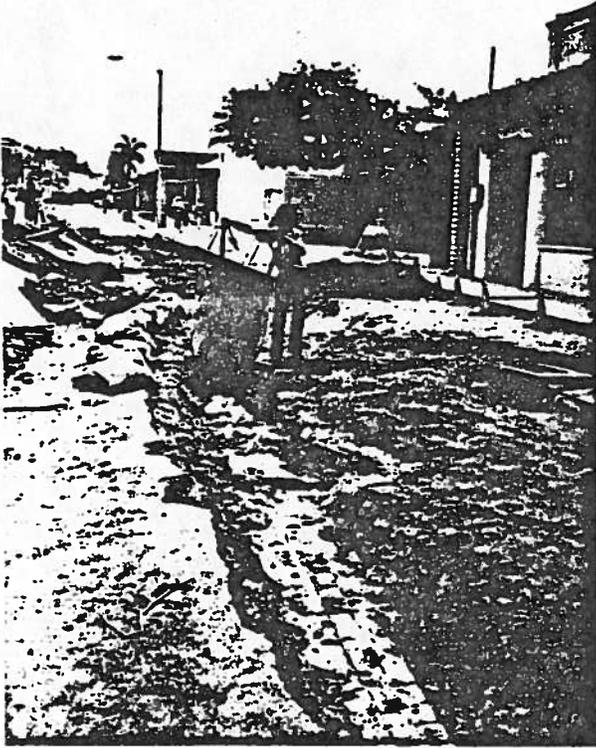
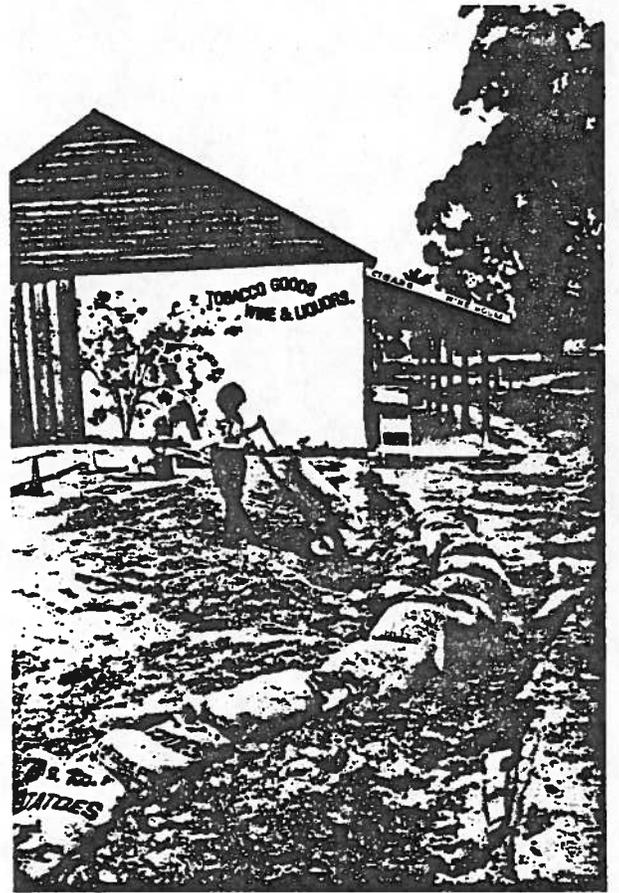
Alexa Luberski dumps sand over the foundations, while Dan Foster takes notes in background, top left. Beach sand from Silver Strand State Beach was placed over the brickwork to mark and protect this historic building feature.

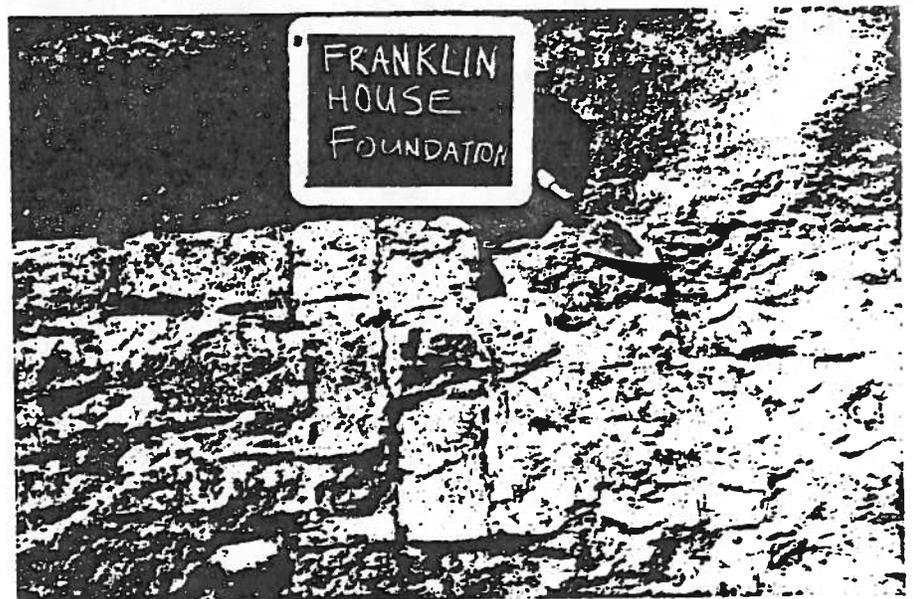
Detail of foundation  
showing vertically  
alligned bricks which  
probably marked the  
placement of internal  
walls.
