Butte Incident

Damage Inspection Summary

CA-AEU-024918

Final

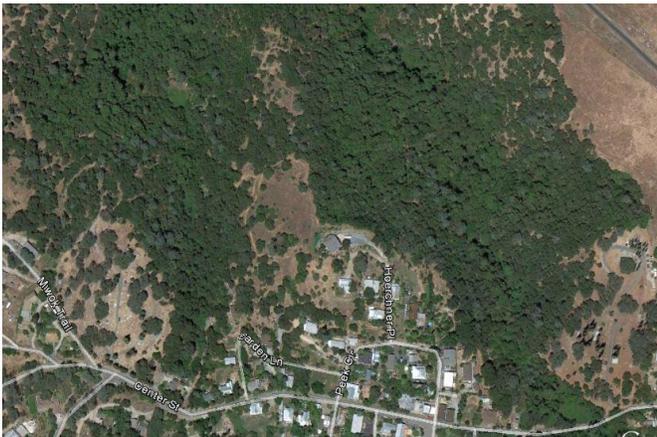
Figure 3: Before the fuel break

The historic town of Mokelumne Hill sits atop the south rim of the Mokelumne River canyon, just east of Highway 49. Fuels in the canyon are a mix of chaparral, dense oak and scattered pine. In 2012, a Western States WUI grant funded the Mokelumne Hill Fire Defense project, creating a shaded fuel break up to 300 feet in width between portions of the north end of town and the canyon. Project maintenance has occurred through 2015.

Field testimony indicated the fuel break was instrumental in providing a reduced fuel zone for firefighters to engage the fire during suppression efforts, effectively stopping the fire prior to reaching the north end of town. No homes were lost in Mokelumne Hill adjacent to the fuel break; approximately 25 homes are immediately adjacent to the fuel break. Had it not been established, the potential of the fire destroying one or more of these homes would have been significantly higher. As evidenced by recent fires, such as the 2014 Boles Fire, home to

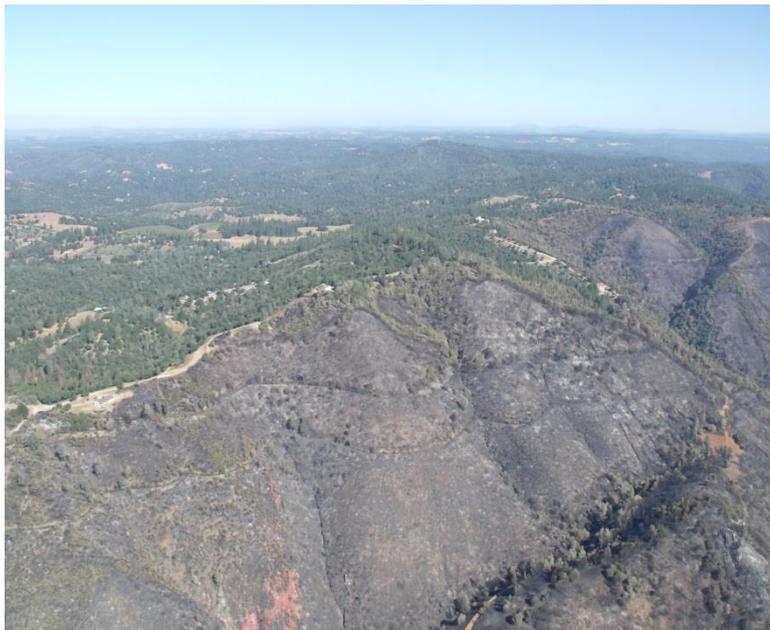
The Pine Acres Vegetation Management Project (PAVMP) has been maintained for approximately 20 years to protect the community of Pine Acres from a fire advancing out of the Mokelumne River drainage. Treatments included thinning stands of trees & brush (reducing fuel loading) and identifying control lines & access points (pre-attack planning). Regular maintenance of the PAVMP helped maintain the effectiveness of the treatment area.

Figure 5: Fuel break begins middle left, and extends to right along fire edge

During the initial stages of the Butte Fire, fire line supervisors recognized the opportunity to use the PAVMP as a critical control line. Crews lit backfires to halt the forward spread of the fire, keeping it from the community of Pine Acres. Additionally, using a pre-identified ridgeline to construct fire line they were able to control the fire from spreading northeast up the Mokelumne River drainage. Had this fire line not held to the east, the next scouted likely contingency line would have added an estimated 50,000 acres to the final fire size. Despite the fire burning in close proximity to hundreds of structures, the PAVMP held the fire and no structures were destroyed in the Pine Acres neighborhood.

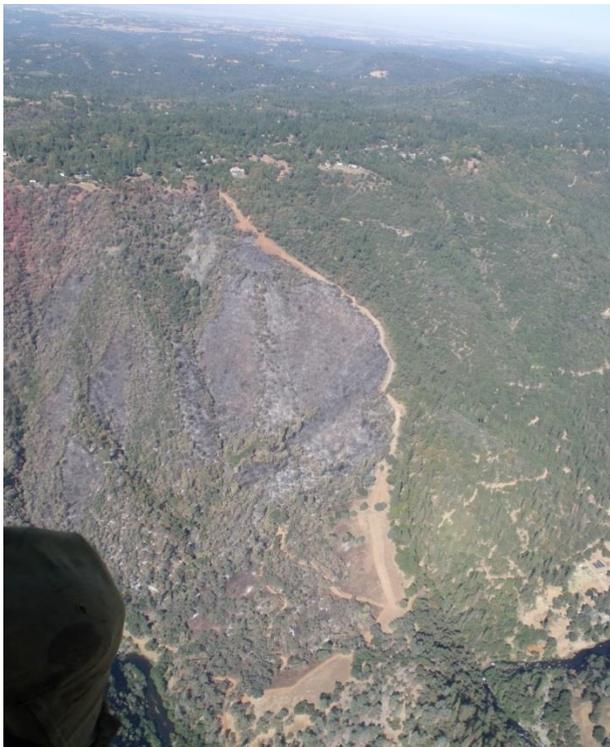
Figure 6: Fire line on predetermined ridge

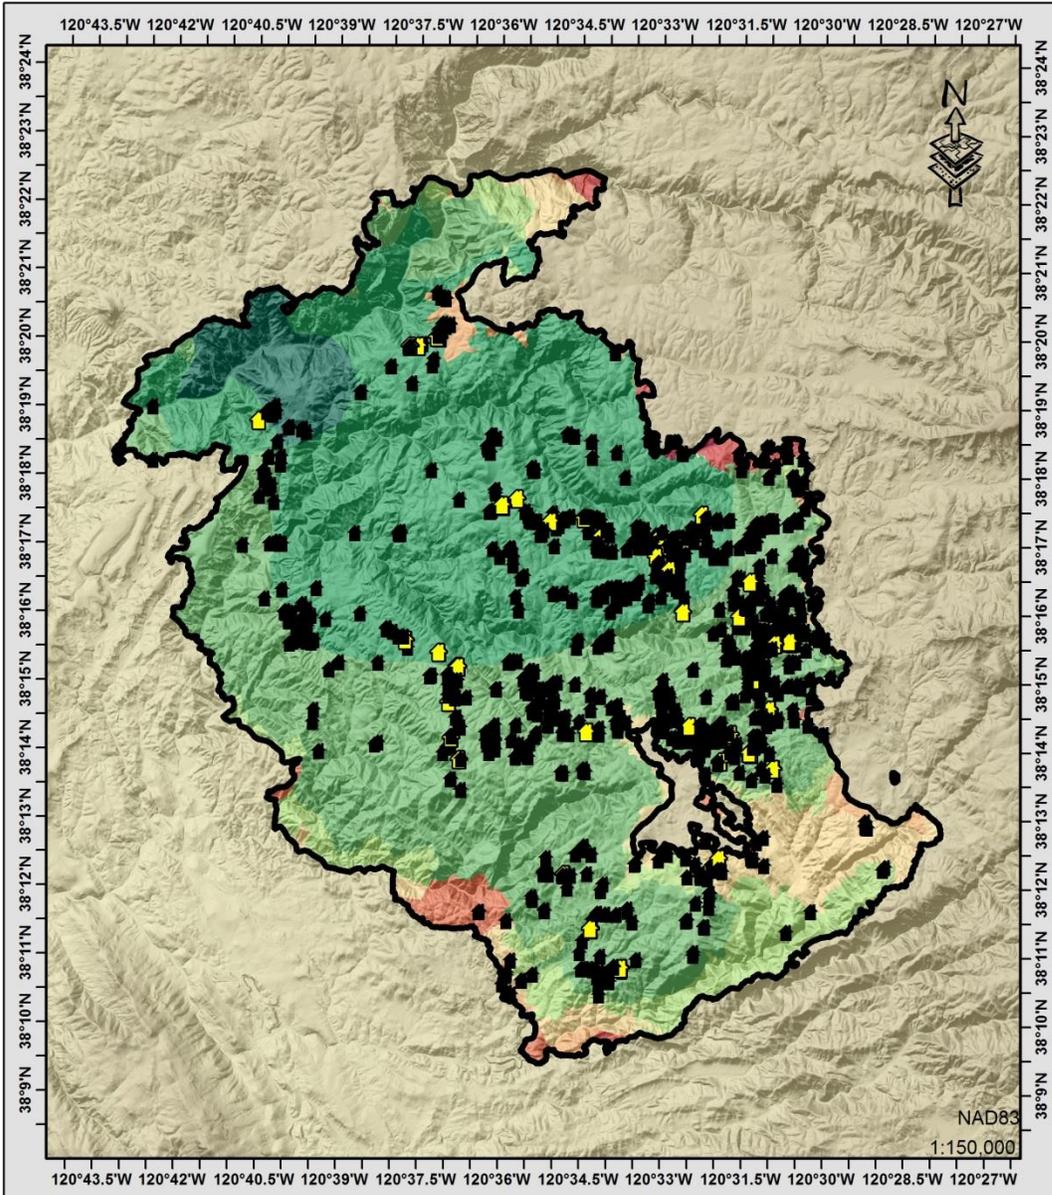
Fire Progression

🏠 Damaged 🏠 Destroyed

9/10/2015		9/13/2015		9/16/2015
	9/11/2015		9/14/2015		9/17/2015
	9/12/2015		9/15/2015		9/18/2015
