IMG_0001 - Cover sheet indicating beginning of photographs.

IMG_0002 - Front of house located at 8015 High Valley Road, Cobb, CA.

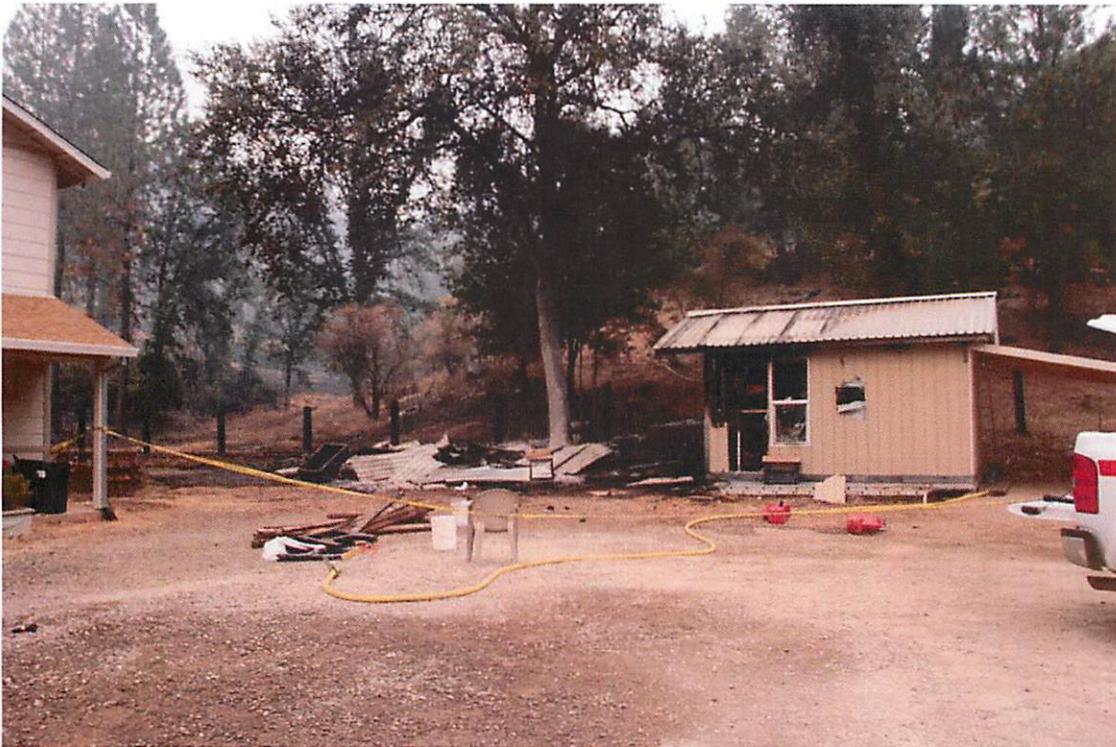
IMG_0006 - Looking southeasterly from driveway toward burnt tool shed and destroyed wood shed.

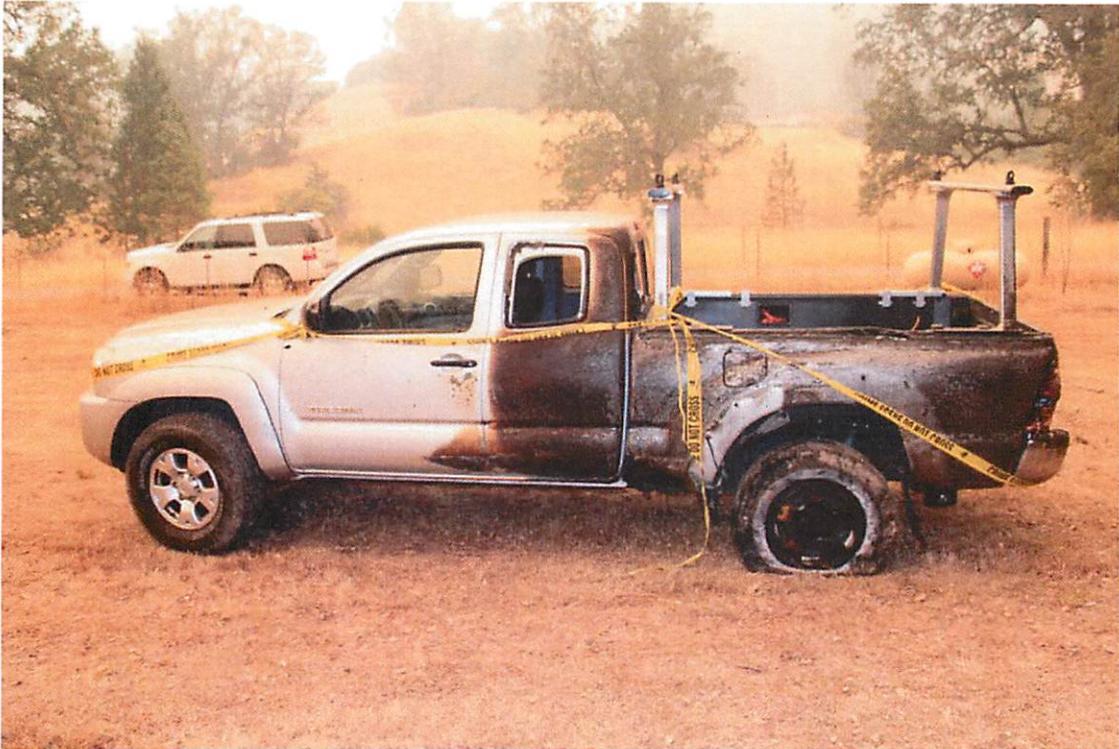
IMG_0011 - Driver side view of Toyota truck pictured in 0007, showing damage sustained when parked adjacent to tool shed pictured in 0006.

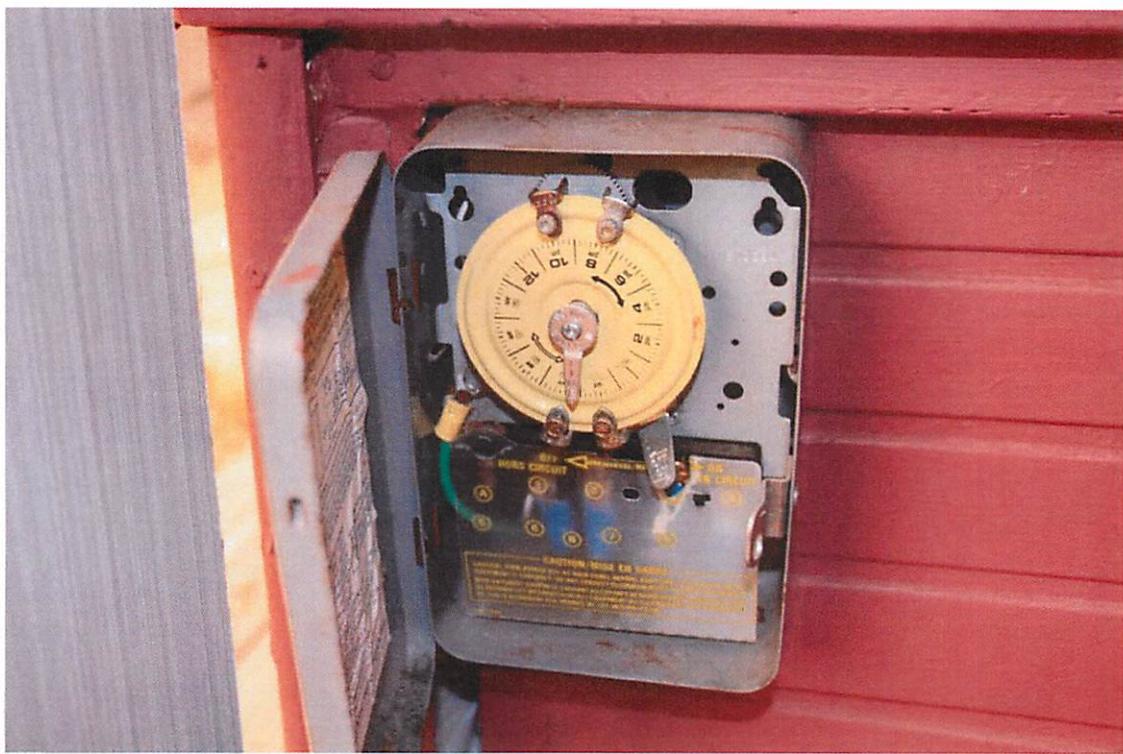
IMG_022 - Close-up of timer control on hot tub. The picture shows the timer was on when power was lost.

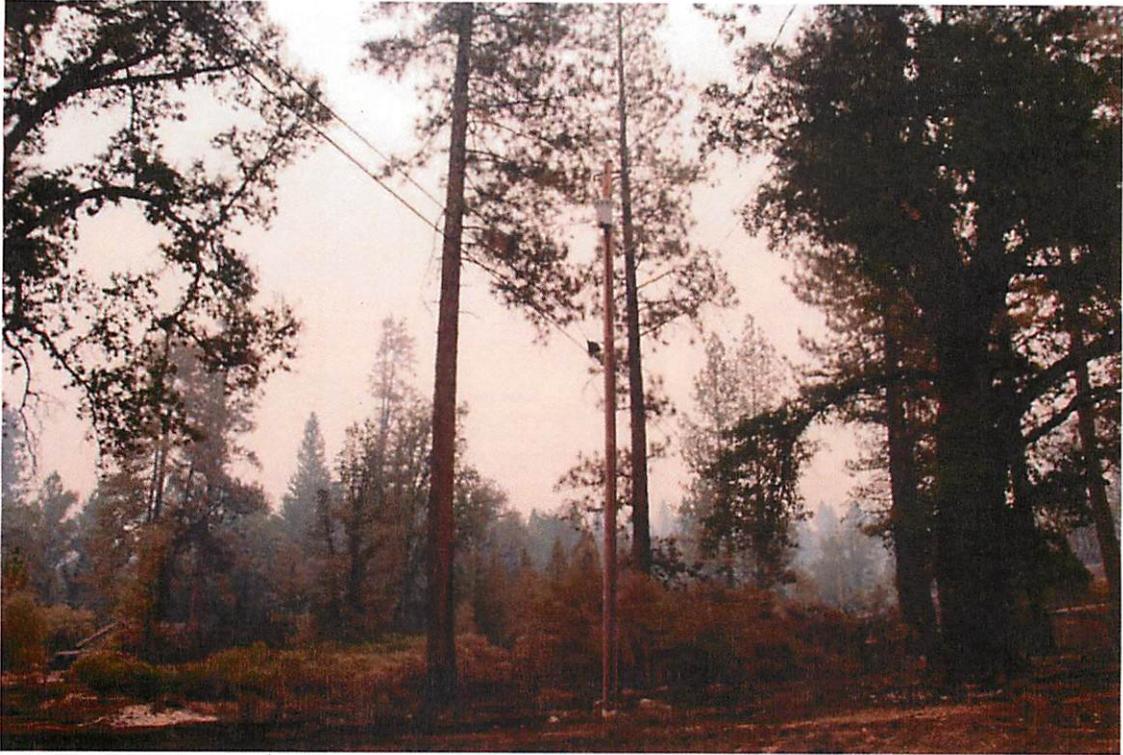
IMG_029 - Looking northeasterly across dry creek, toward power pole from northeast corner of house. Photo of entire pole, transformer and drop.

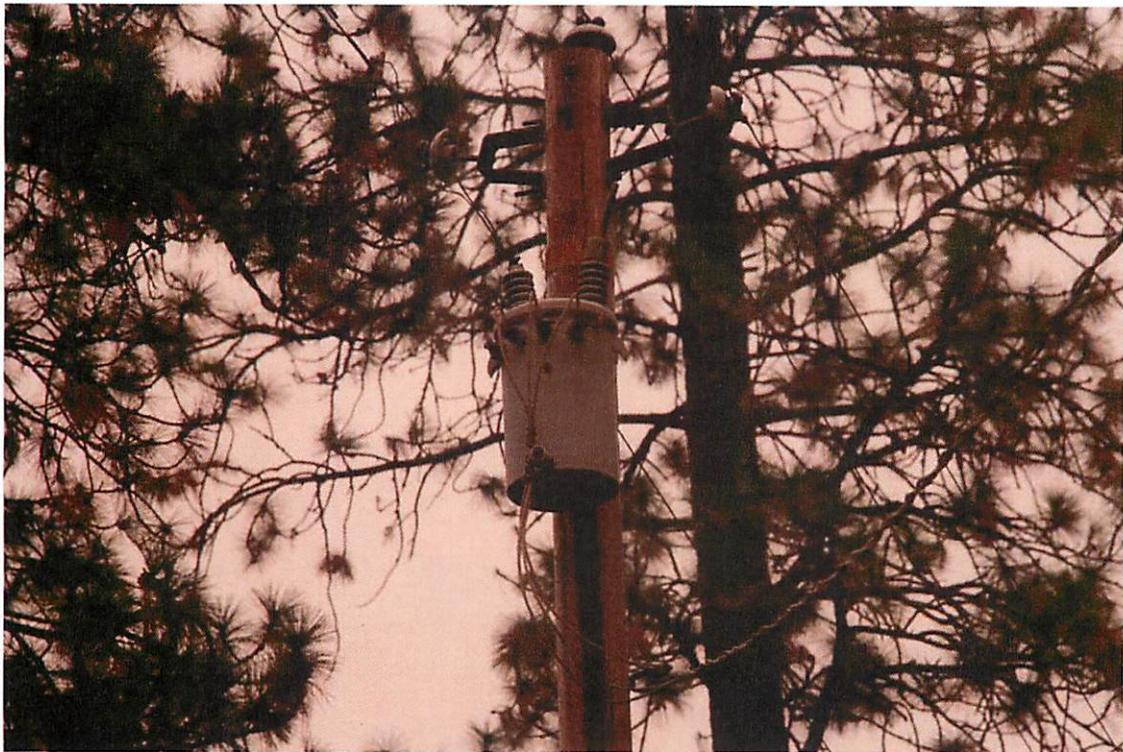
IMG_030 - Same location as #29 above, but zoomed on transformer, drop and other equipment.

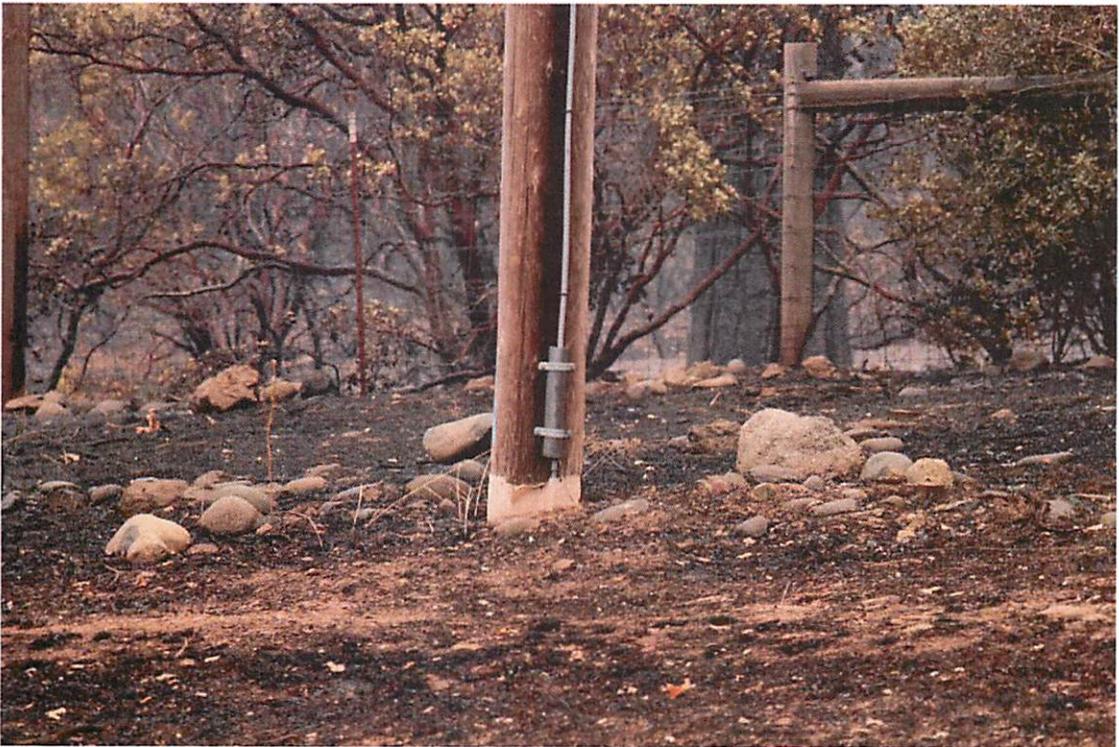
IMG_032 - Same location and direction of view as #24 & #29, zoomed in on base of power pole.

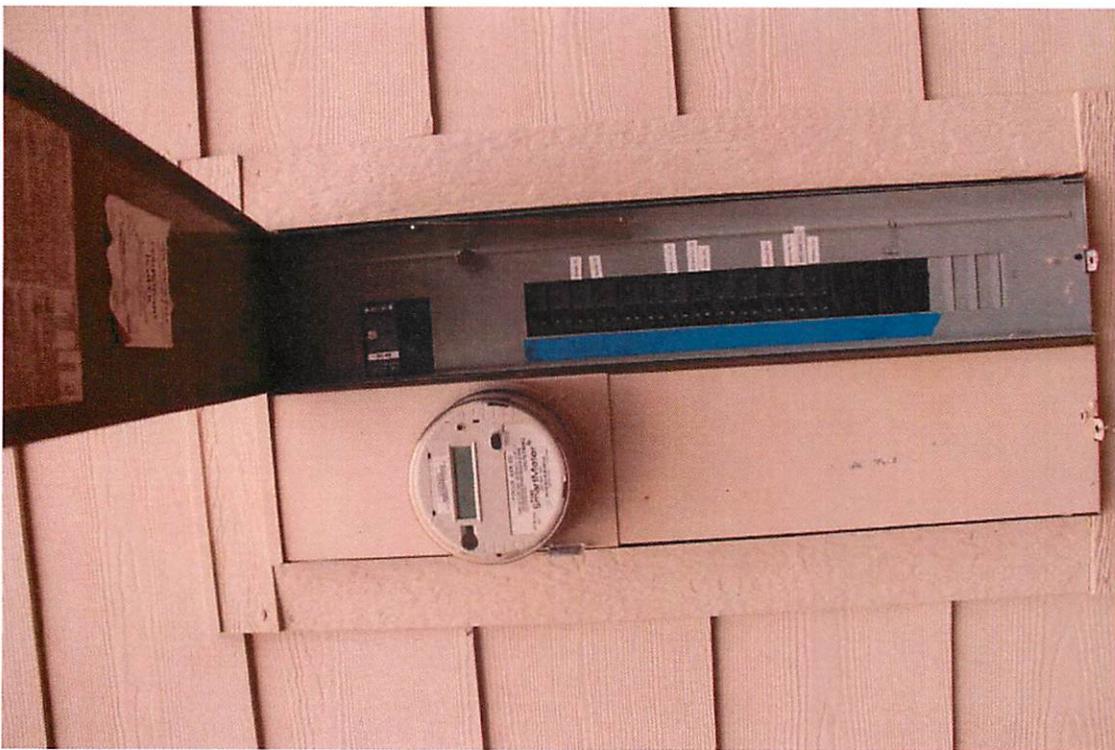
IMG_034 - Power meter and primary breaker box at rear of house near the north east corner.

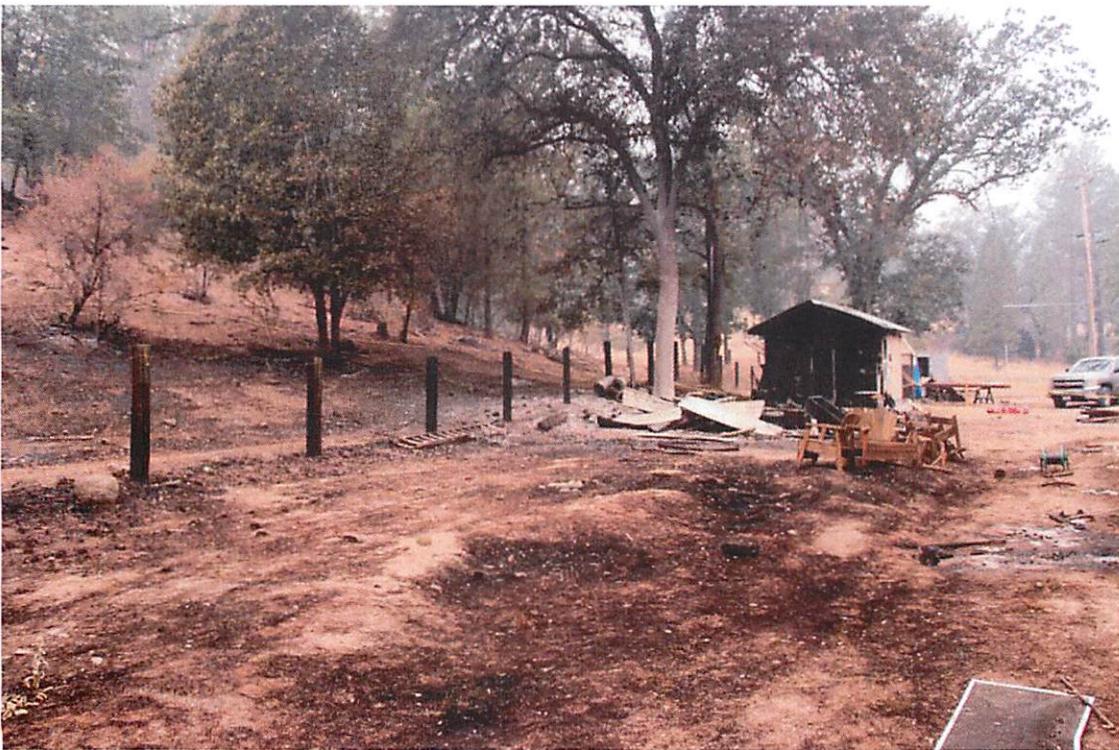
IMG_042 - Looking westerly toward destroyed wood shed and damaged tool shed, from adjacent to the southeast corner of house.

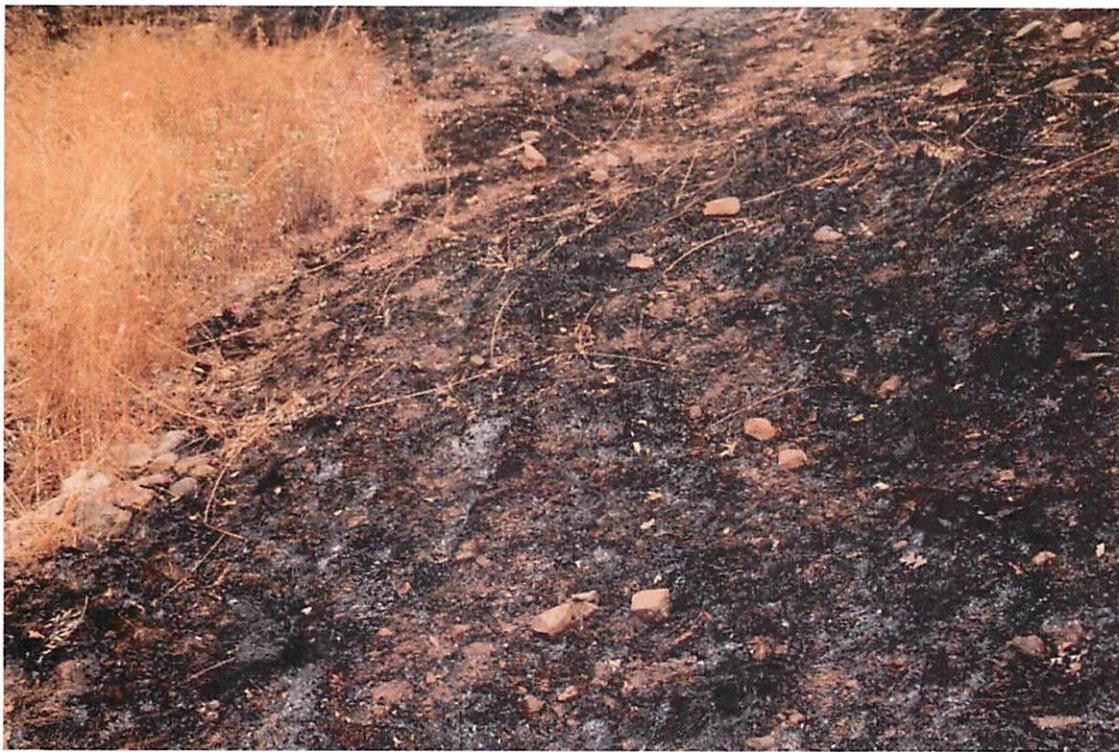
IMG_044 - Looking northerly at creek bed and east bank of creek adjacent to the garden area from the foot bridge.

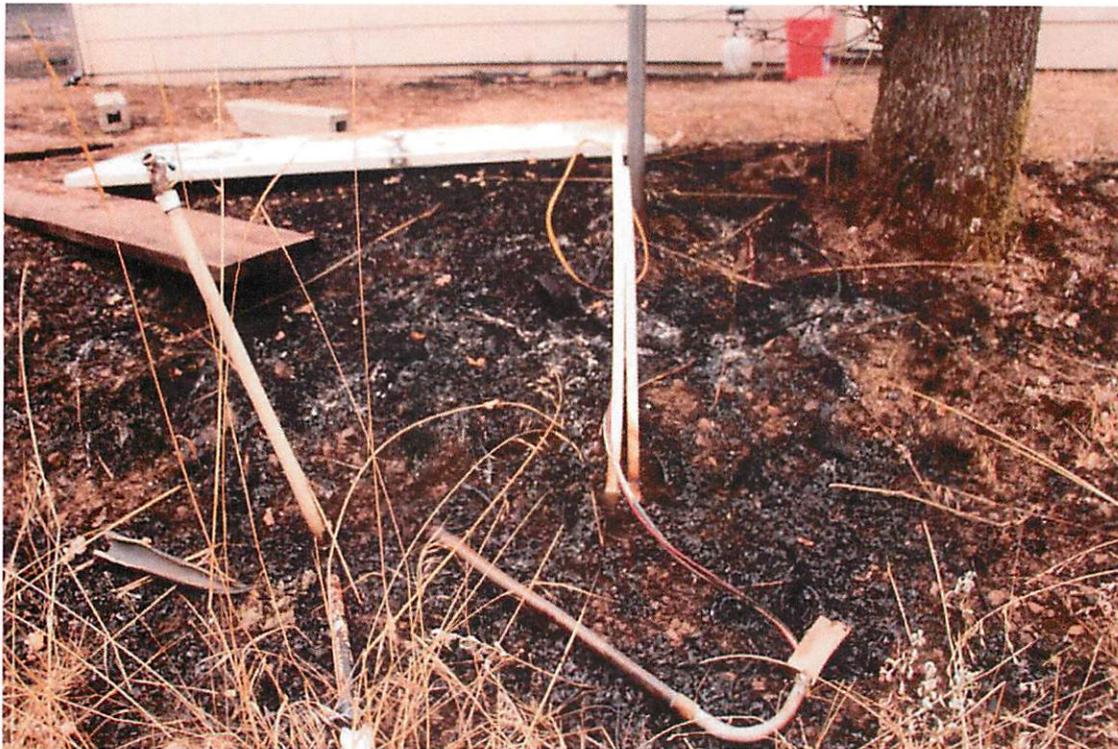
IMG_045 - Looking northwesterly from #43 location. Zoomed photo of melted PVC (water and electrical conduit) with visible wires.

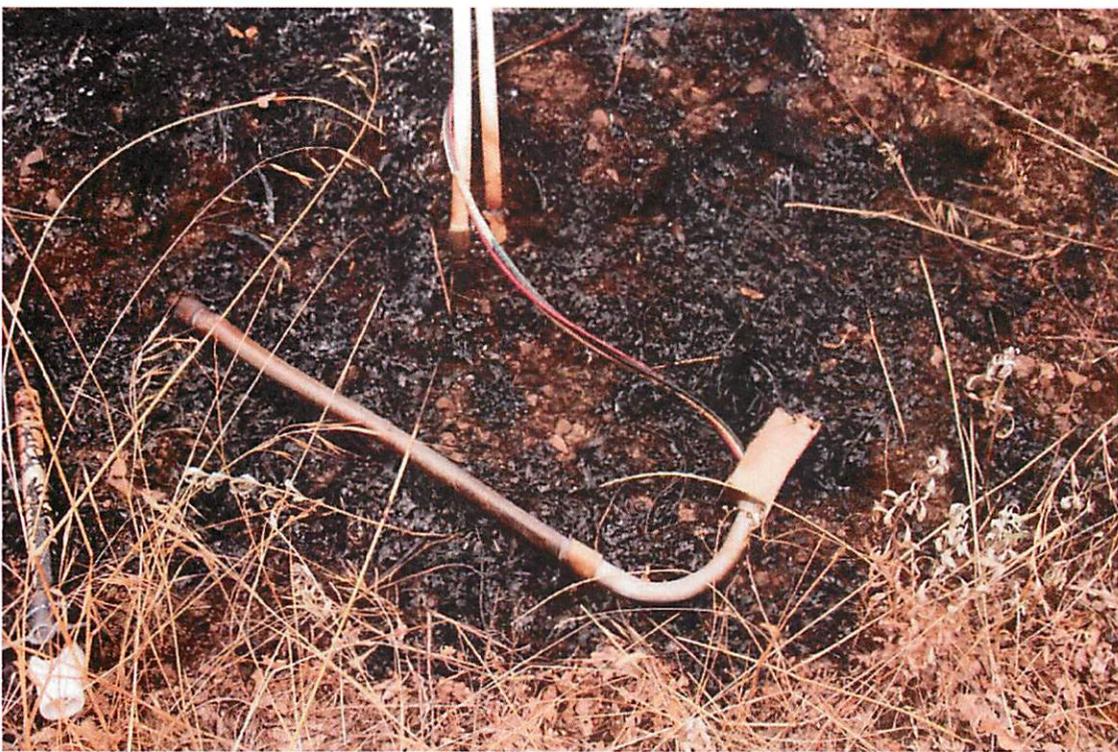
IMG_046 - Same perspective as #45. Detailed photo of melted electrical conduit with visible red, black and white wires.

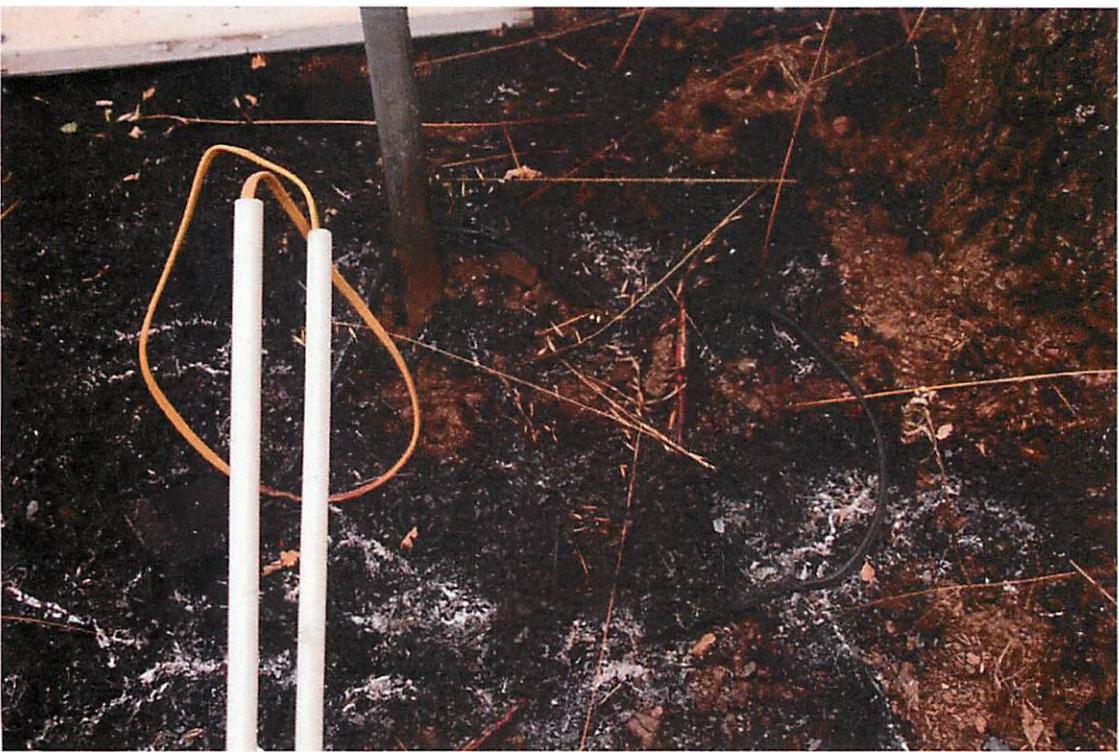
IMG_048 - Same perspective as #45. Detailed photo of wires running along ground and white PVC and Romex type wires.

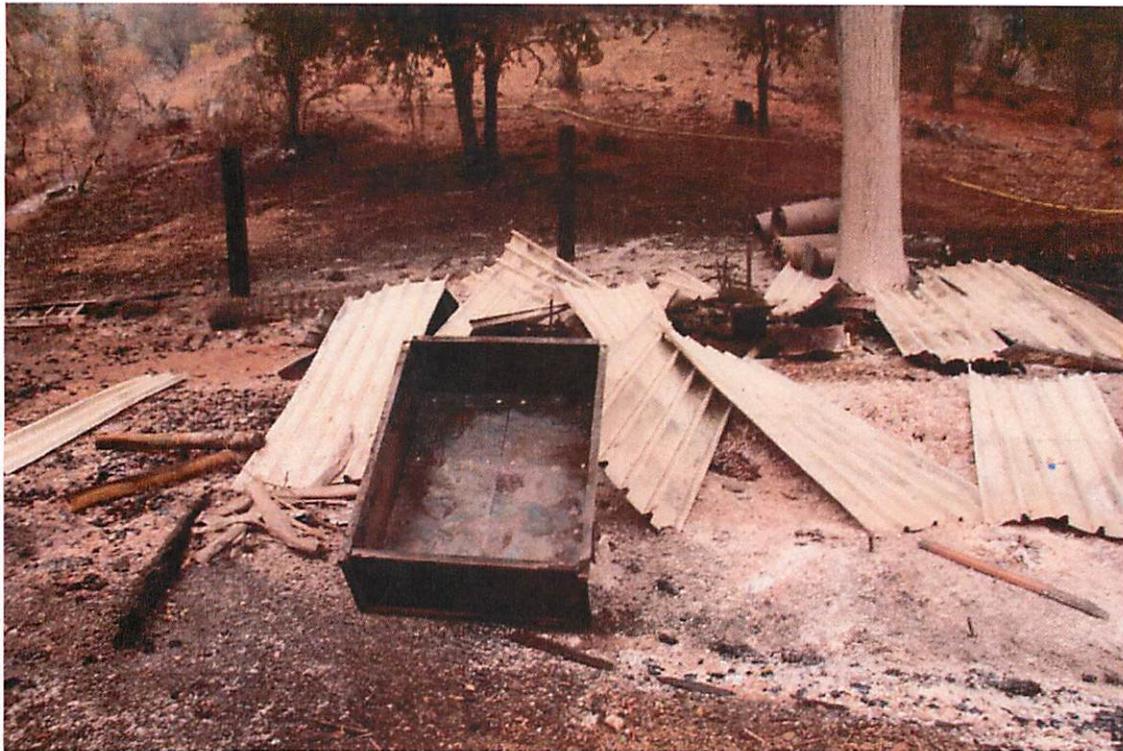
IMG_051 - Looking southerly at destroyed wood shed with burnt lawn mower and attached trailer.

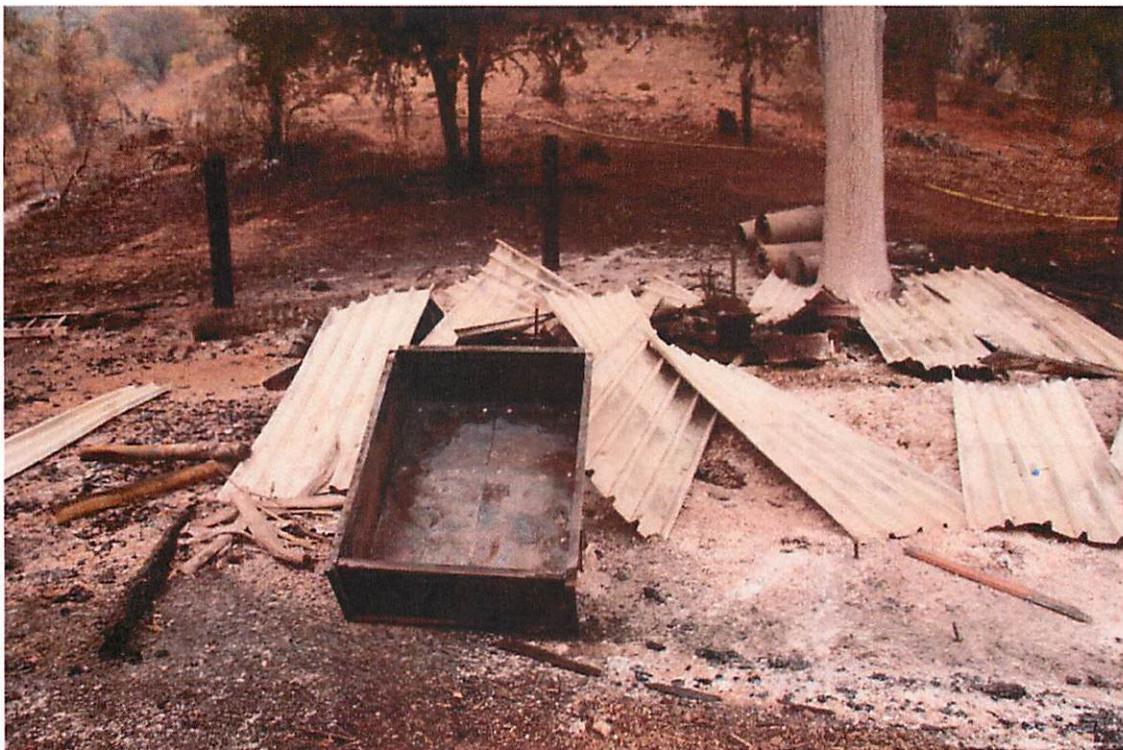
IMG_052 - Same as #51.

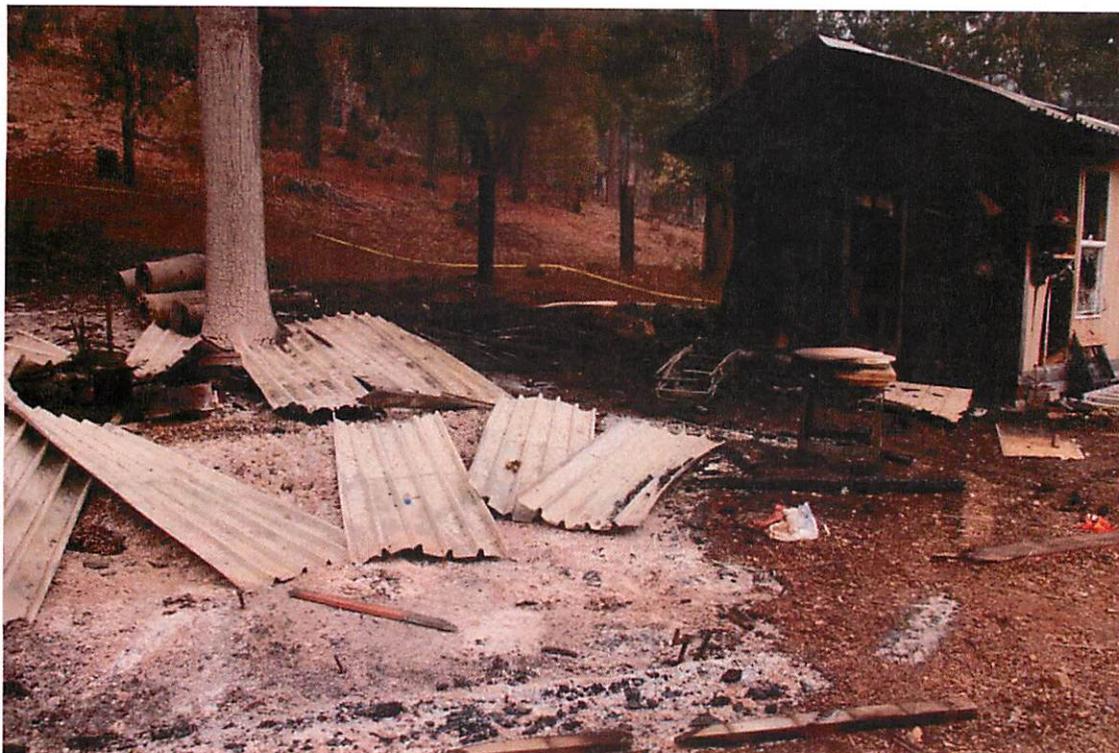
IMG_053 - Looking northwesterly at destroyed wood shed and burnt tool shed taken from near southwestern corner of house.

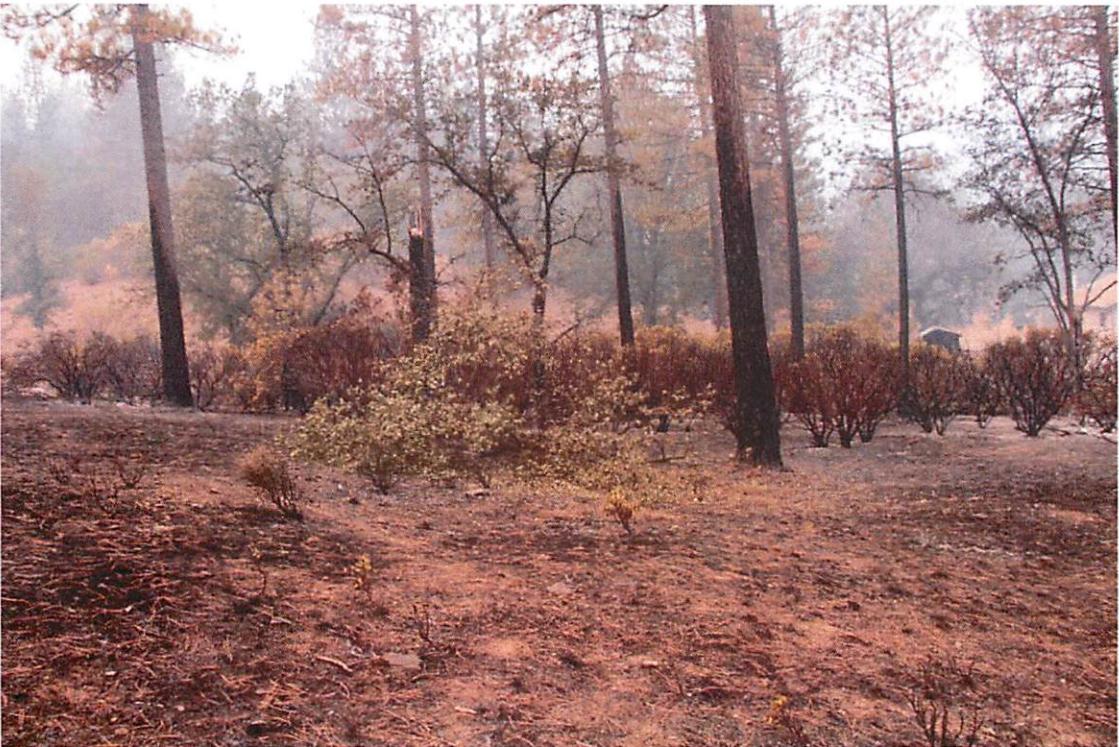
IMG_060 - Looking westerly, at south side of house and burnt tool shed from a point on adjacent property, uphill and south of 8015.

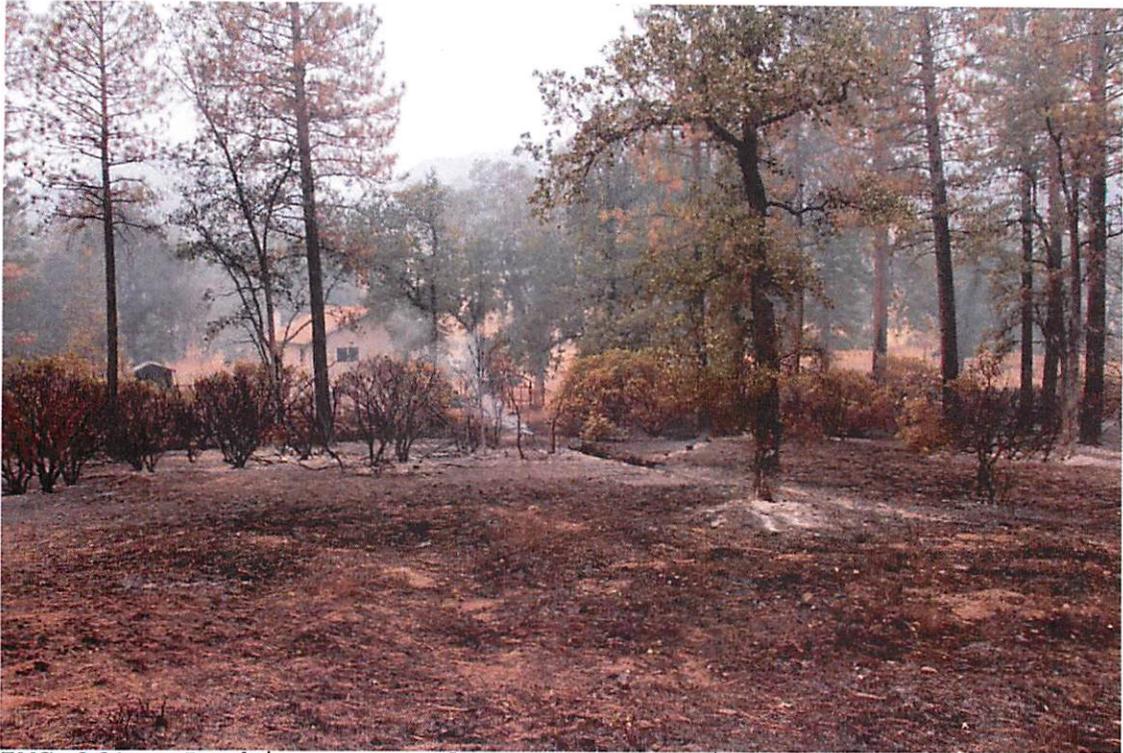
IMG_061 - Looking westerly, at south side and rear of house and burnt tool shed from a point south and uphill on adjacent property.

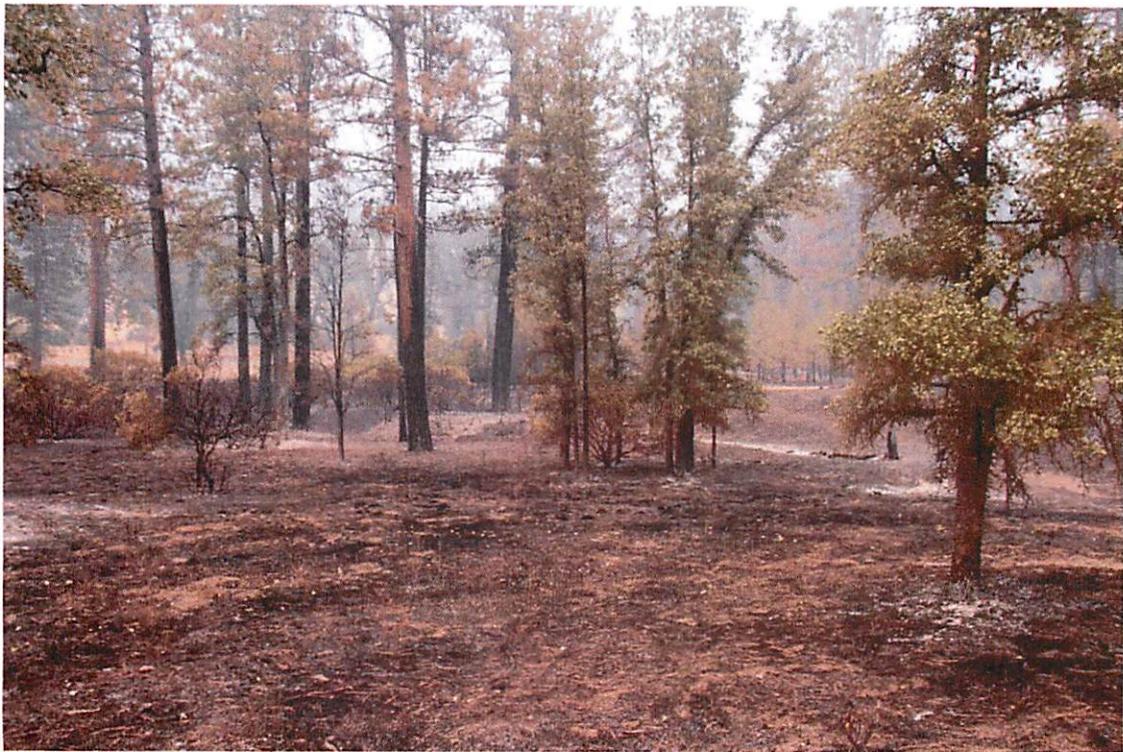
IMG_062 - Looking northerly toward High Valley Road and driveway east of 8015, showing angles of char on large trees.

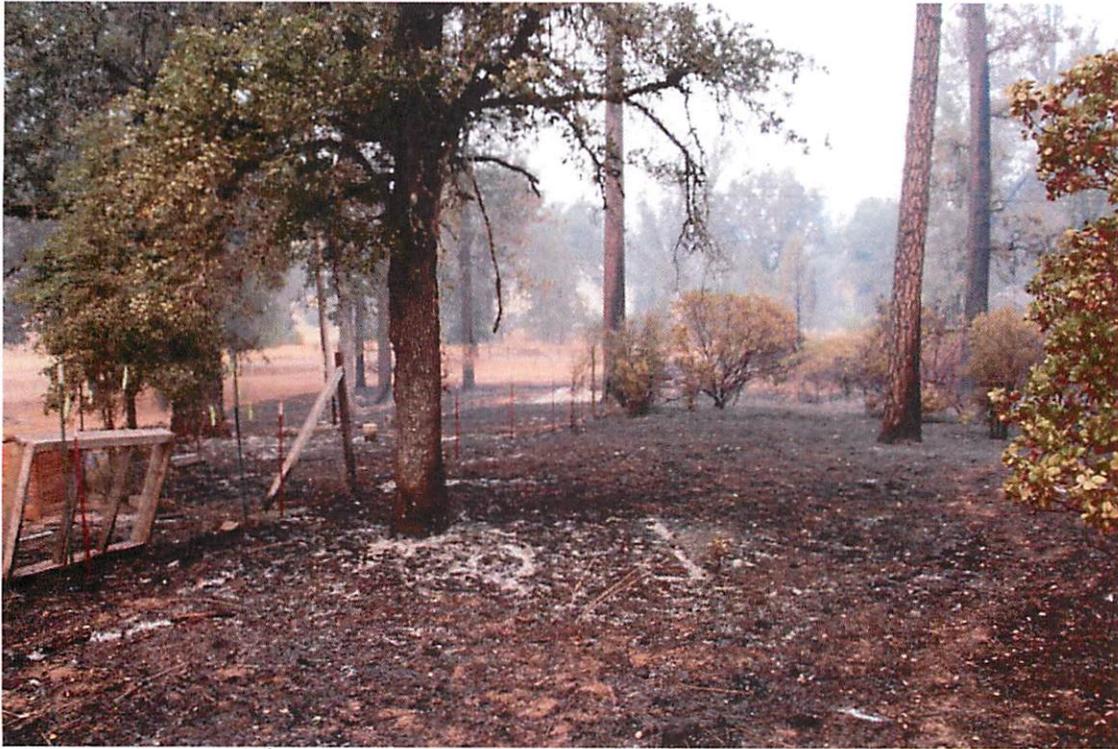
IMG_063 - Looking northwesterly from east of garden area along fence list, showing angle of char on large trees.

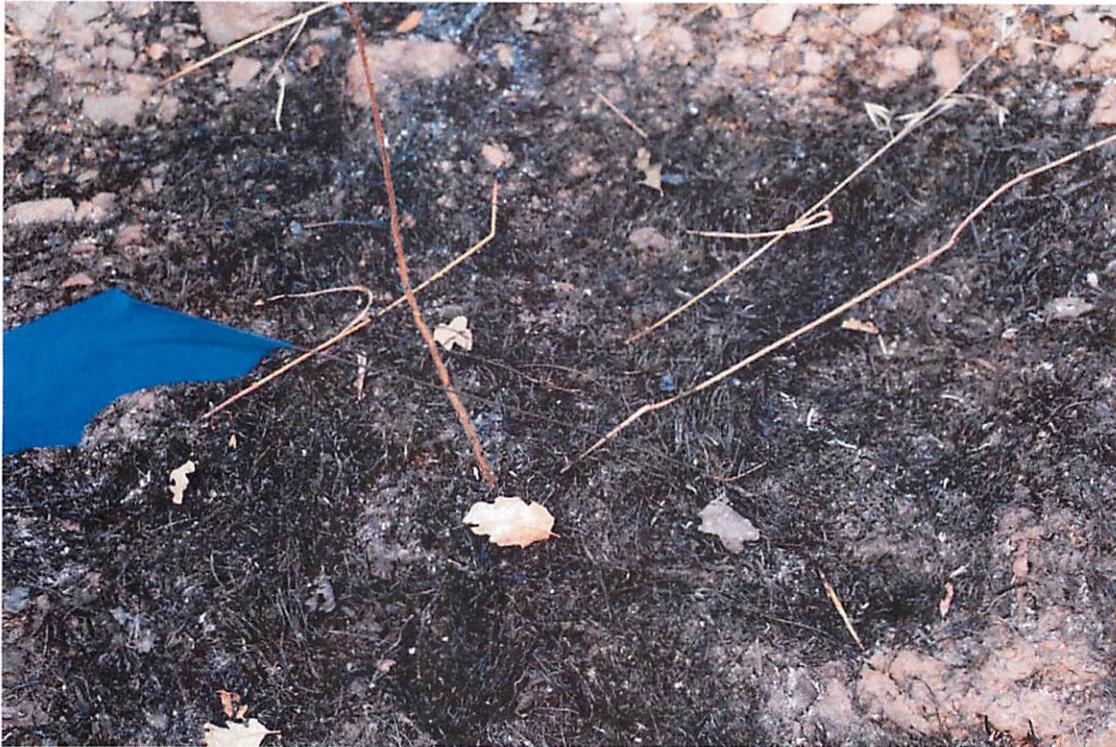
IMG_077 - Zoomed stem fall backing indicator on east bank of creek, near foot bridge, taken from #75's location.

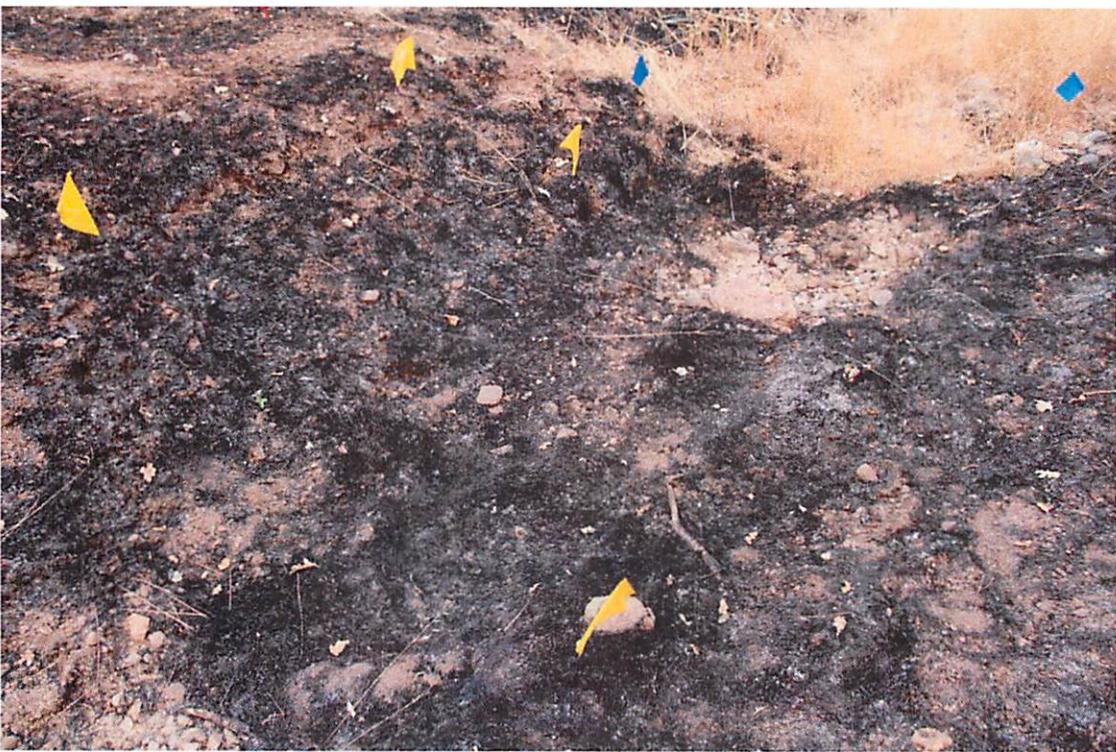
IMG_078 - Zoomed lateral and backing indicators including protection, stem fall and die out, on banks of creek, taken from #75's location.

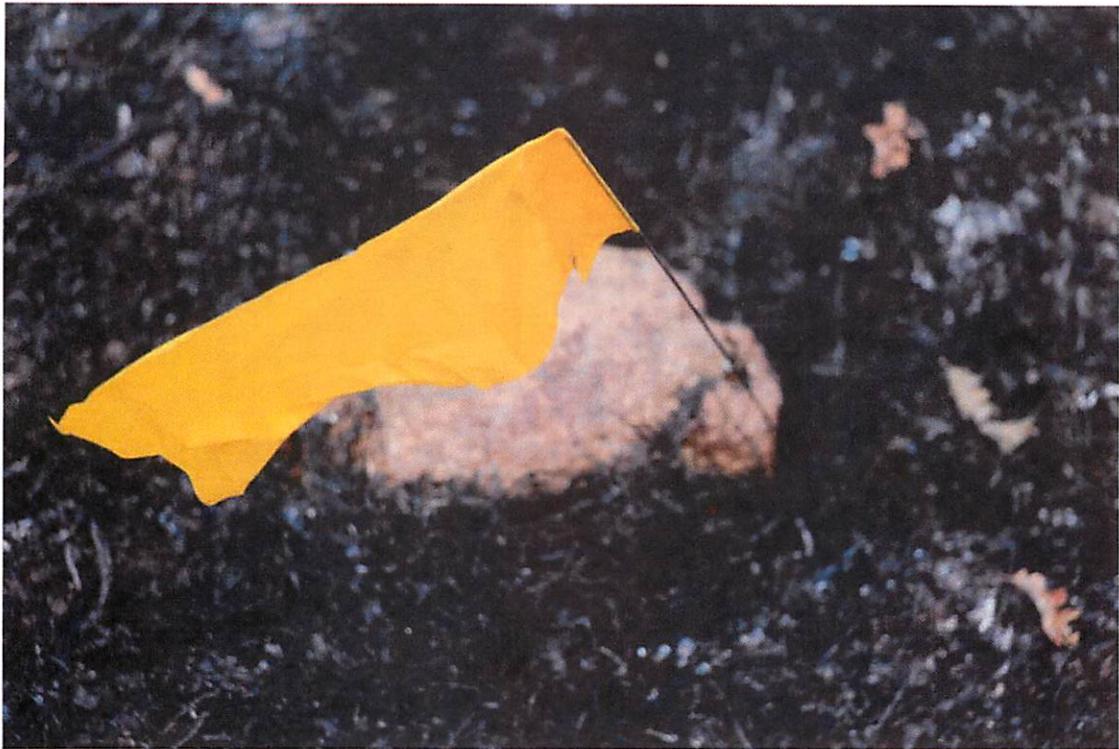
IMG_079 - Zoomed lateral indicator from #78 showing protection.

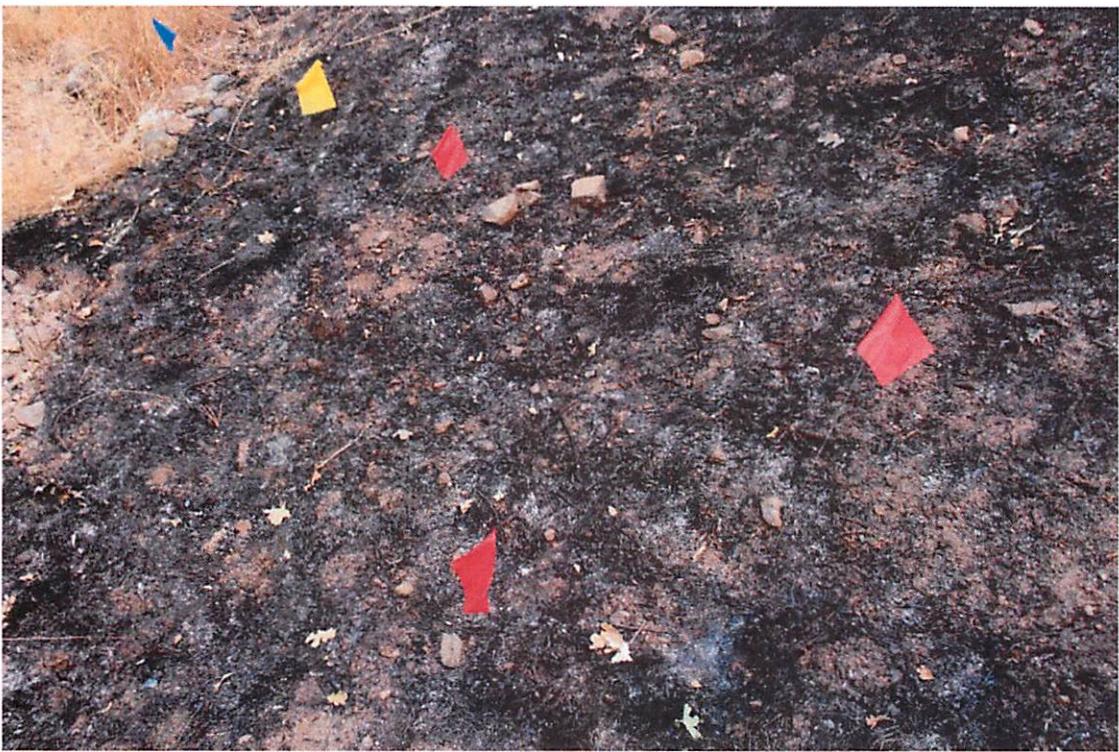
IMG_080 - Advancing indicators and flagging on east bank of creek, taken from #75's location.

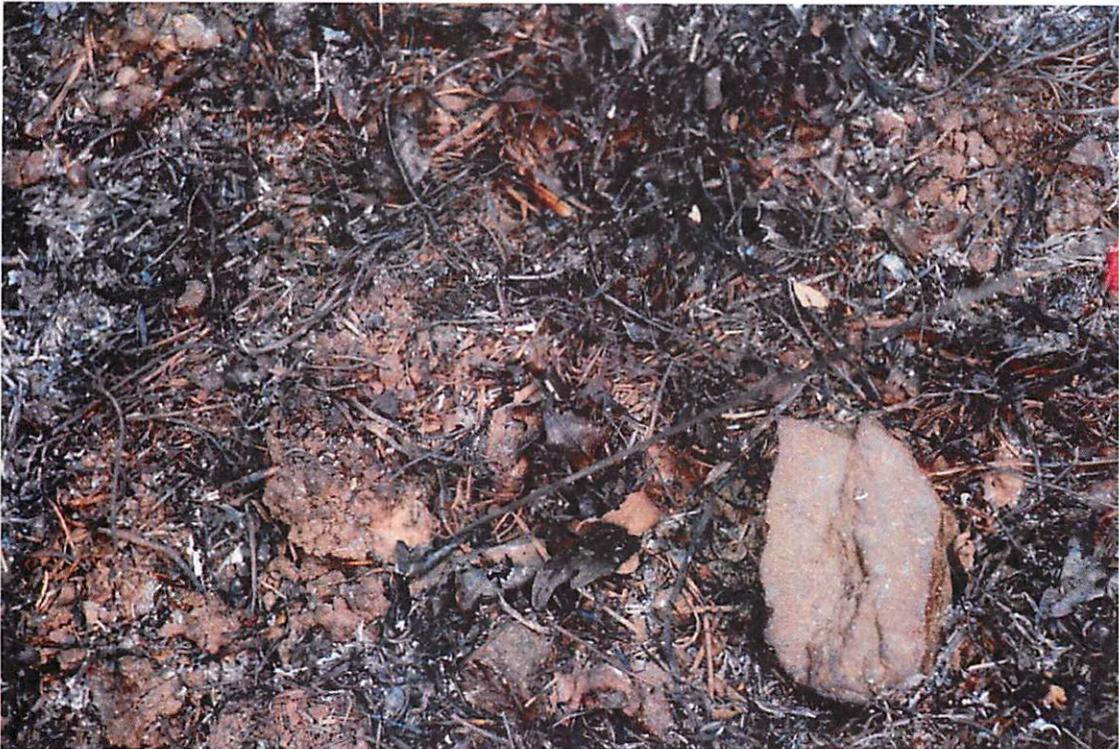
IMG_081 - Zoomed advancing indicator from #78 showing protection sooting and staining.

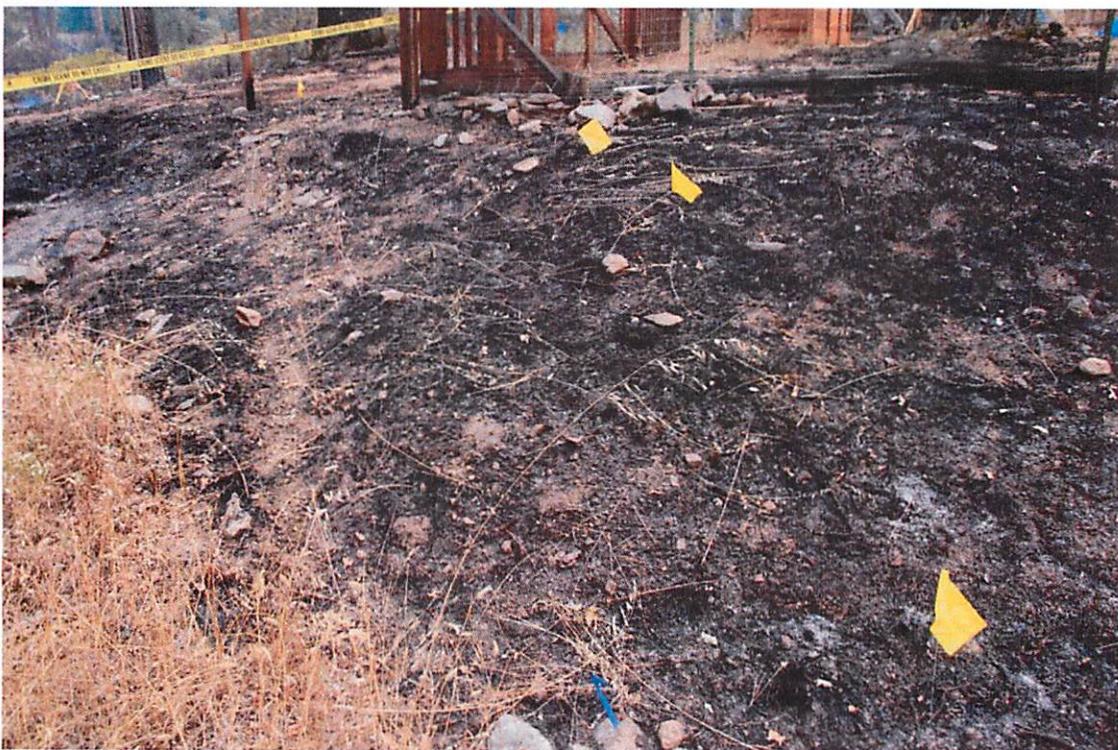
IMG_086 - Lateral indicator flagging and stem fall indicators on east bank of creek, taken from west bank, looking northeasterly.

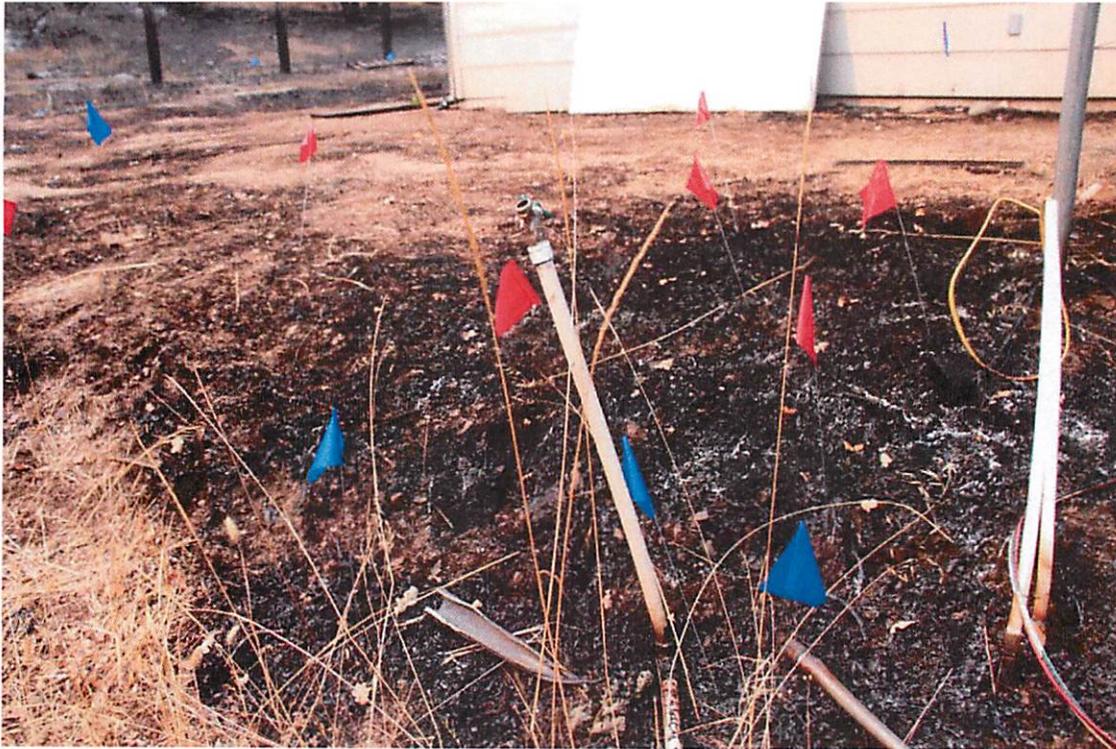
IMG_087 - Indicator flagging on west bank of creek, with part of SOA on right, taken from creek bed, looking northwesterly.
