IMG_0001 - Cover sheet indicating beginning of photographs.

IMG_0002 - Front of house located at 8015 High Valley Road, Cobb, CA.

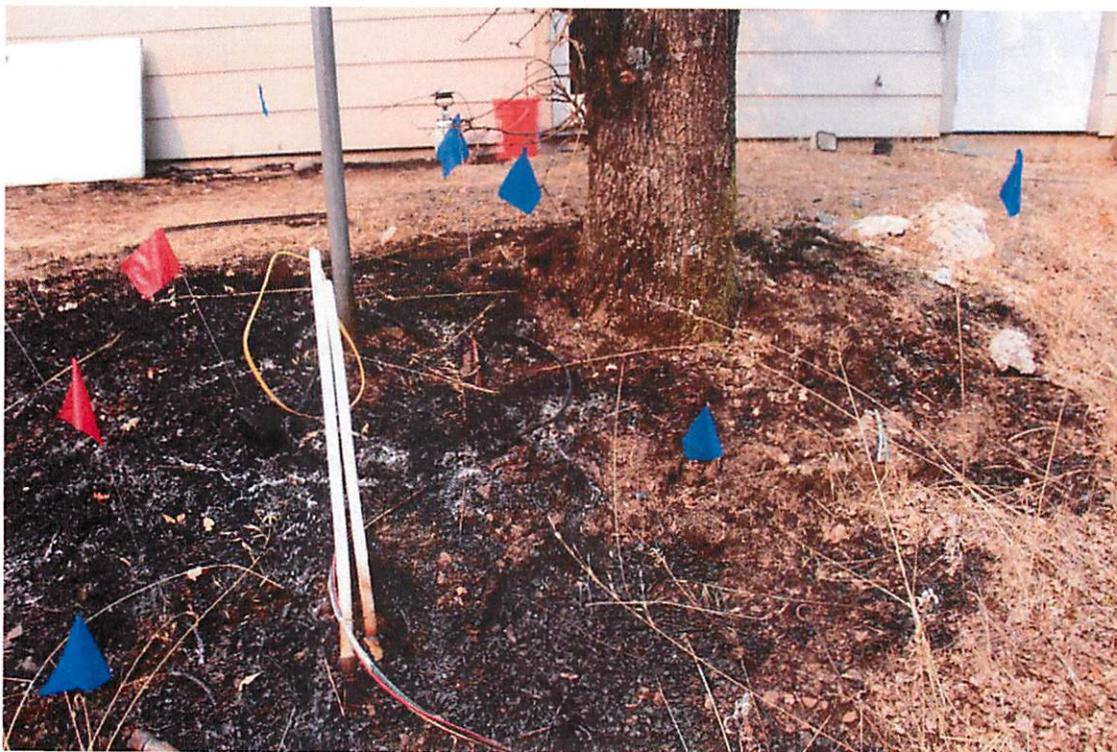
IMG_088 - Indicator flagging on west bank of creek, SOA centered, taken from creek bed, looking westerly.

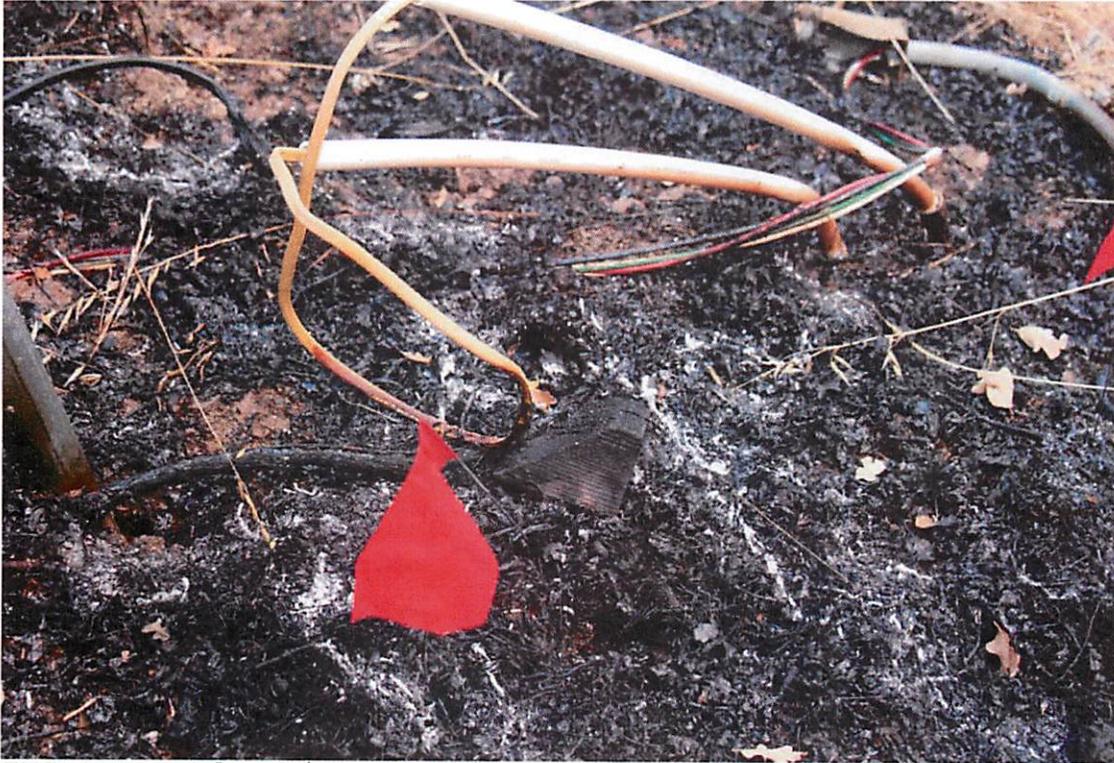
IMG_093 - Advancing burn indicator from #94. Photograph of suspended Romex wire loop. Red, black, green and white wires on the ground.

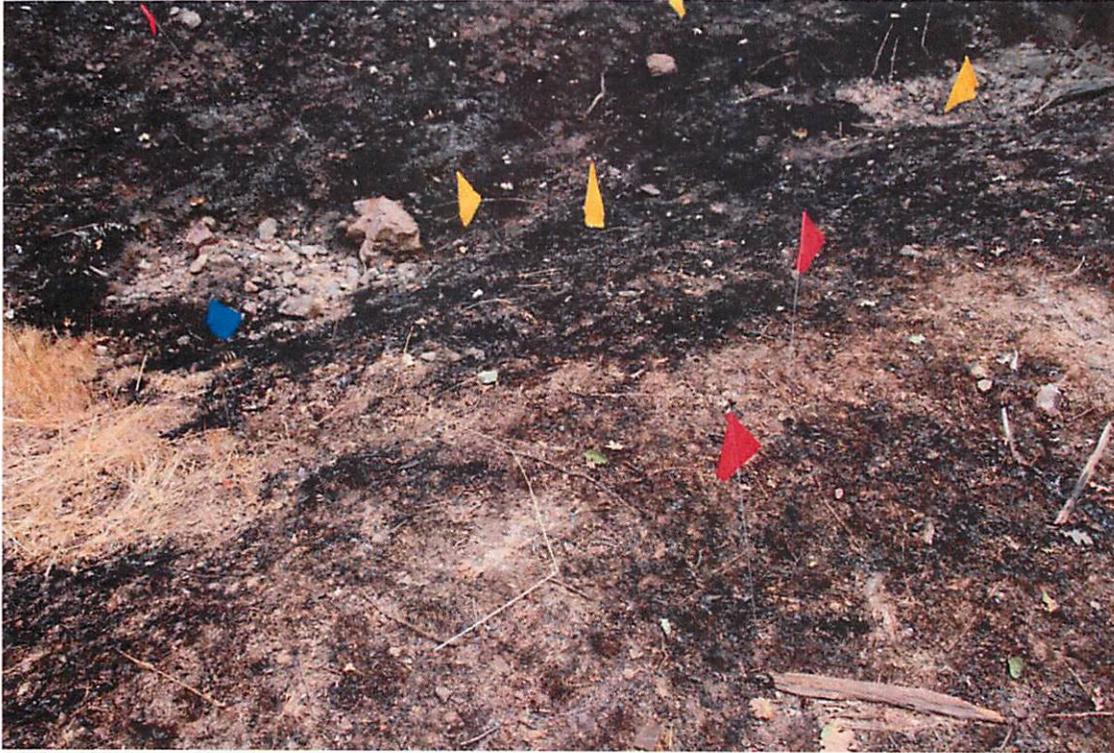
IMG_095 - Indicator flagging on west bank of creek, taken from west edge, looking easterly.

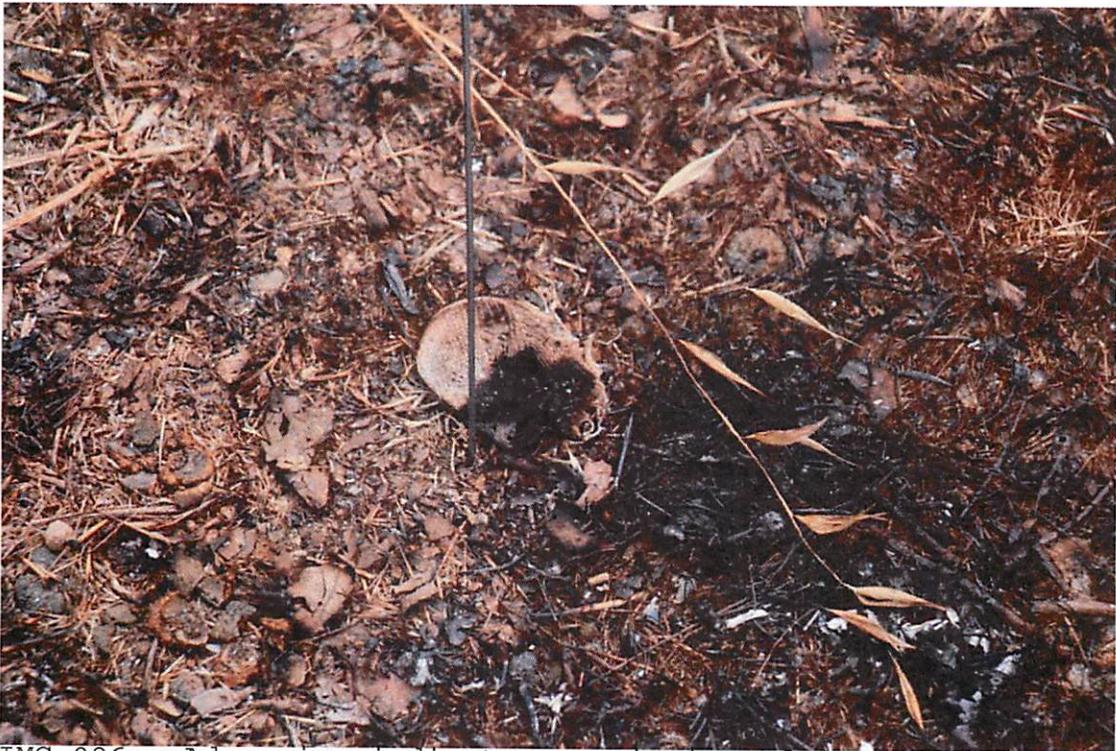
IMG_096 - Advancing indicator consisting of degree of damage and protection on a discarded lantern mantle, taken from same location as #95.

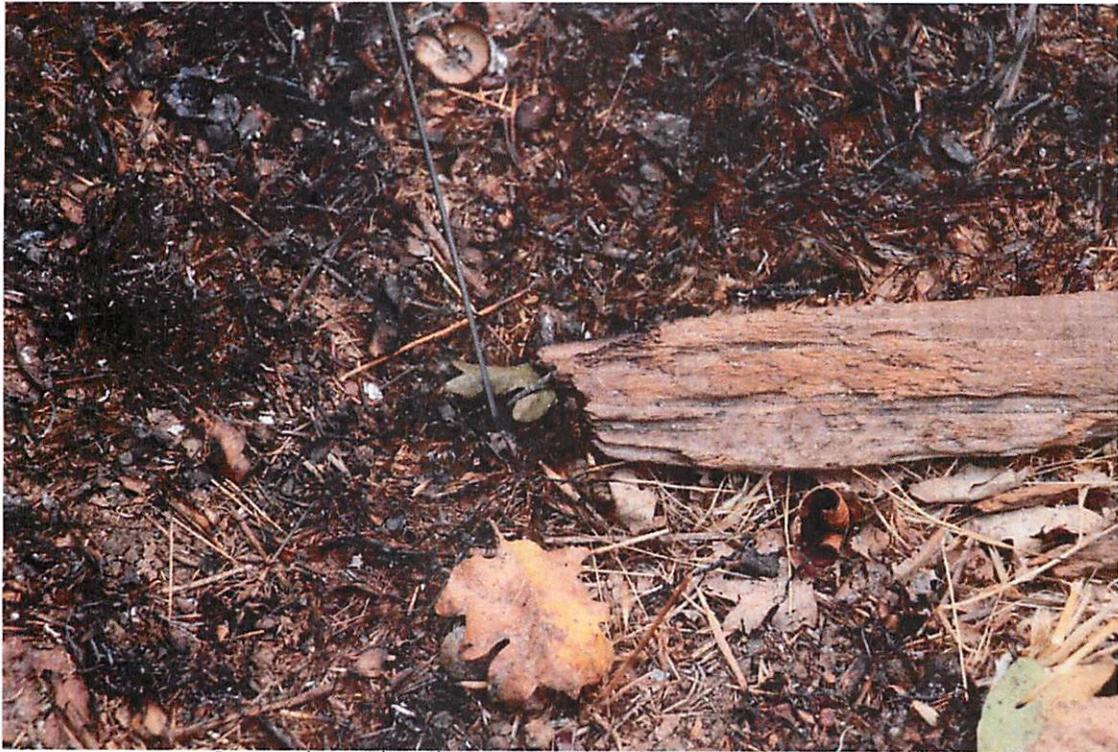
IMG_097 - Advancing indicator consisting of degree of damage and protection, taken from same location as #95.

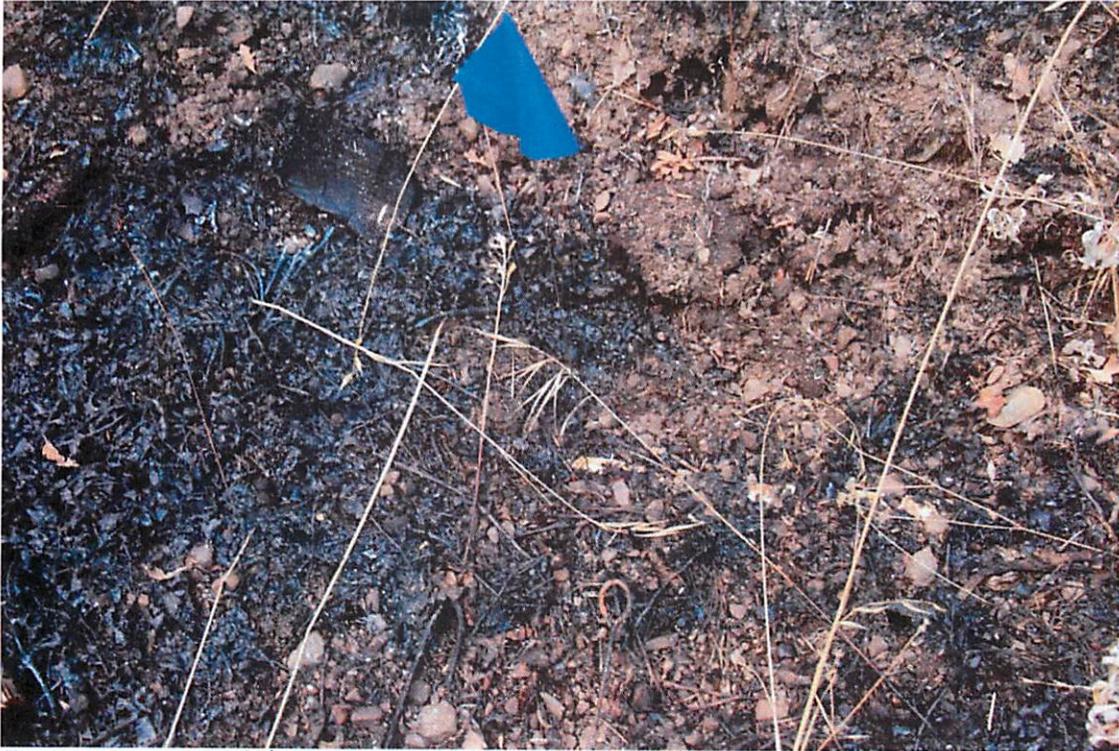
IMG_099 - Backing grass stem fall indicators, taken from same location as #98.

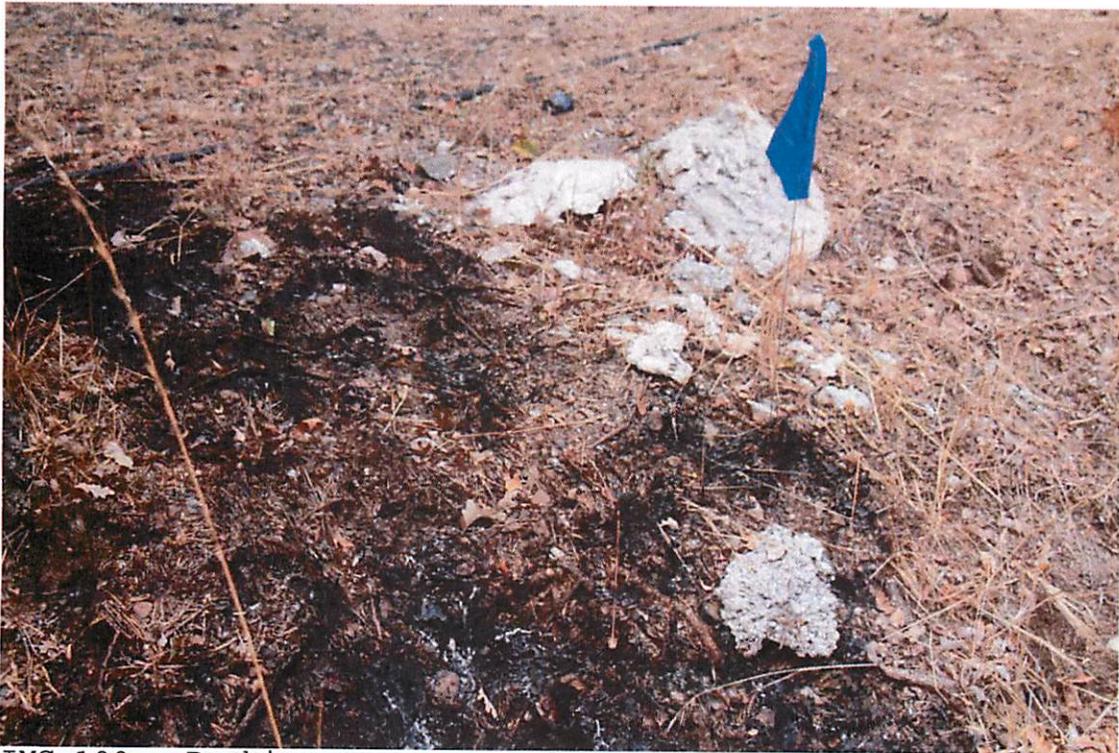
IMG_100 - Backing grass stem fall and die out indicators to the north of SOA, taken from same location as #98.

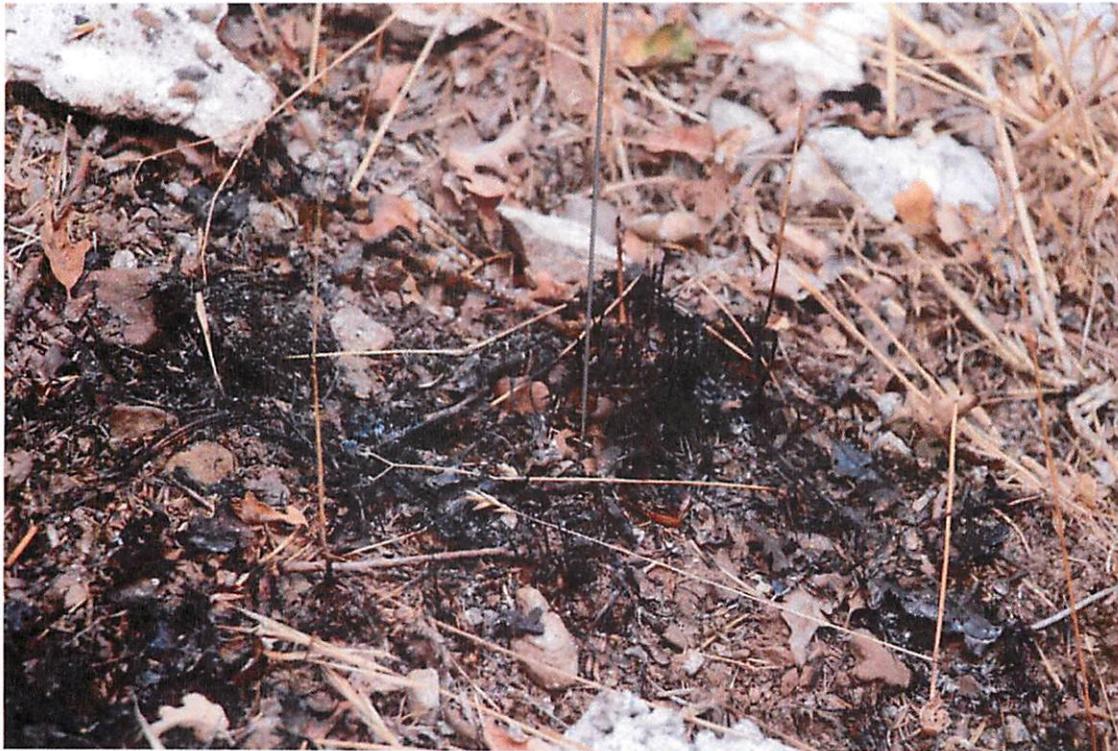
IMG_101 - Backing grass stem fall and die out indicators to the north of SOA, taken from same location as #98.

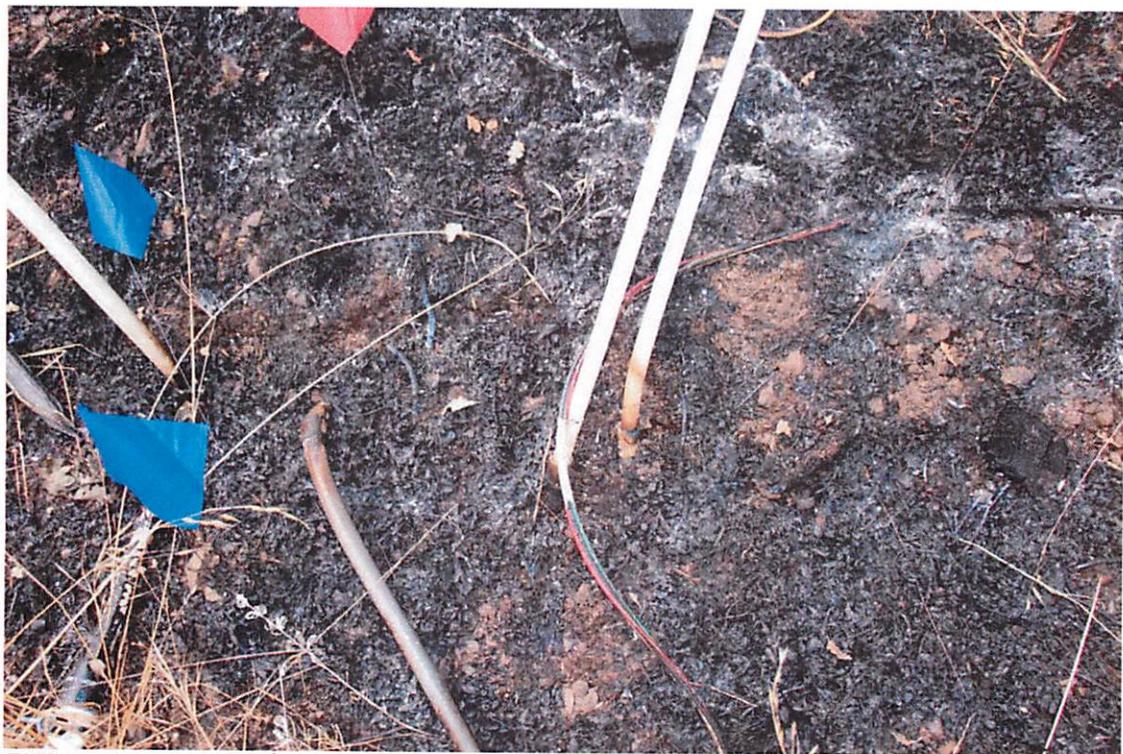
IMG_102 - Backing grass stem fall indicators, conduits, water pipe and wires on the ground, taken from same location as #98.

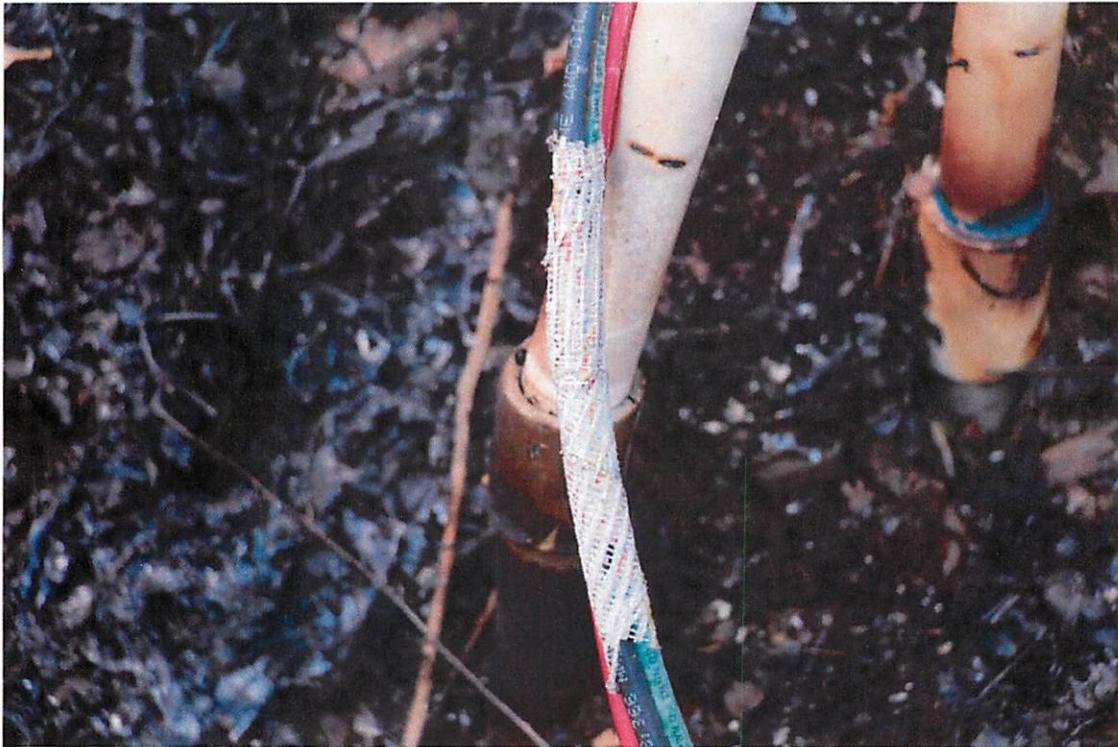
IMG_103 - Detail view of white, red, black and green wire bundle, held by remnants of duct tape on ground and looped around PVC.

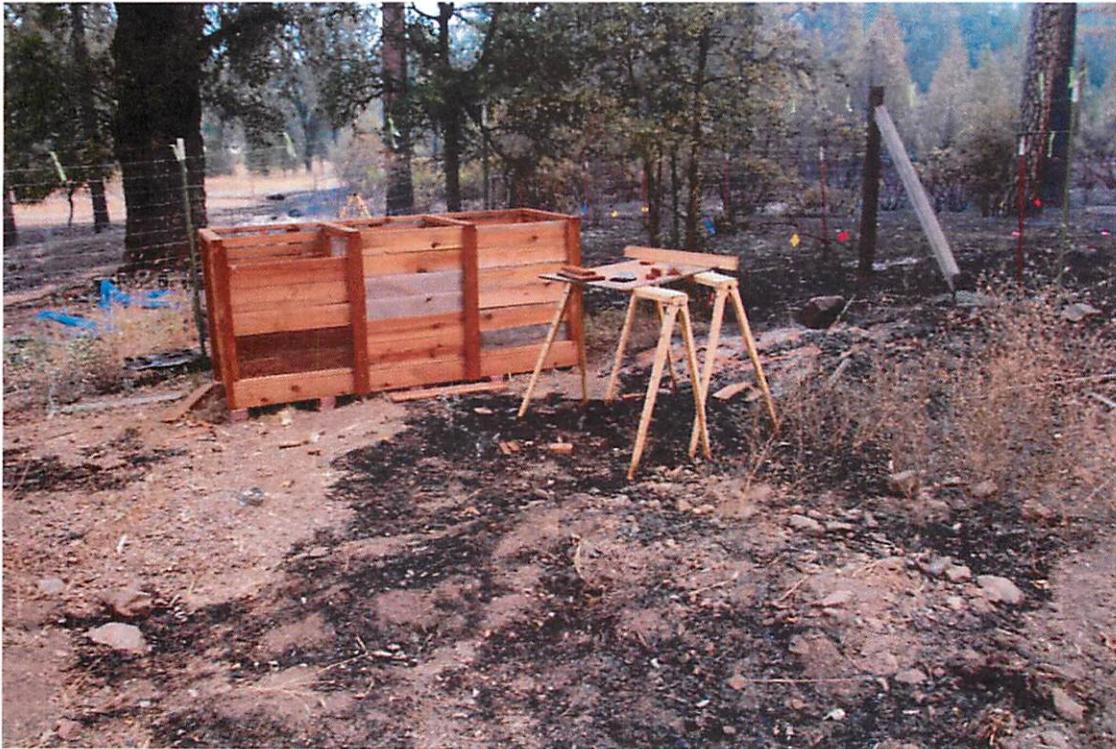
IMG_106 - Lateral burn indicator flagging with stem fall, taken from #104, looking easterly.

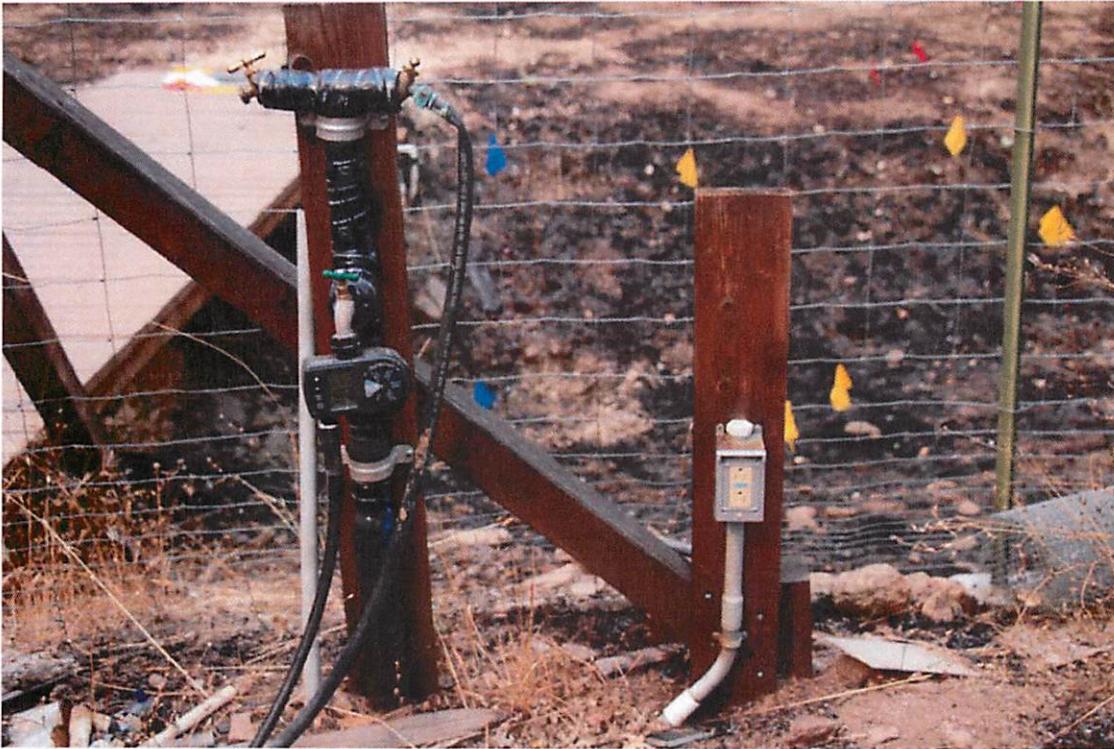
IMG_115 - Electrical GFI plug and water system, located on west side of garden area, adjacent to pedestrian gate.

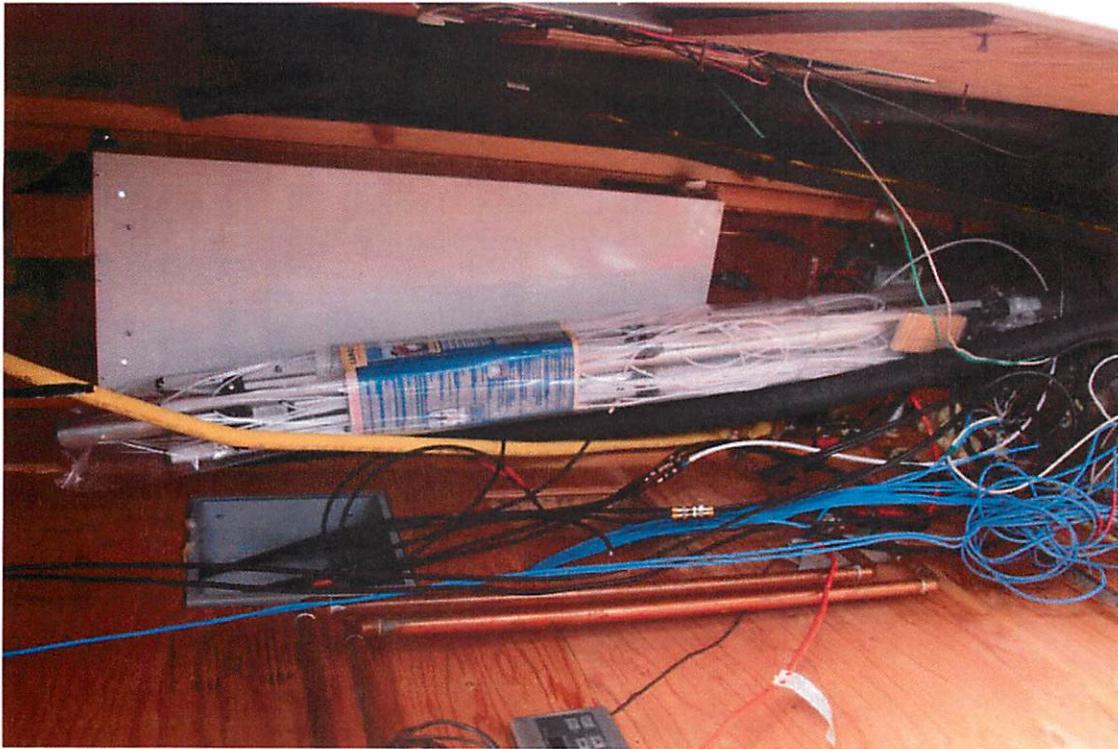
IMG_117 - Photo in landscape of the contents of utility room. Sub-panel (breakers) located on right.

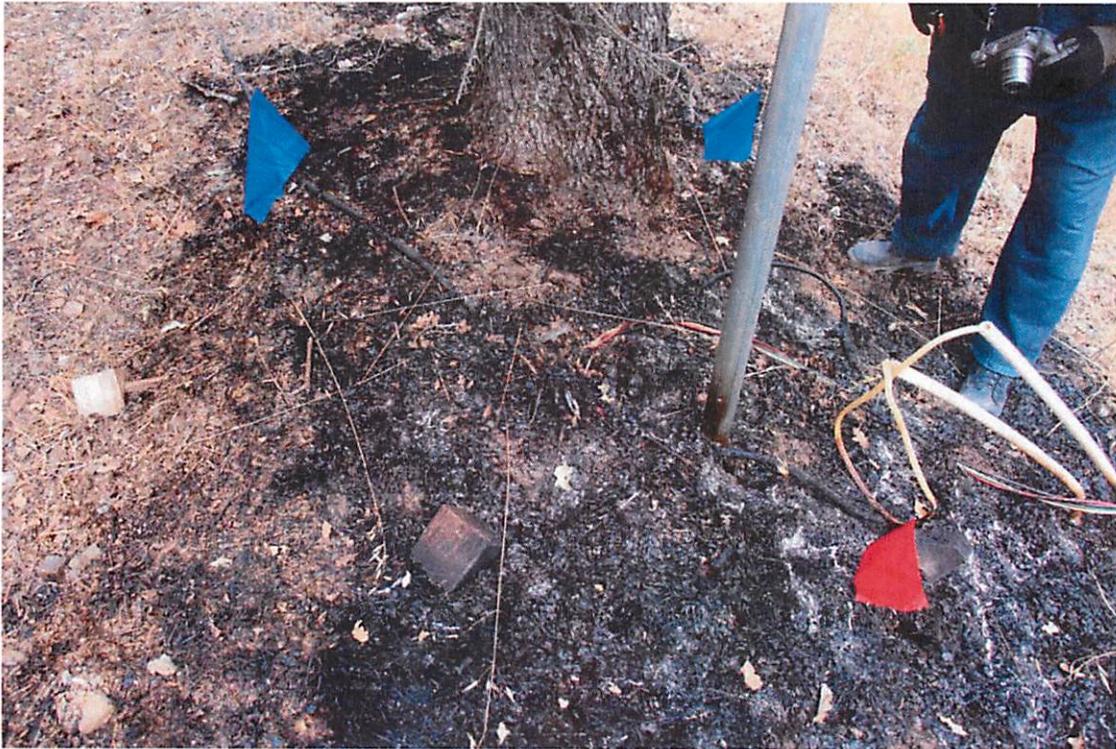
IMG_123 - SOA with previously photographed wires. A splice is evident to the left of the metal pipe vertically in ground.

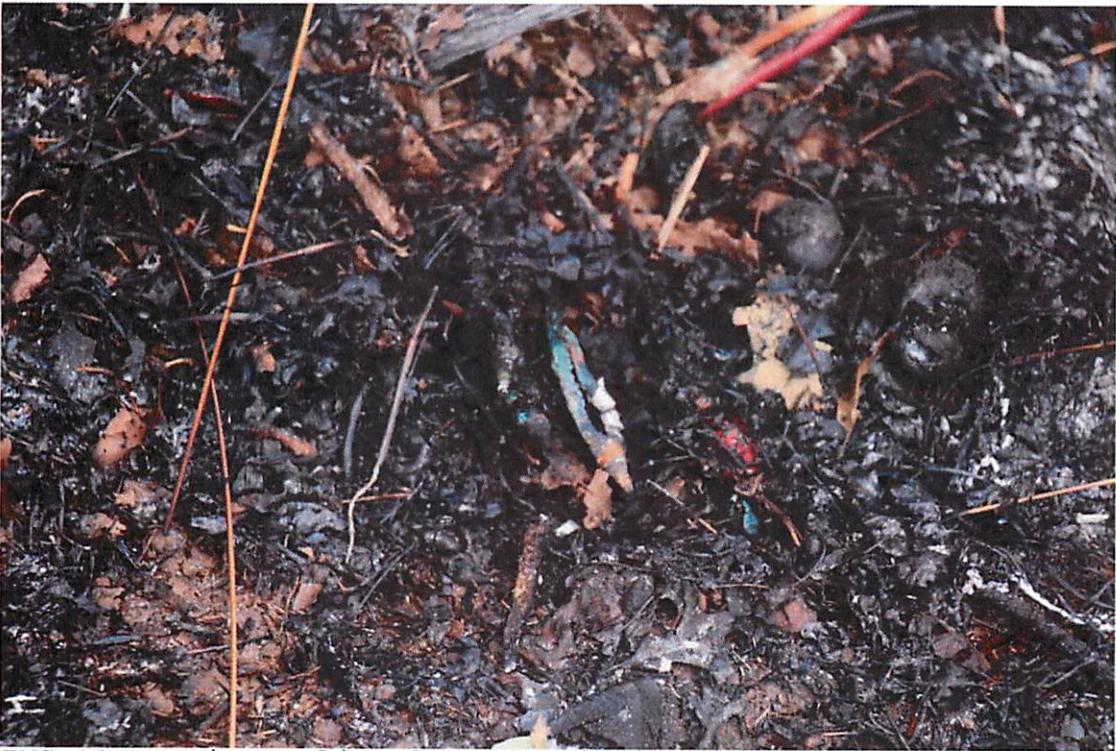
IMG_124 - Wire splice located within the SOA. This splice shows the green, black, white and red wires were connected with wire nuts.

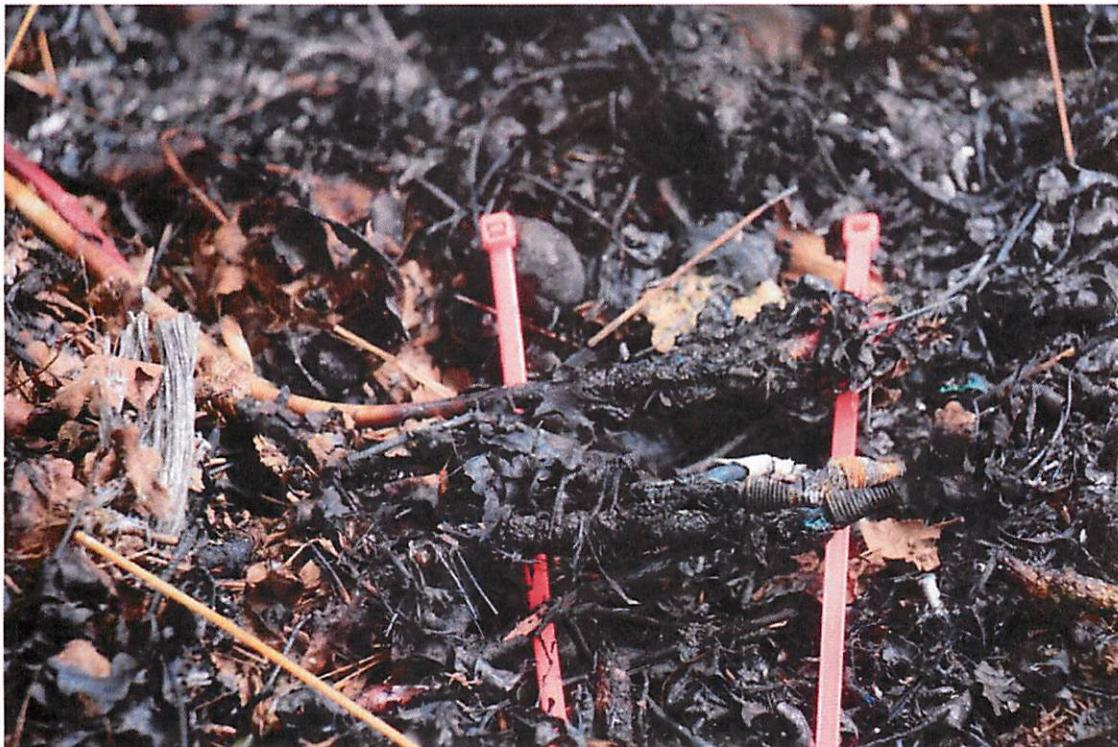
IMG_126 - Wire splice close-up with wire ties to differentiate the splice from the burnt vegetation.

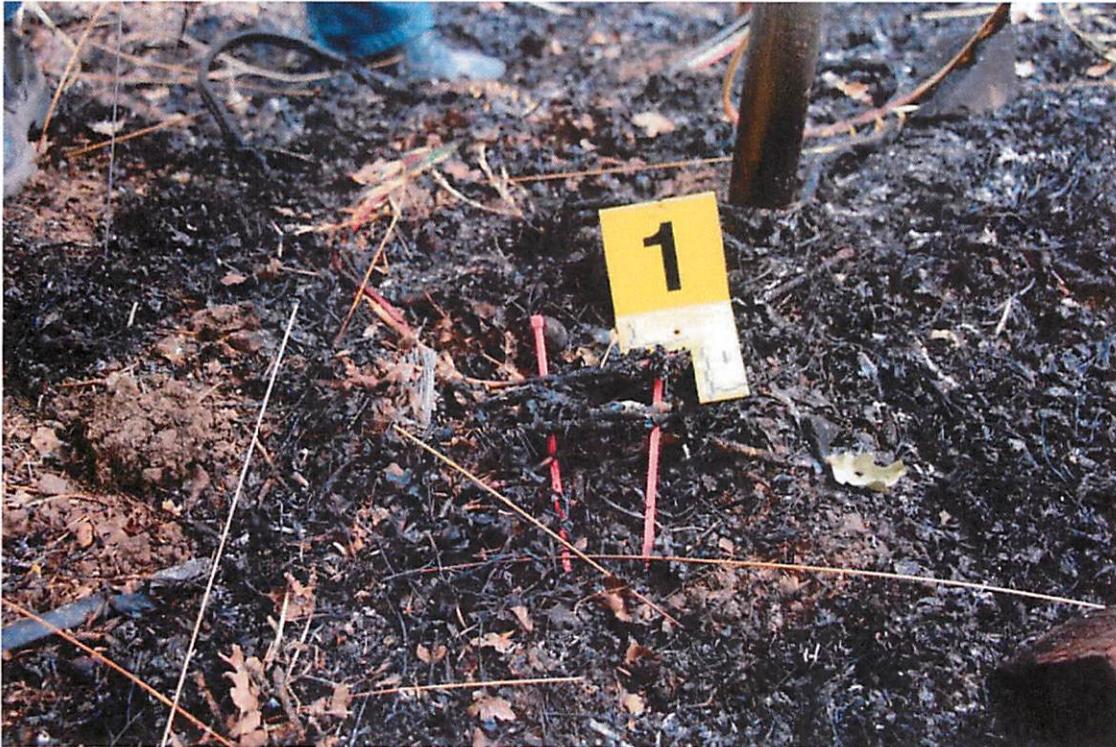
IMG_127 - Wire splice close-up with wire ties and evidence identifier tent 1.

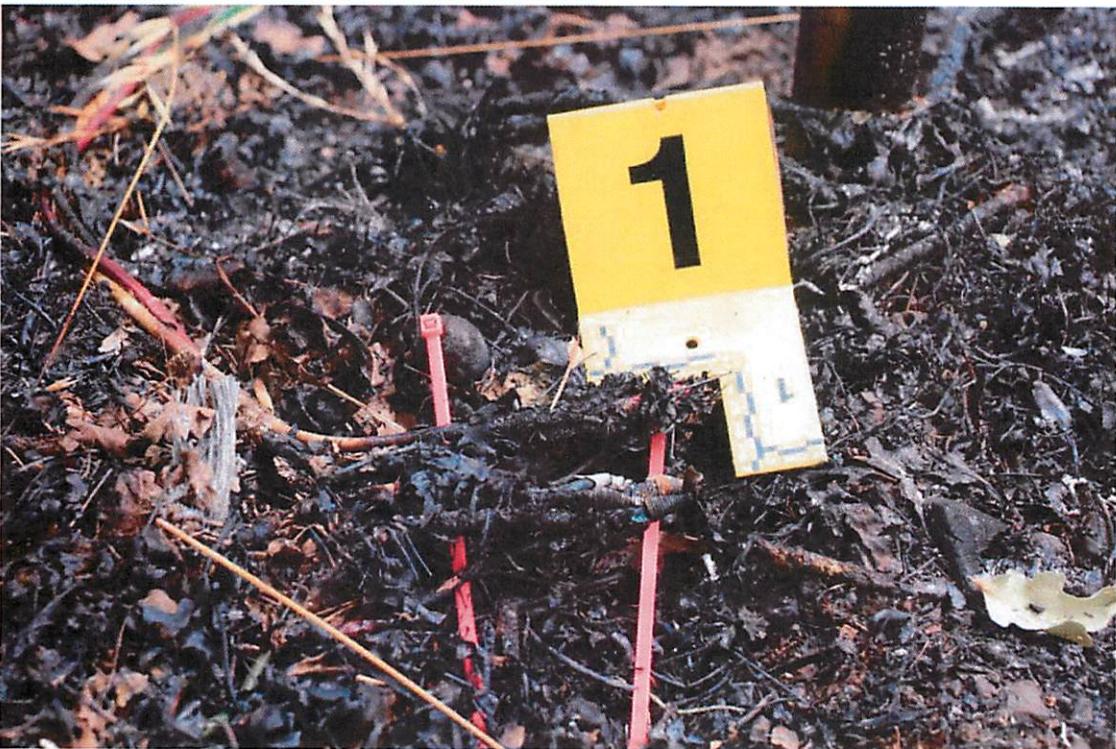
IMG_128 - Wire splice close-up with wire ties and evidence identifier tent 1.

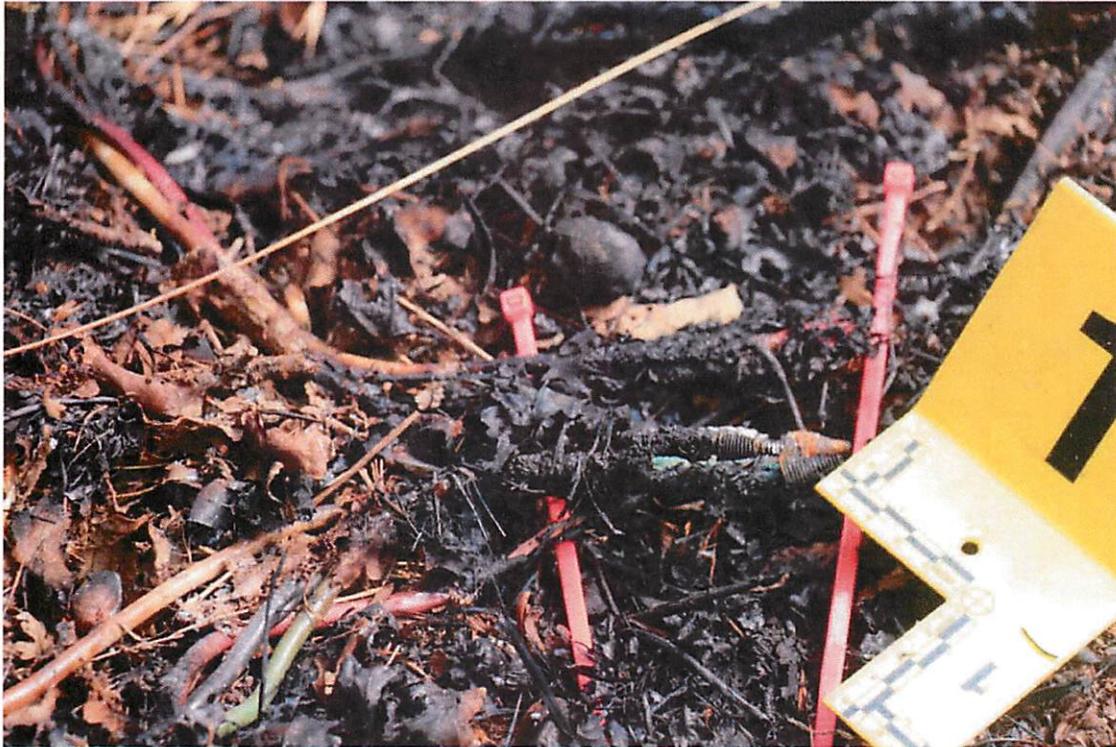
IMG_129 - Wire splice close-up with wire ties and evidence identifier tent 1.

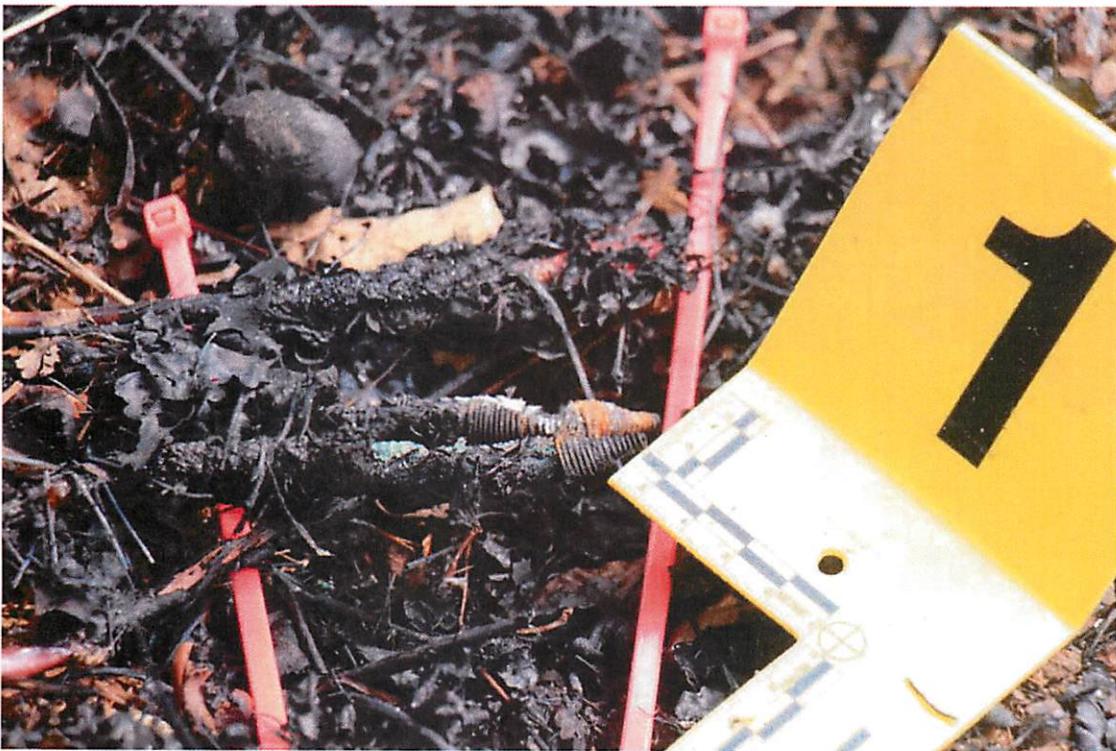
IMG_130 - Wire splice close-up with wire ties and evidence identifier tent 1.

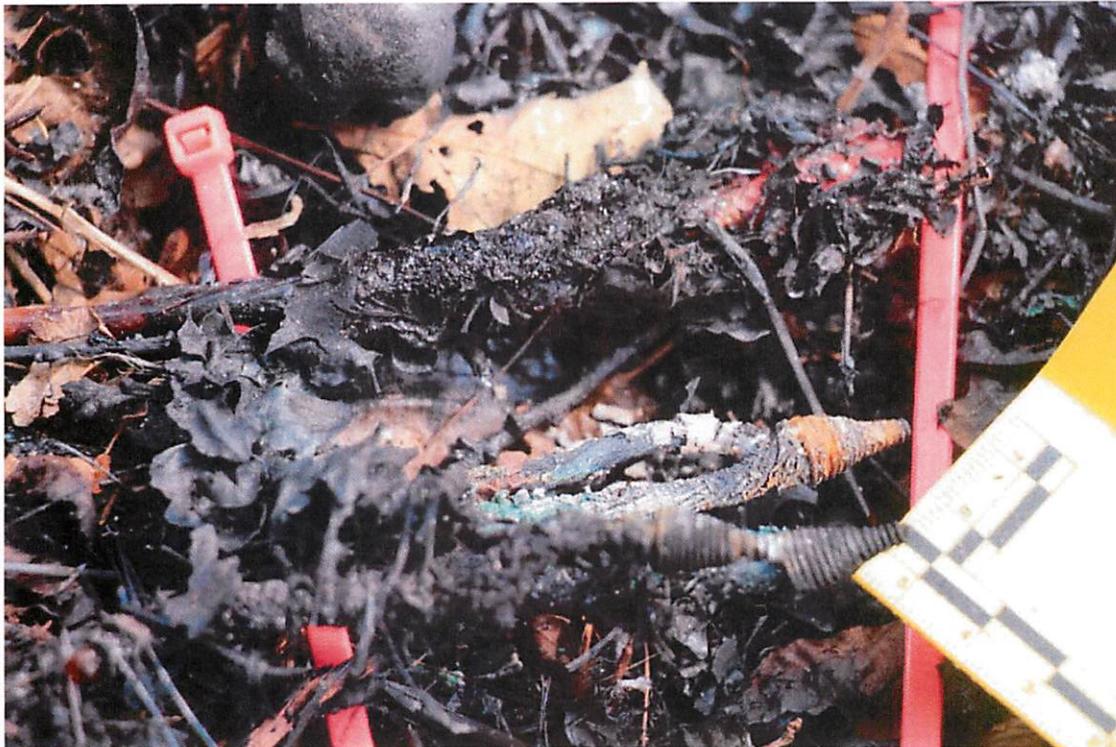
IMG_131 - Wire splice close-up with wire ties. Detail photo focusing on wire nuts.

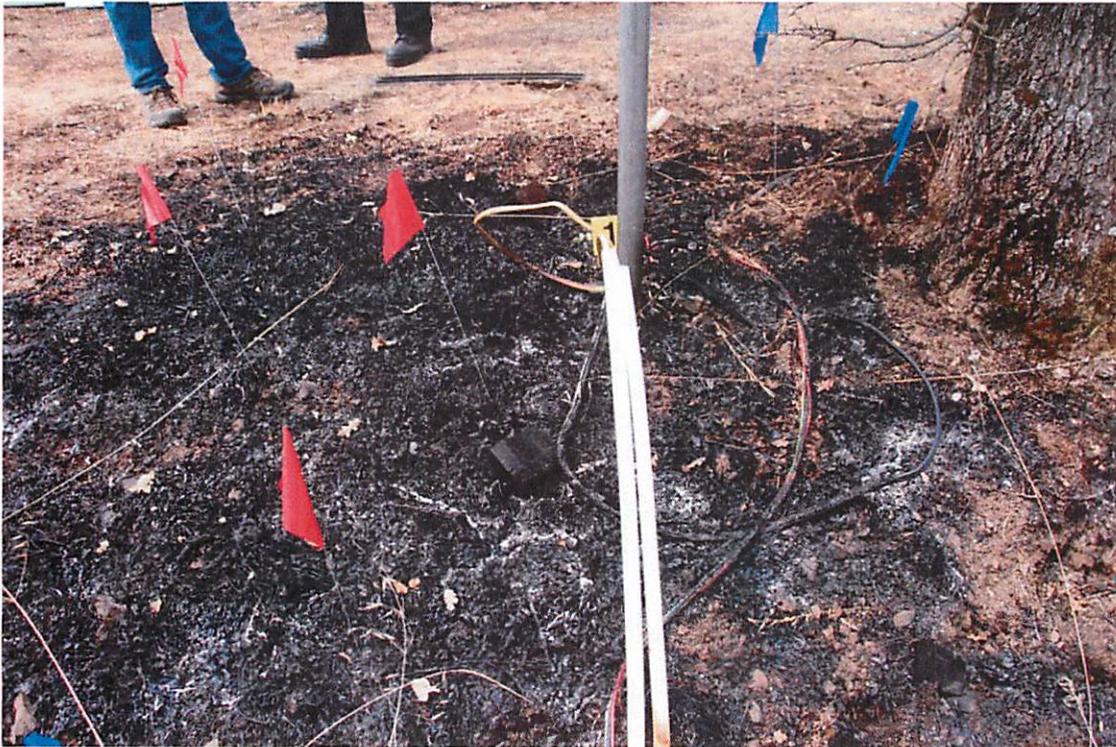
IMG_132 - Wire splice close-up with wire ties. Detail photo focusing on wire nuts.

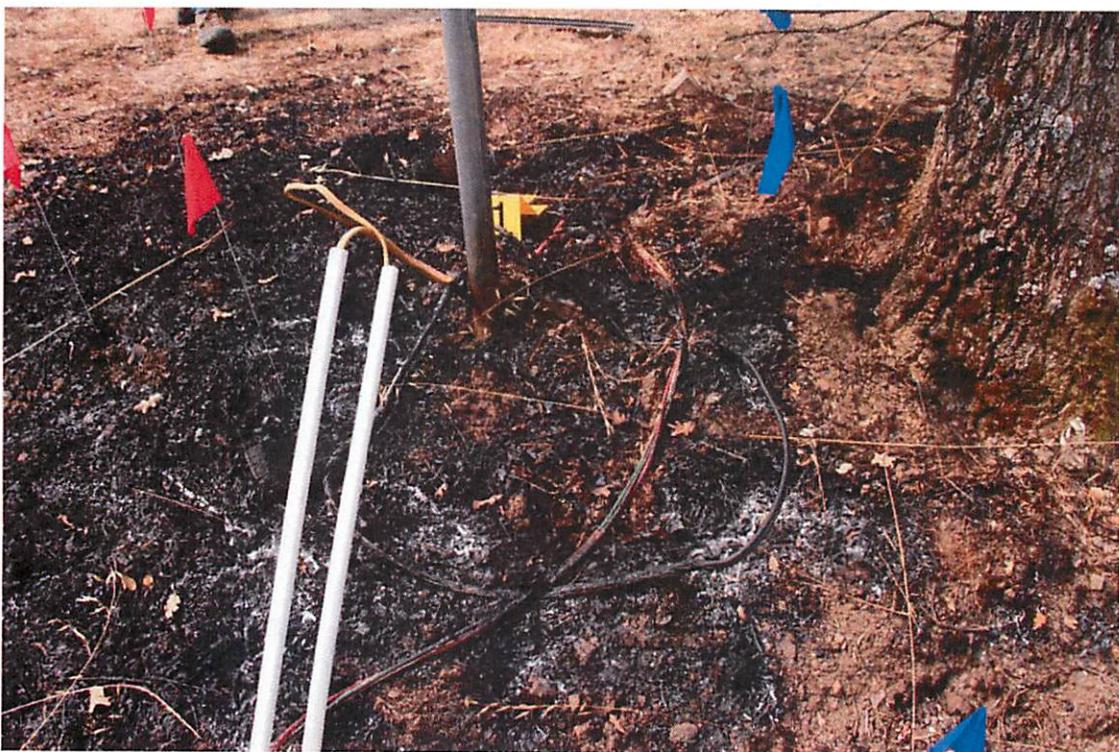
IMG_133 - SOA looking from east to west showing location of wire splice relative to wires, PVC and metal piping within the area.

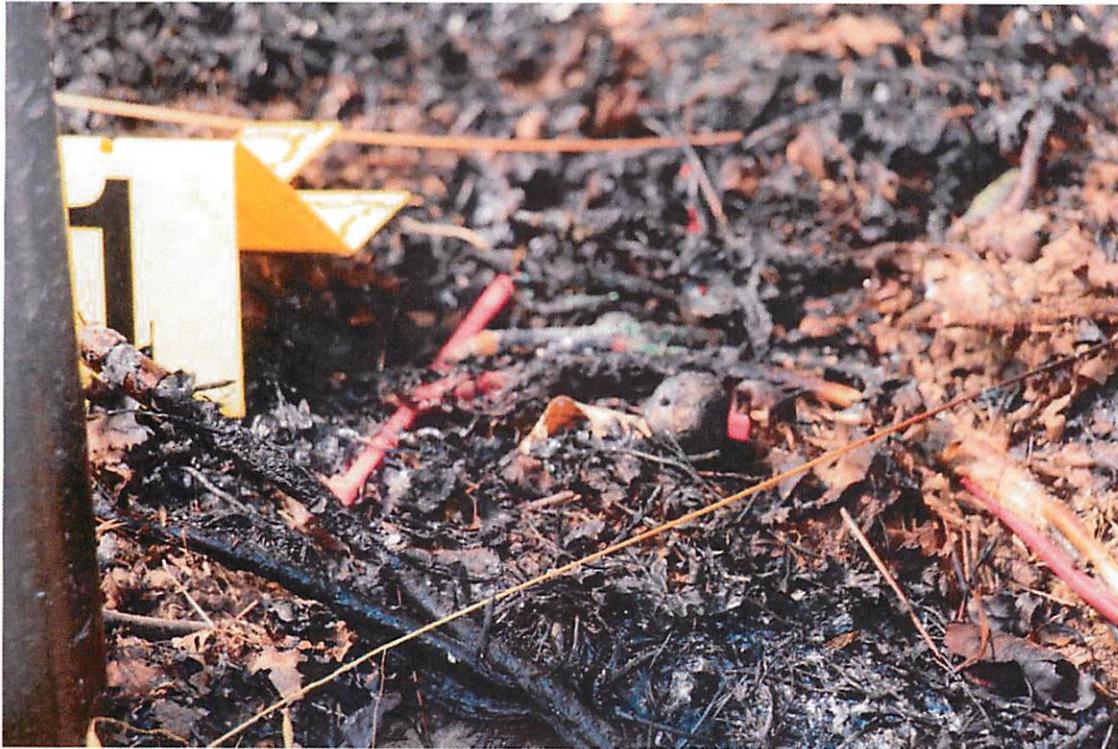
IMG_134 - SOA looking from east to west showing location of wire splice relative to wires (Romex, coaxial cable, and red, white, green, and black wire bundle), PVC and metal piping within the area.

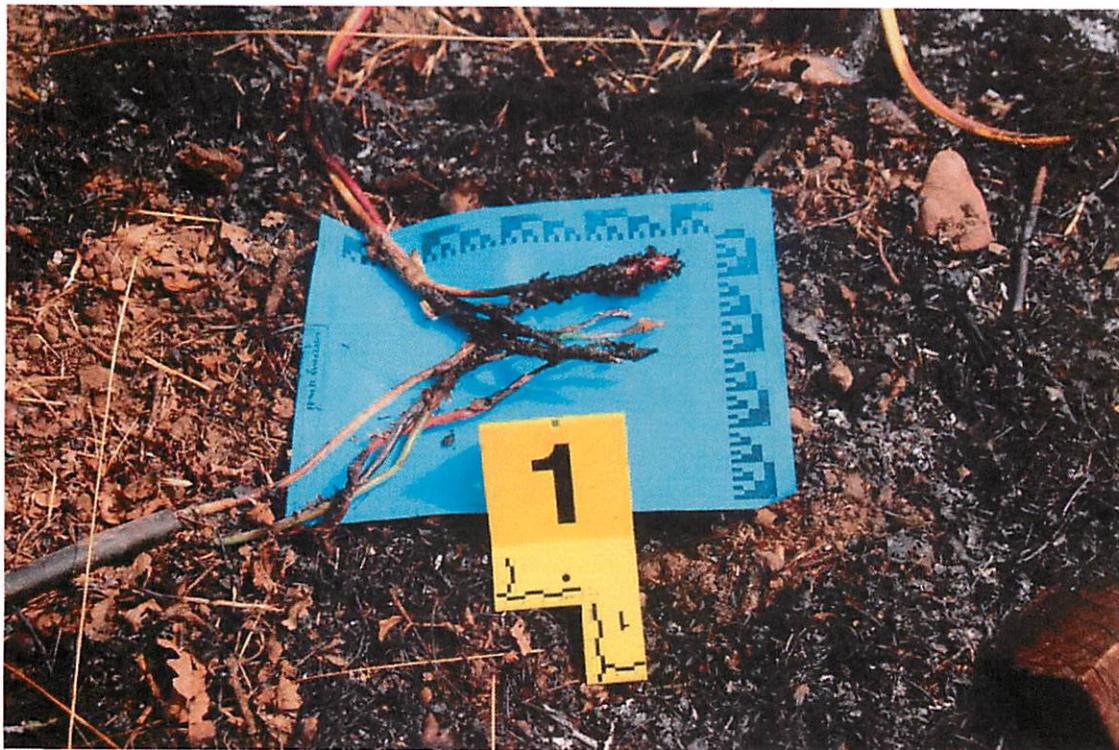
IMG_135 - Detail photo from east to west showing location of wire splice relative to coaxial cable ends and metal pipe.

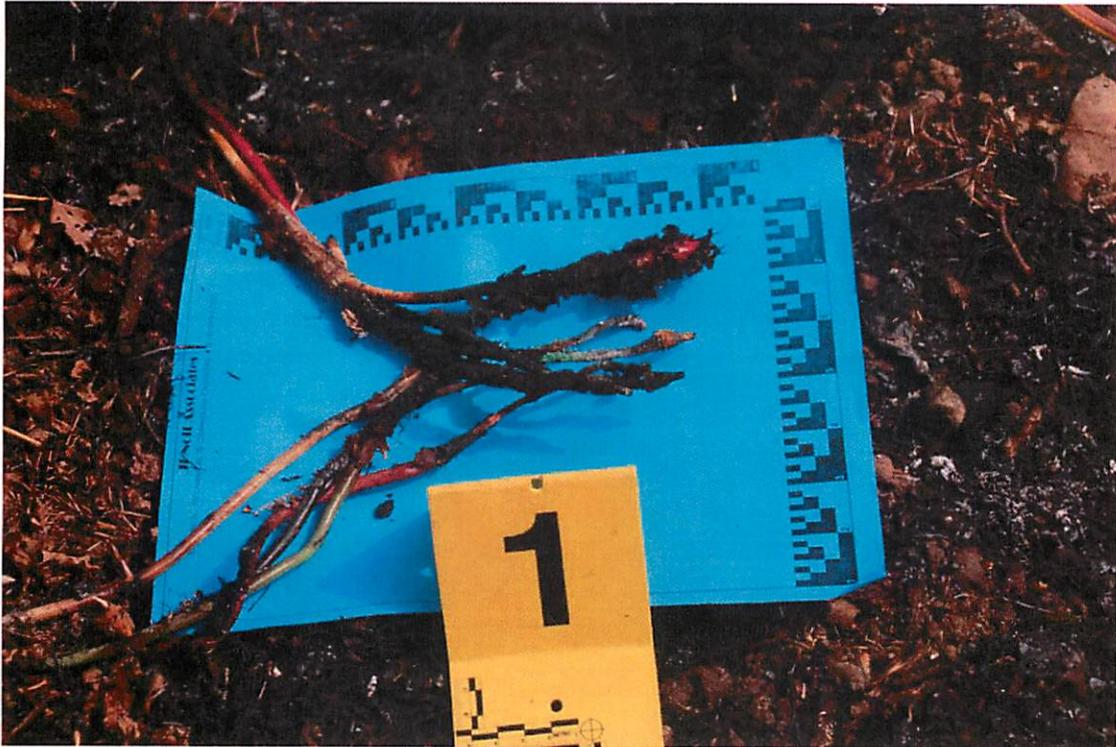
IMG_136 - Detail photo of splice with scaled blue paper beneath for contrast.
