IMG_0001 - Cover sheet indicating beginning of photographs.

IMG_0002 - Front of house located at 8015 High Valley Road, Cobb, CA.

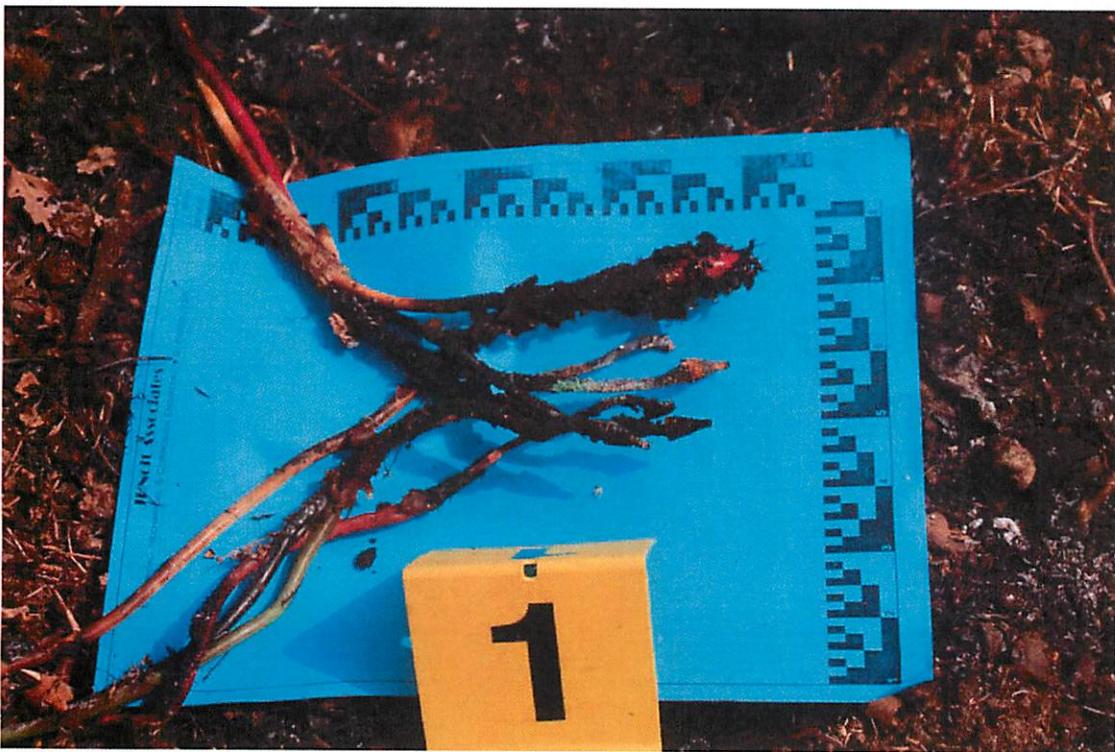
IMG_137 - Detail photo of splice with scaled blue paper beneath for contrast. Shows wires in greater detail and their separation.

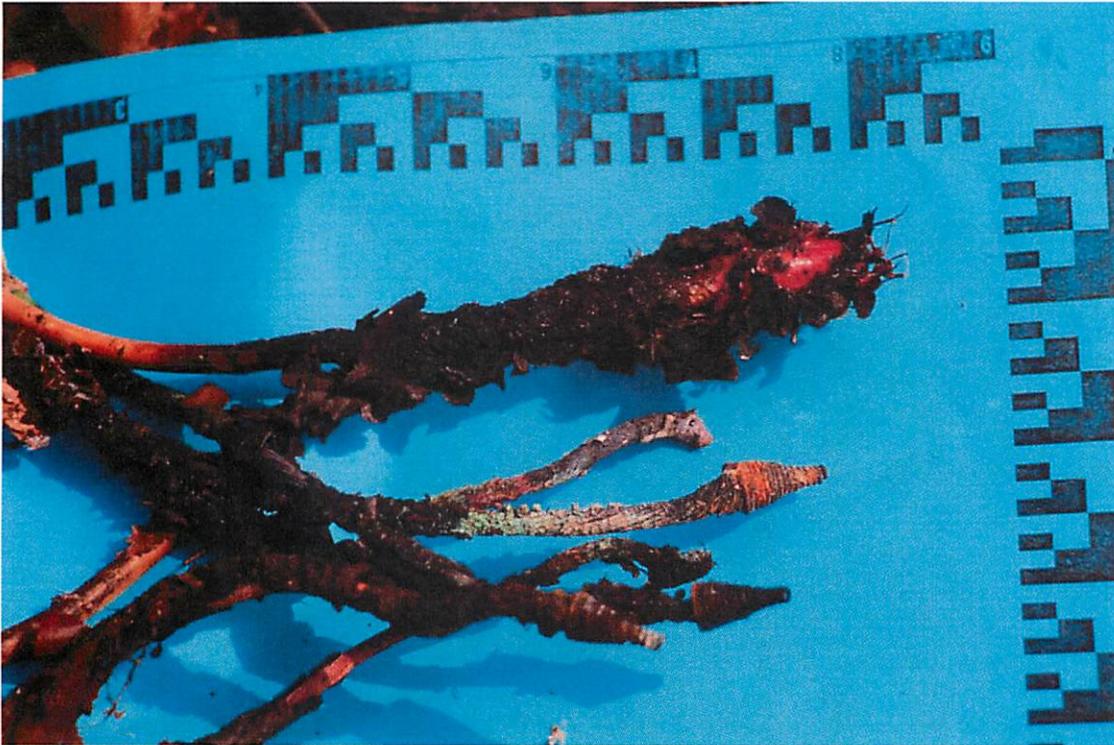
IMG_138 - Detail photo of splice with scaled blue paper beneath for contrast. Shows wires in greater detail and their separation.

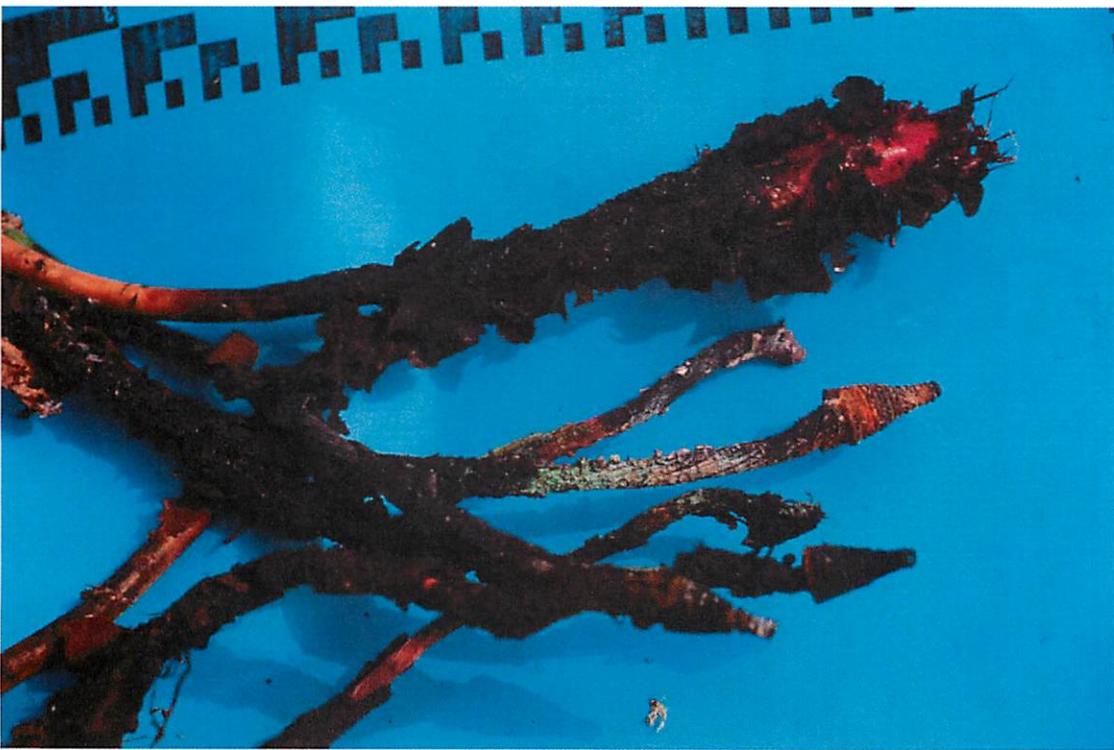
IMG_139 - Close-up photo of splice with scaled blue paper beneath for contrast. Shows wires in detail and their condition.

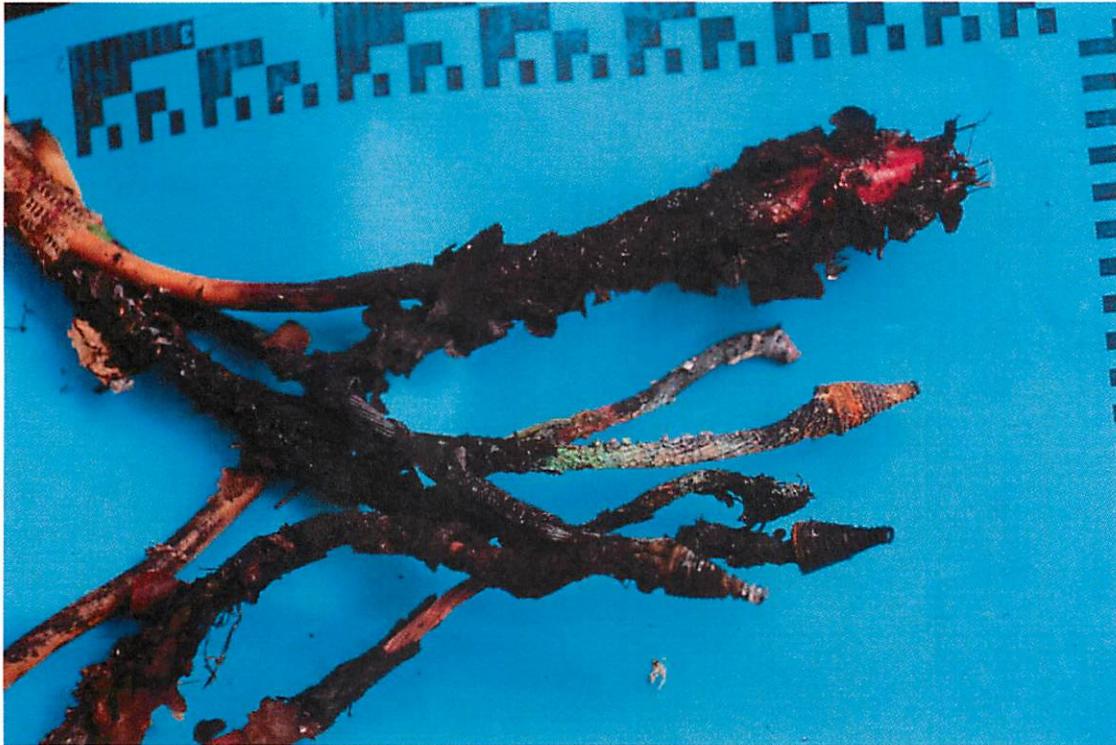
IMG_140 - Close-up photo of splice with scaled blue paper beneath for contrast. Shows wires in detail and their condition.

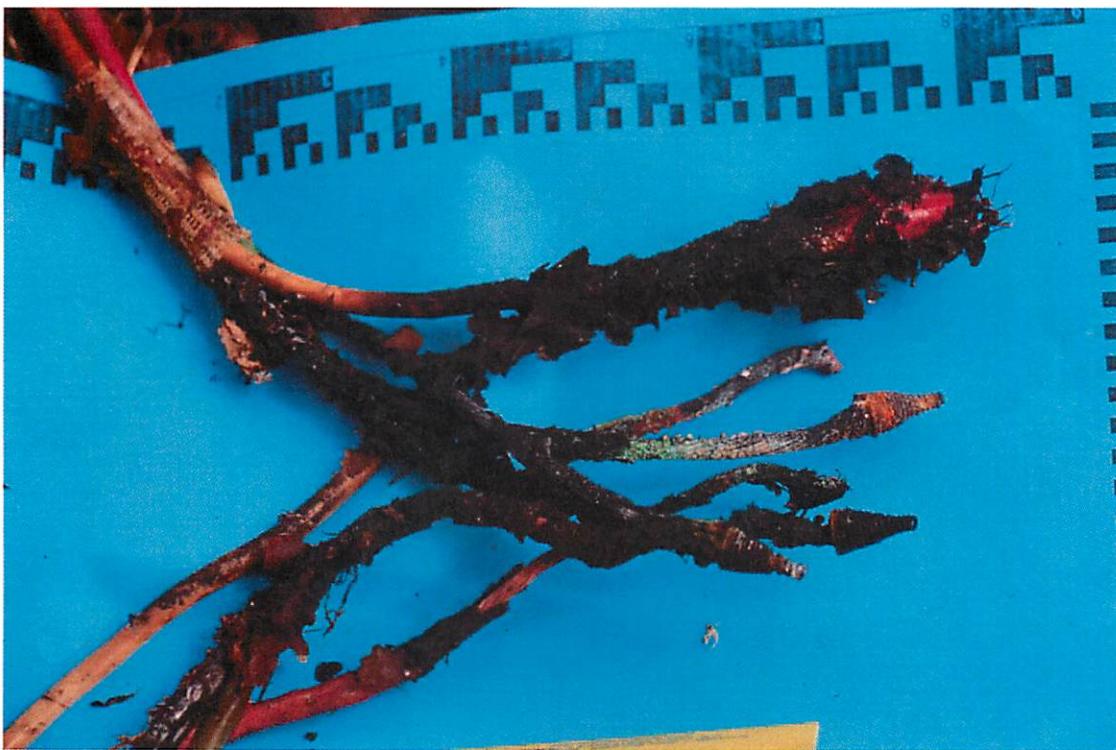
IMG_141 - Close-up photo of splice with scaled blue paper beneath for contrast. Shows wires in detail and their condition.

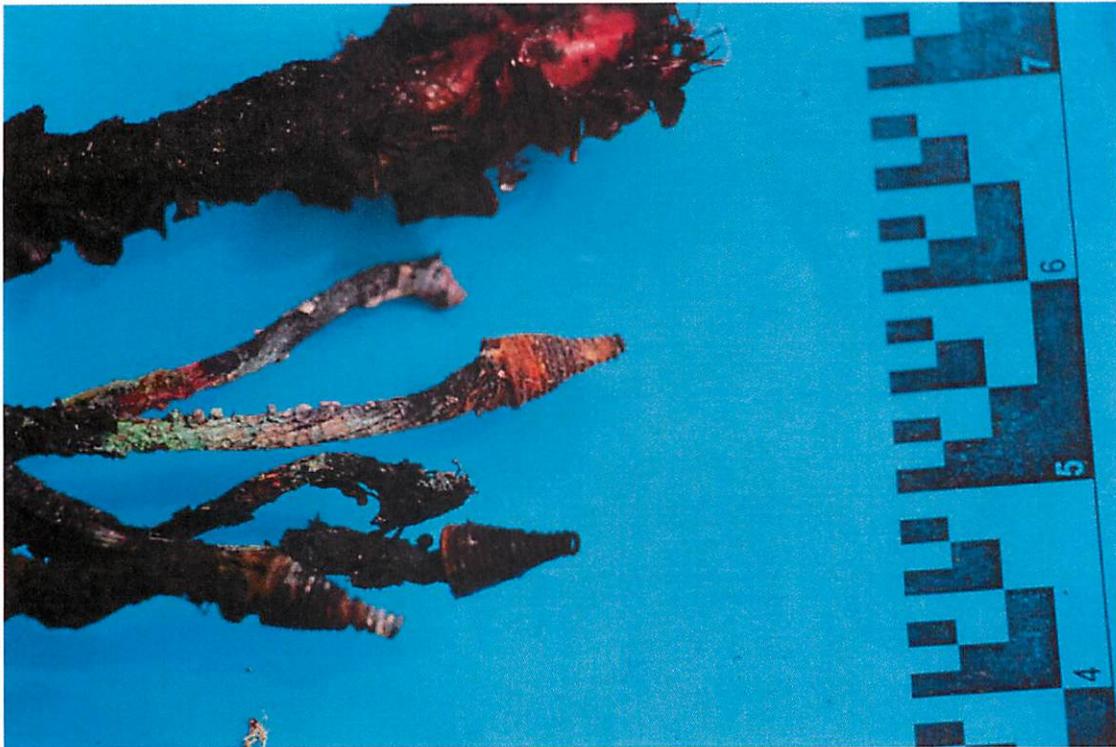
IMG_142 - Close-up photo of splice with scaled blue paper beneath for contrast. Shows wires in detail and their condition.

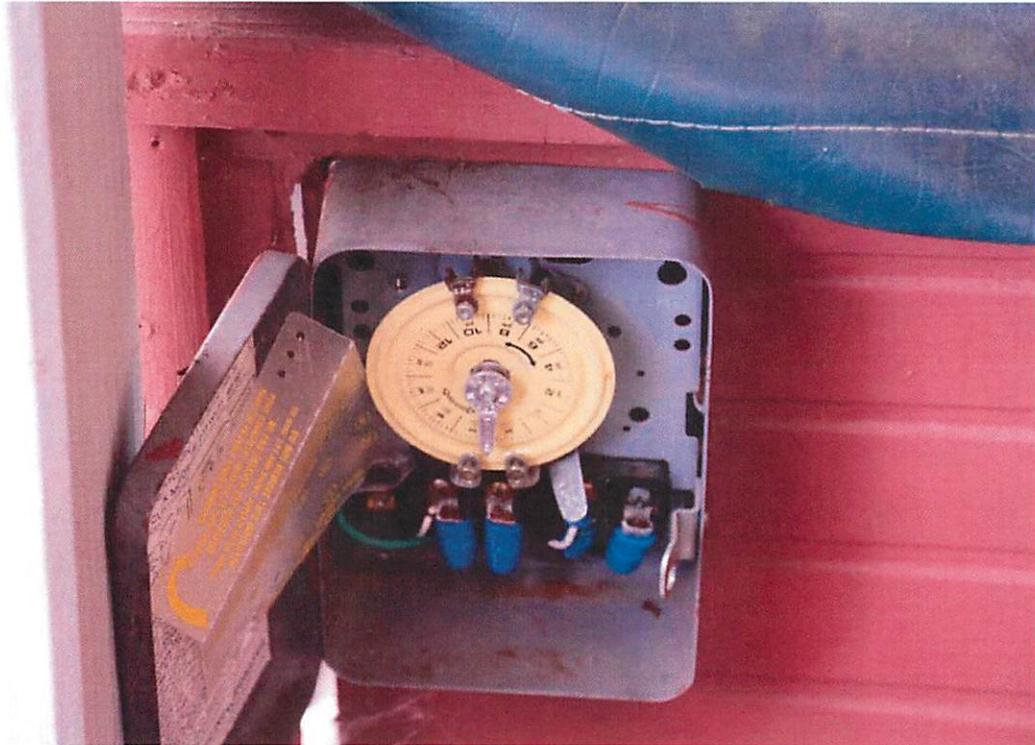
IMG_148 - Overall view of hot tub electrical and plumbing parts with front cover of box removed. External wiring pictured in lower portion of photo, including wiring splice between extension cord and hot tub wires identified in lower right of picture near neon wire tie.

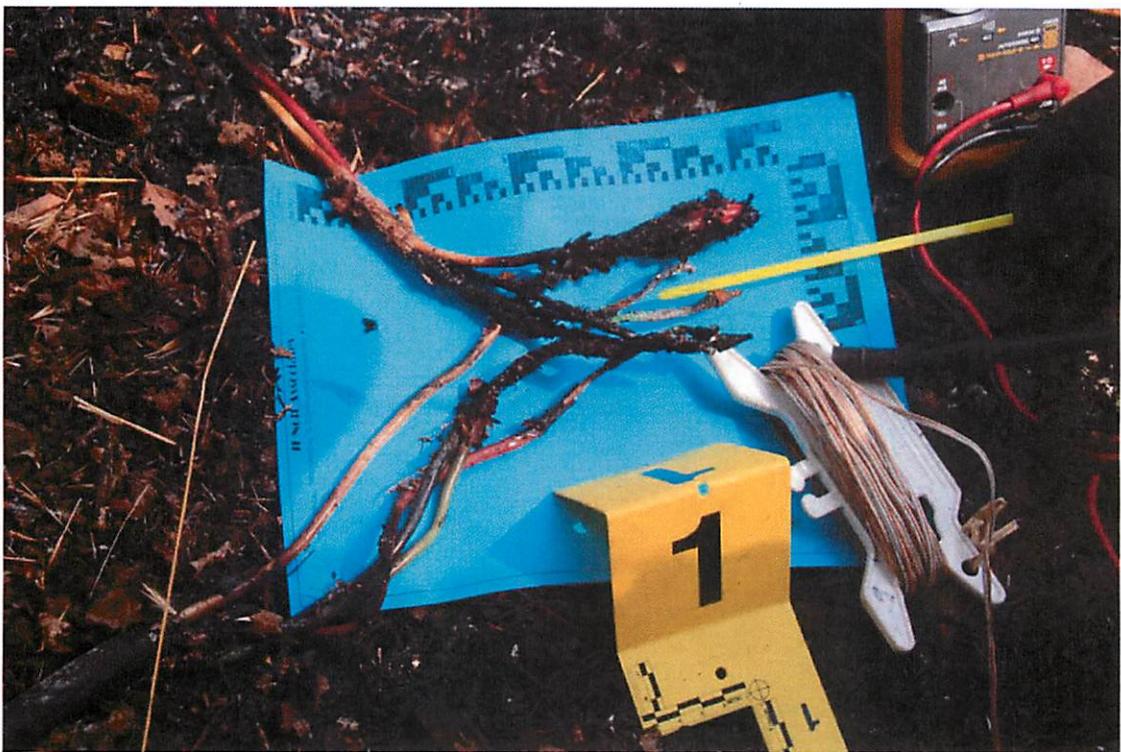
IMG_157 - Detail photo of splice with scaled blue paper beneath for contrast. Yellow wire tie pointed to location where wires were welded.

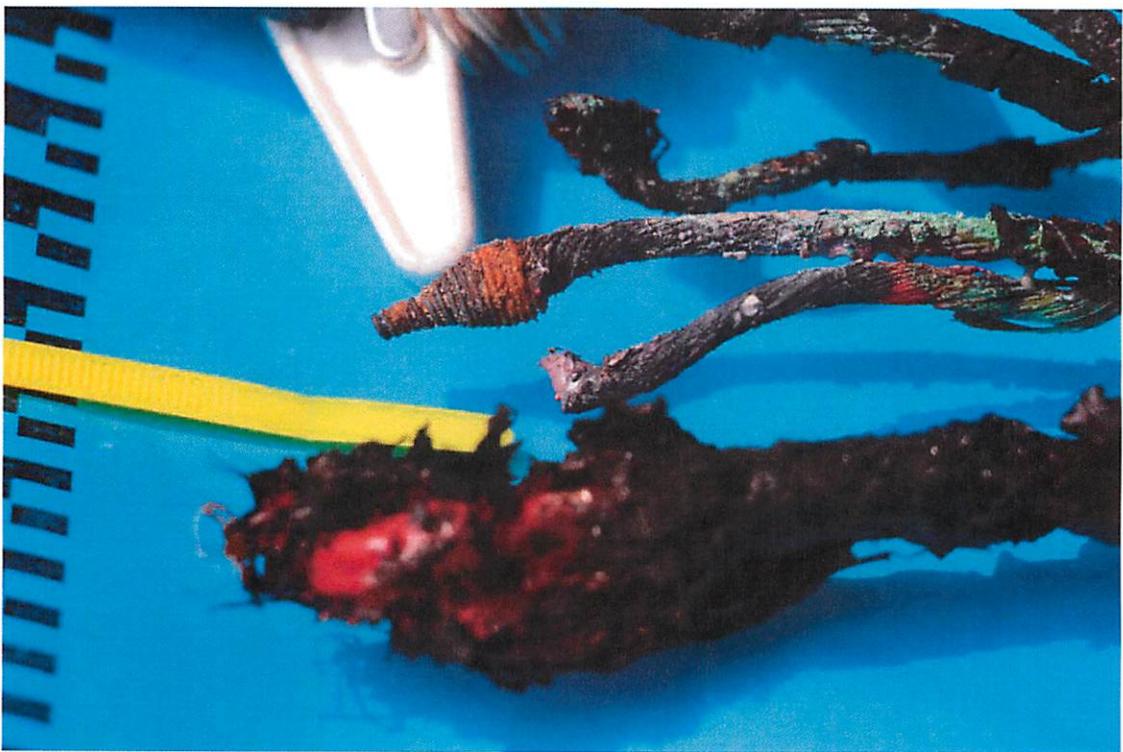
IMG_159 - Close-up of splice showing condition of wires.

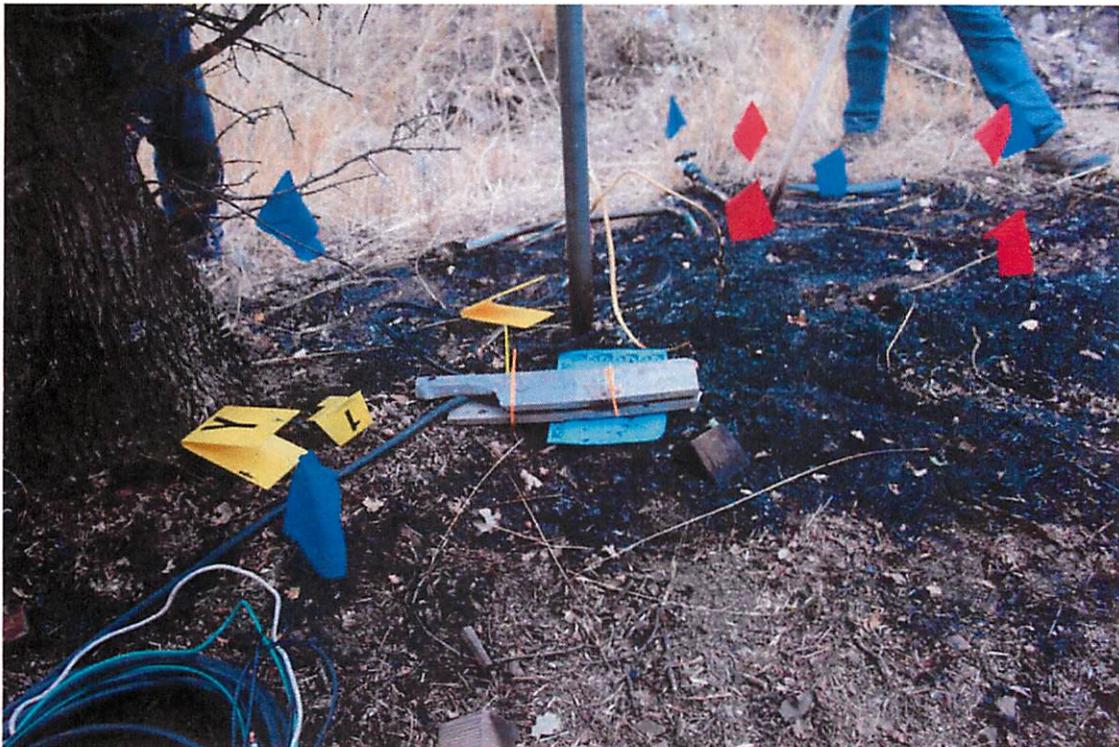
IMG_181 - Splice between the two boards. The load side of splice is rolled and wire tied in lower left corner of photo.

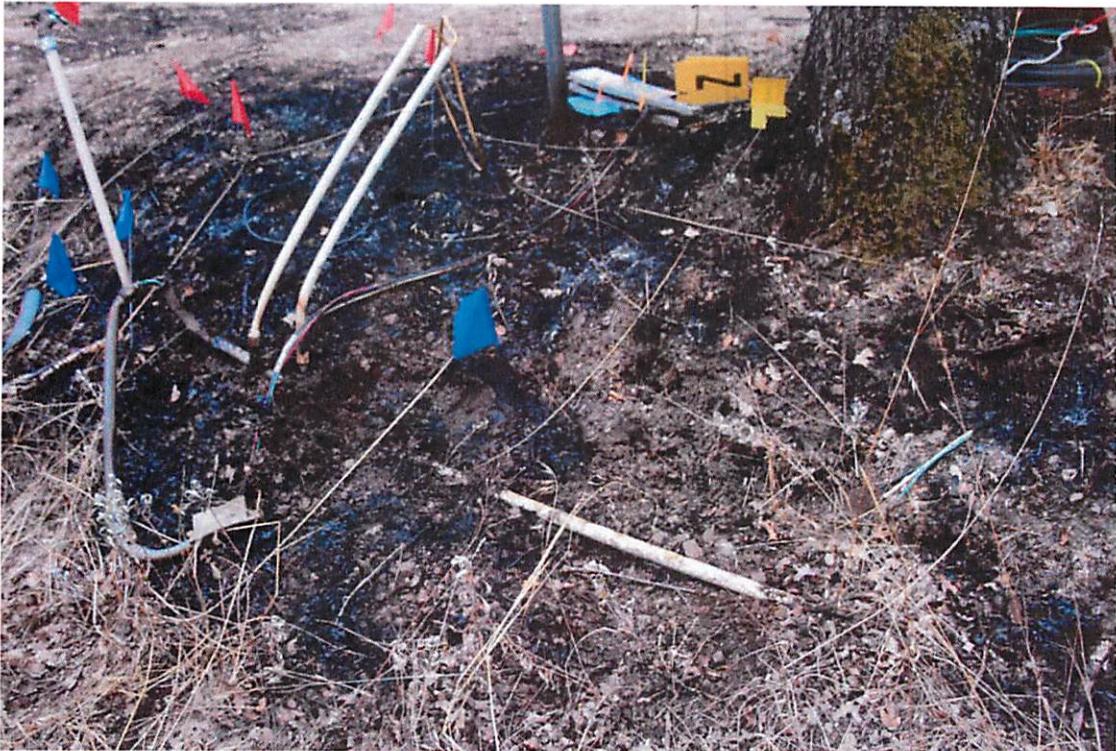
IMG_183 - Overall view of boarded splice, load side rolled and ties (upper right corner) and supply side traveling from splice into conduit.

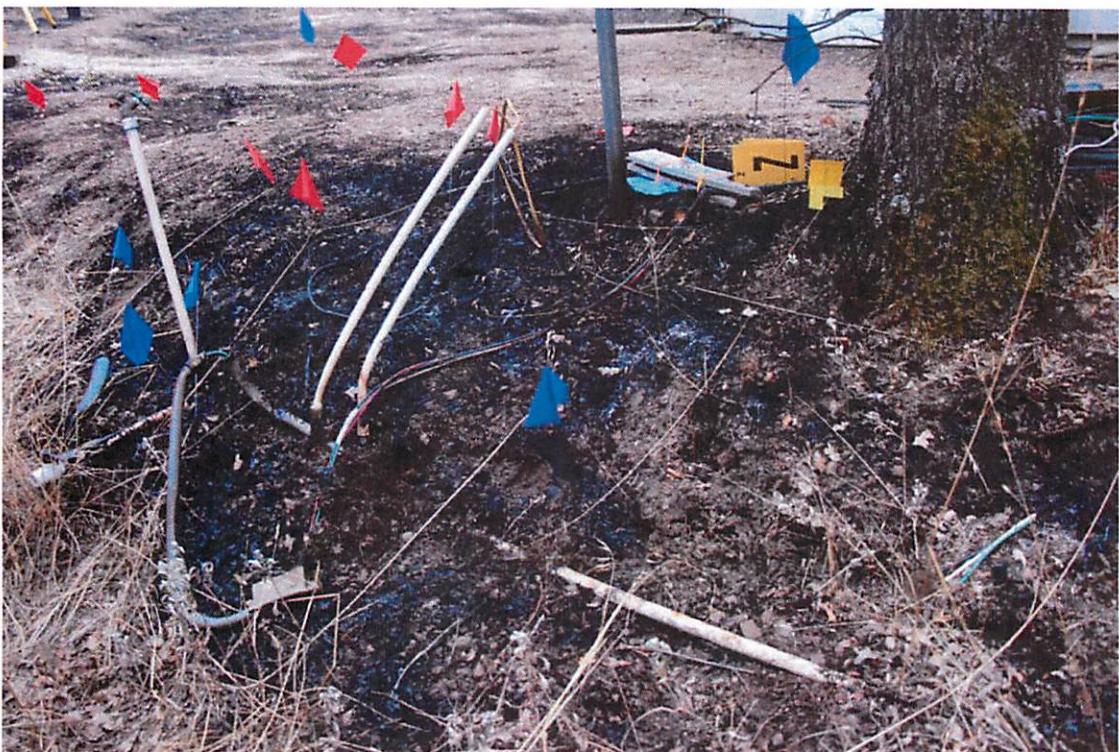
IMG_184 - Overall view of boarded splice, load side rolled and ties (upper right corner) and supply side traveling from splice into conduit.

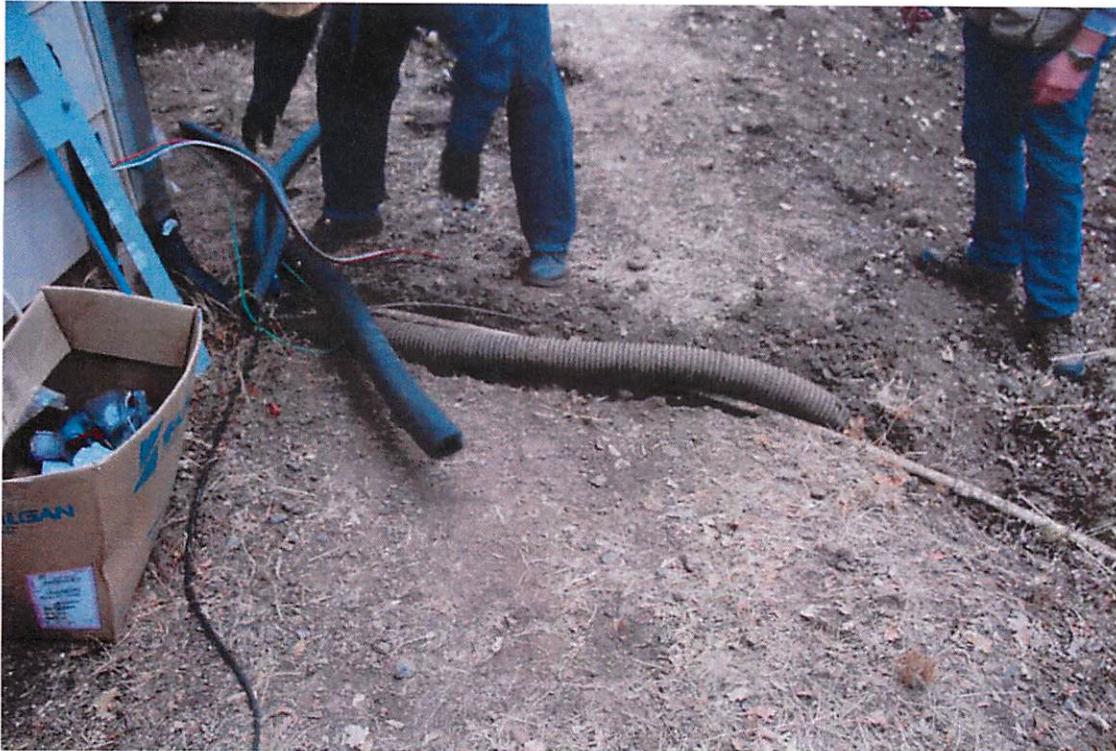
IMG_185 - Unburied conduit and water pipe leading from northeast corner of house and traveling to SOA.

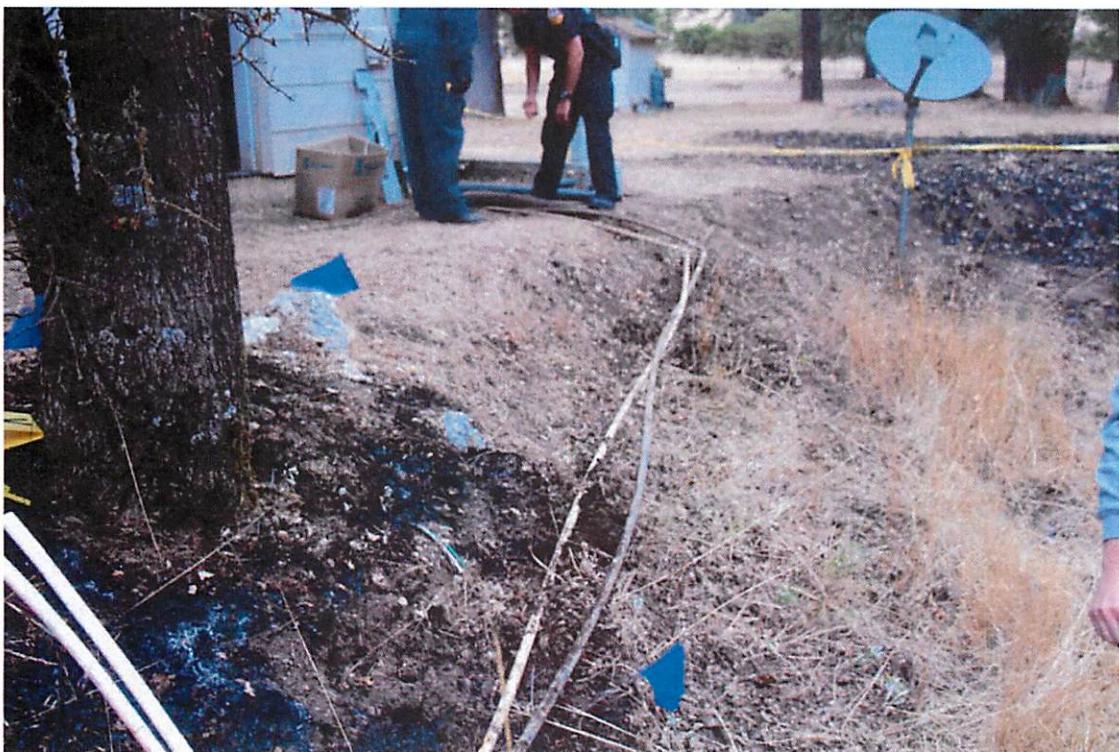
IMG_186 - Unburied conduit and water pipe leading from northeast corner of house and traveling to SOA.

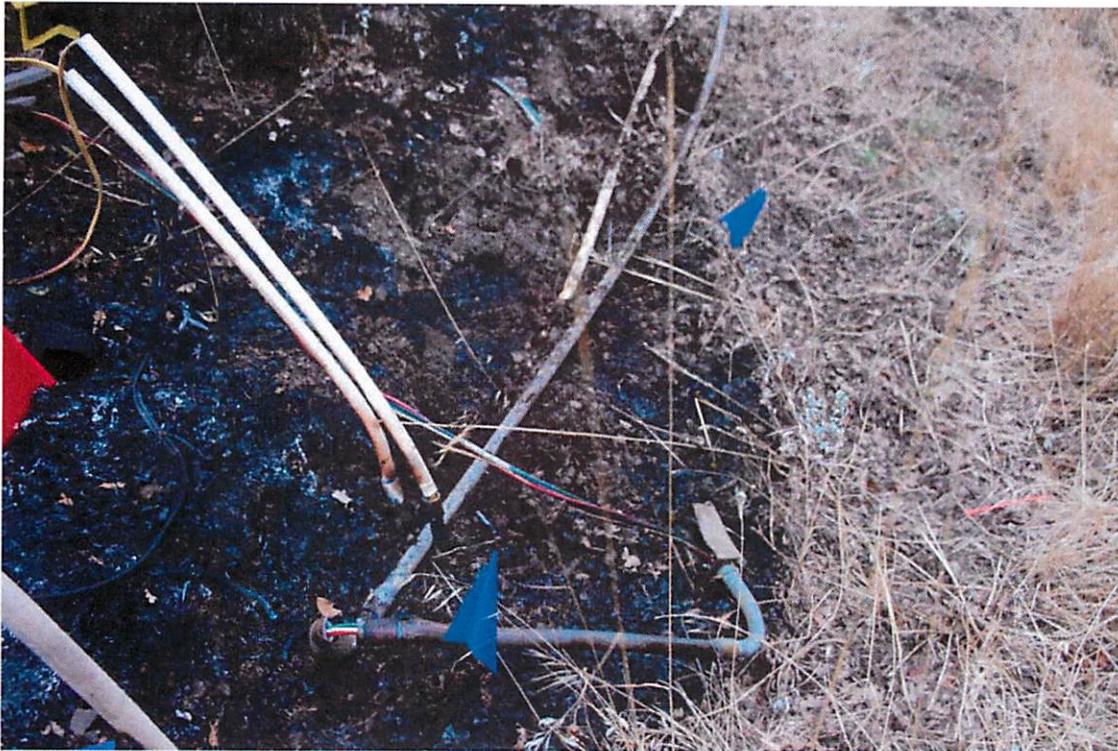
IMG_187 - Unburied conduit terminus, which contained the wires on the supply side of splice, originating at the northeast corner of house.

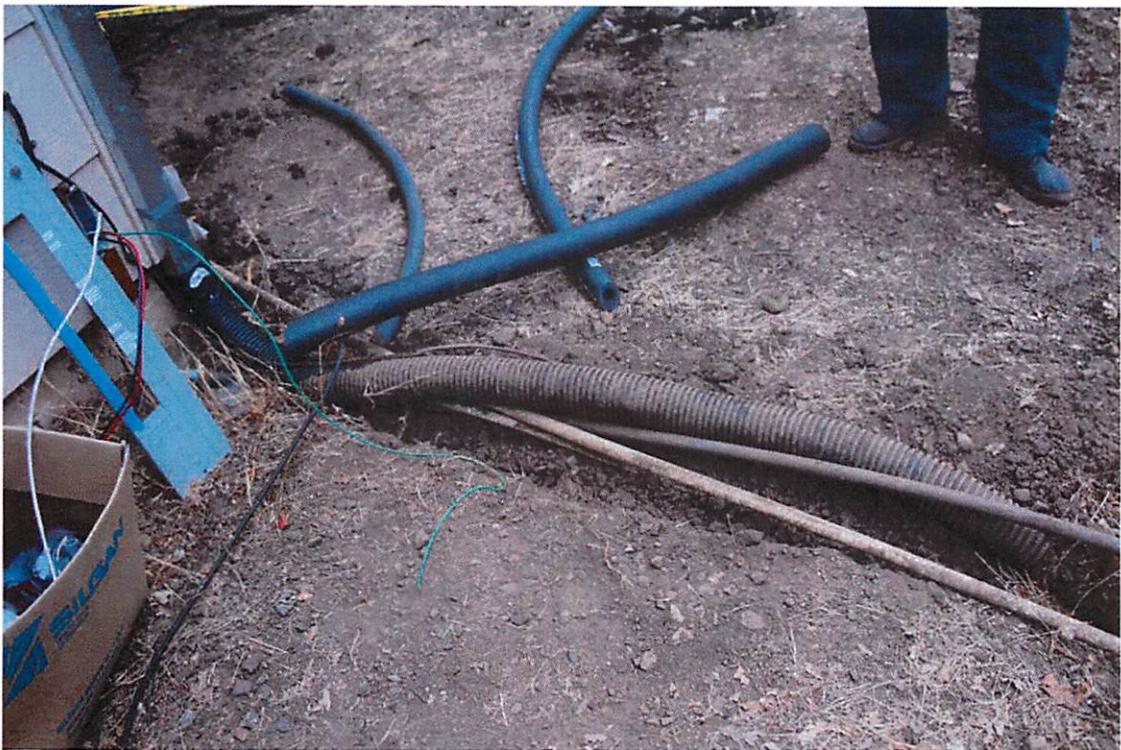
IMG_188 - Unburied conduit and water pipe leading from northeast corner of house and traveling to SOA.

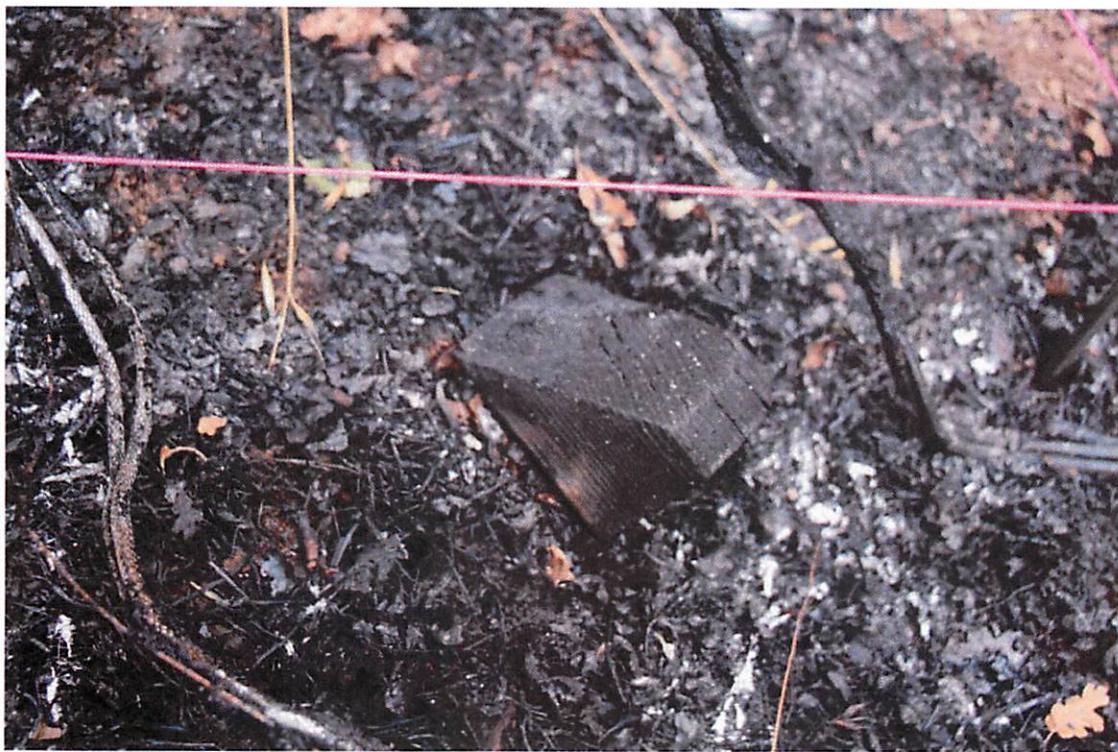
IMG_190 - Block of wood, located within first grid area, showing burn pattern invalidators consistent with protection, degree of damage and depth of char.

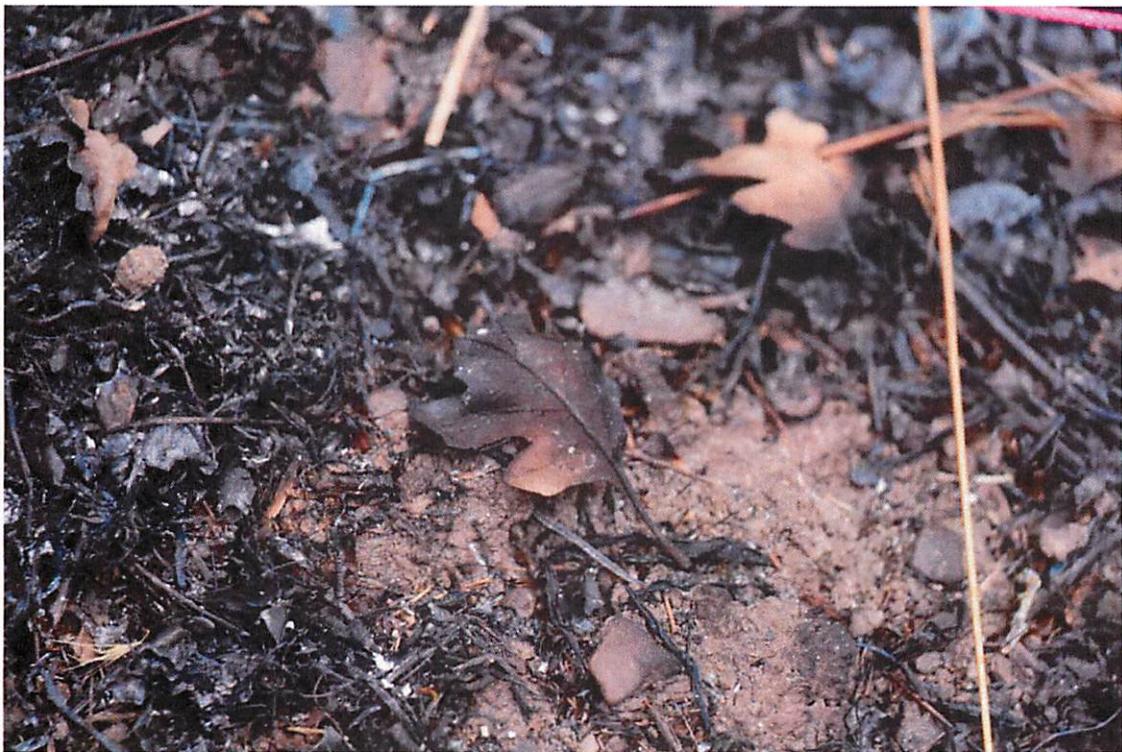
IMG_194 - Protection and degree of damage on oak leaves located within first grid.

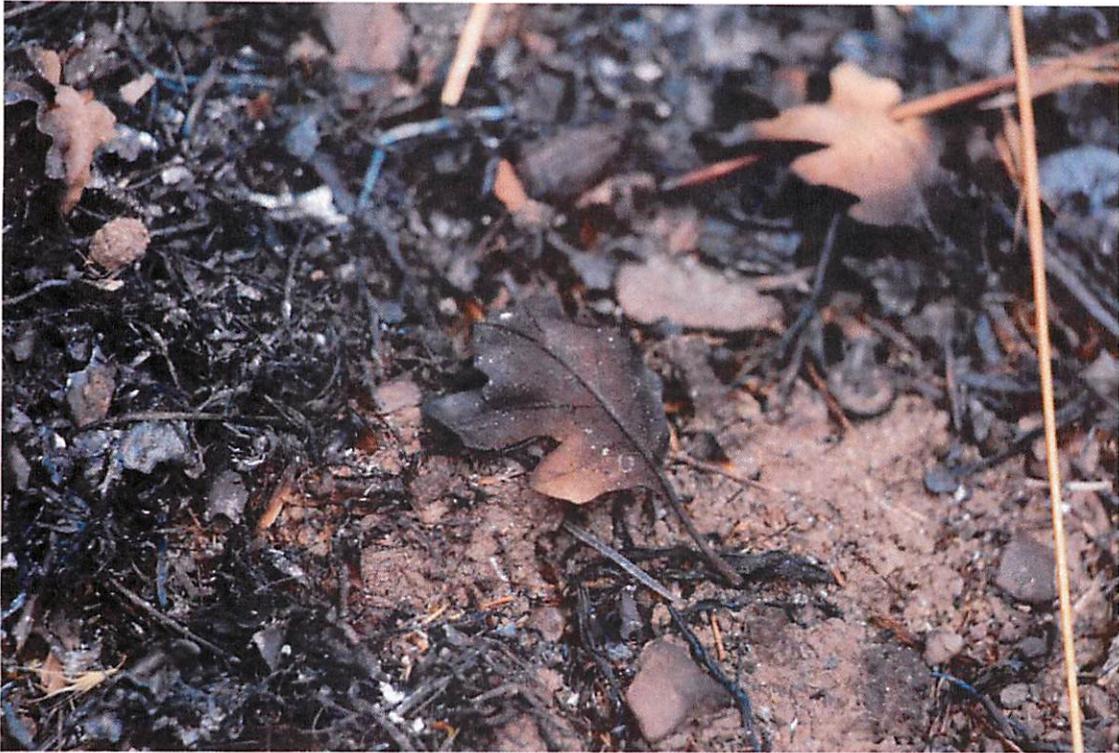
IMG_195 - Close-up of oak leaves pictured in #194 above.

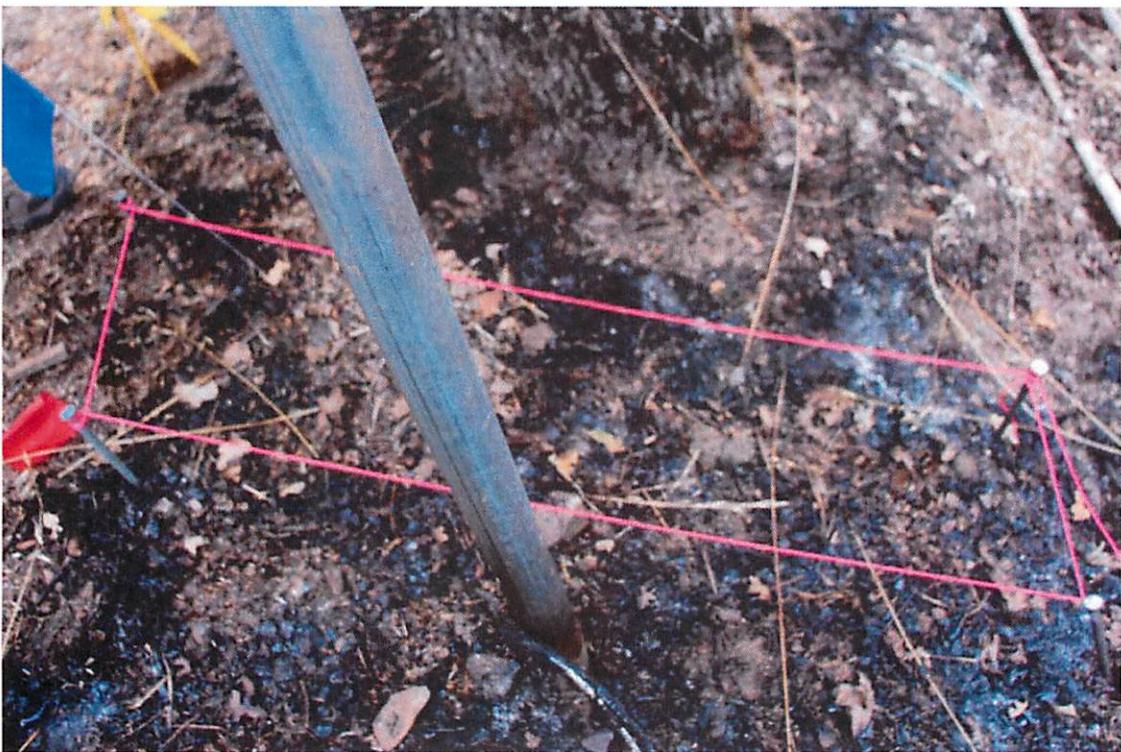
IMG_196 - Second grid within SOA, with stem fall backing indicators visible.

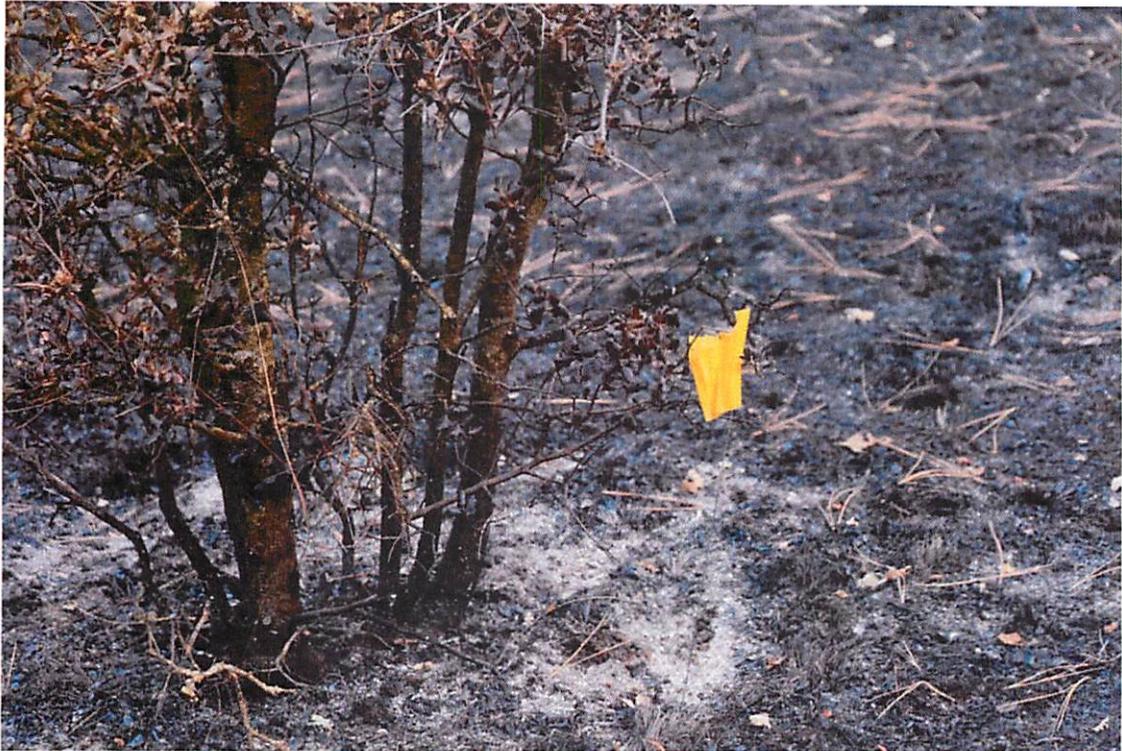
IMG_205 - Looking southeasterly at lateral indicator flagging, from same location as #203. Angle of char, protection and cupping is visible.

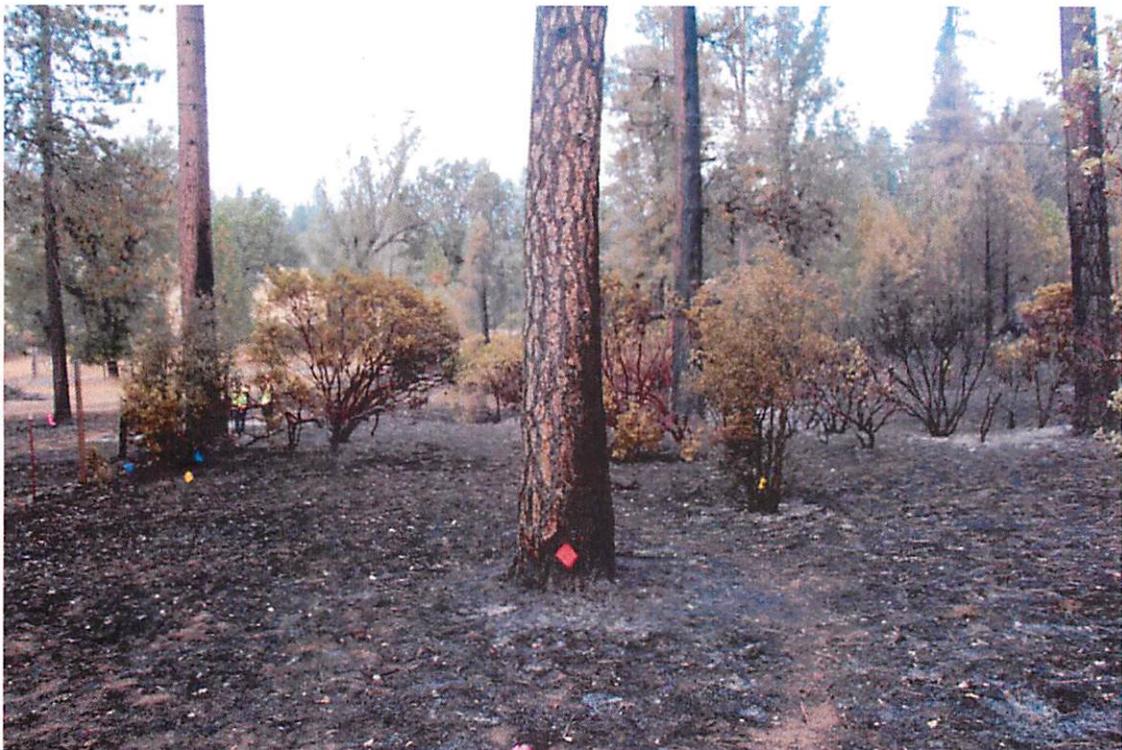
IMG_206 - Looking northerly at angle of char, indicating advancing fire progression.

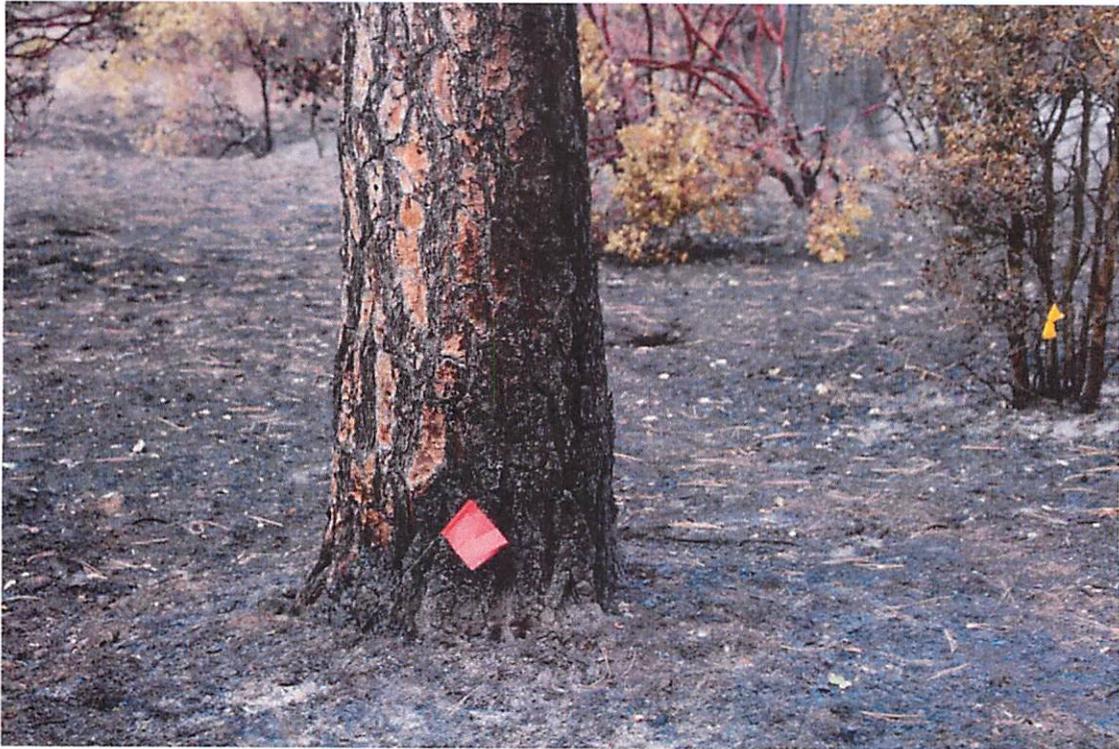
IMG_207 - Looking northerly at angle of char, indicating advancing fire progression.

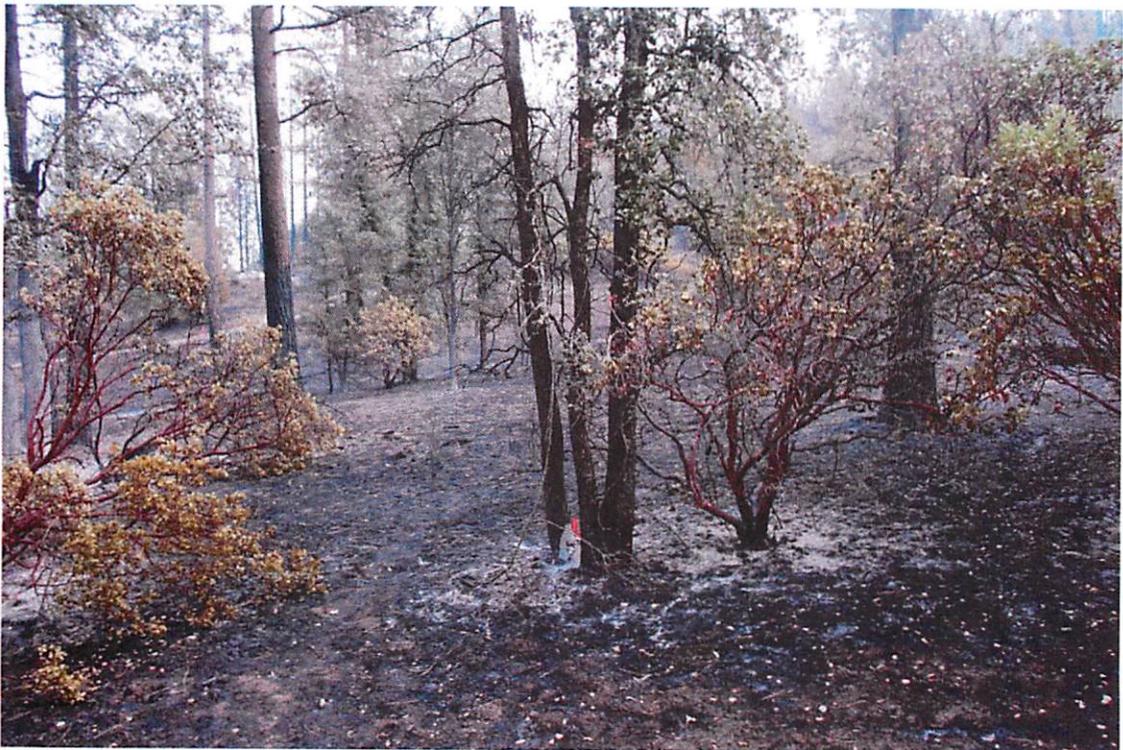
IMG_208 - Looking easterly at angle of char, indicating advancing fire progression.

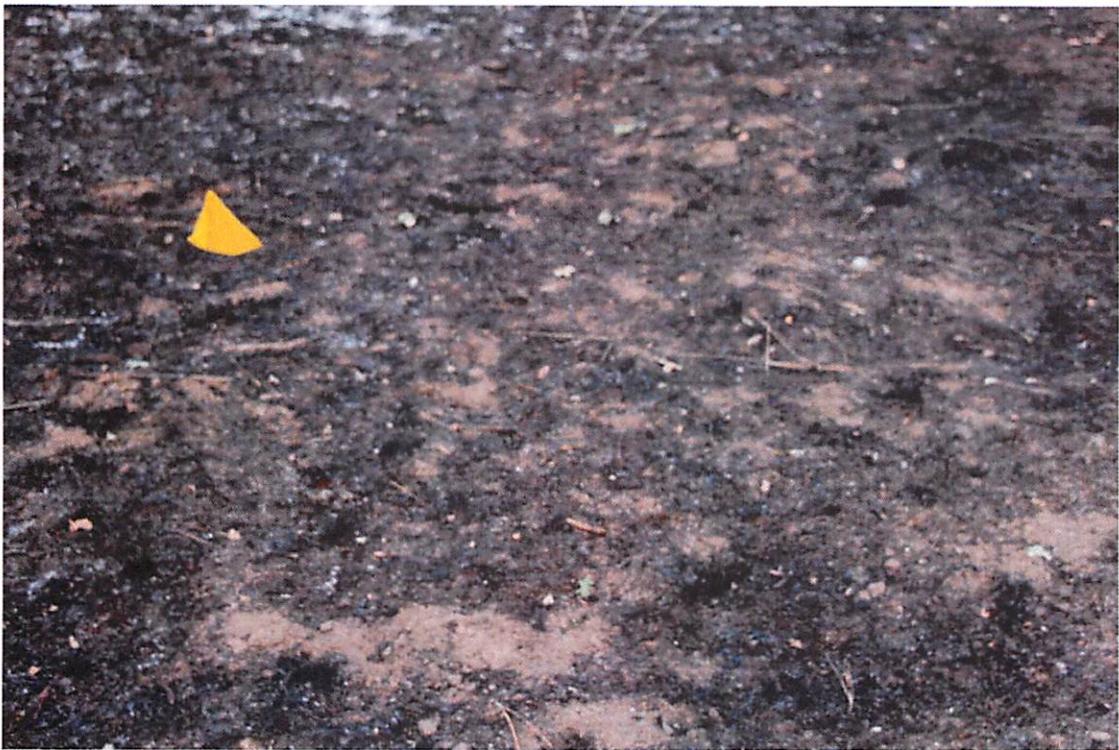
IMG_214 - Looking northerly at lateral transition line with indicator flagging from same location as #210.

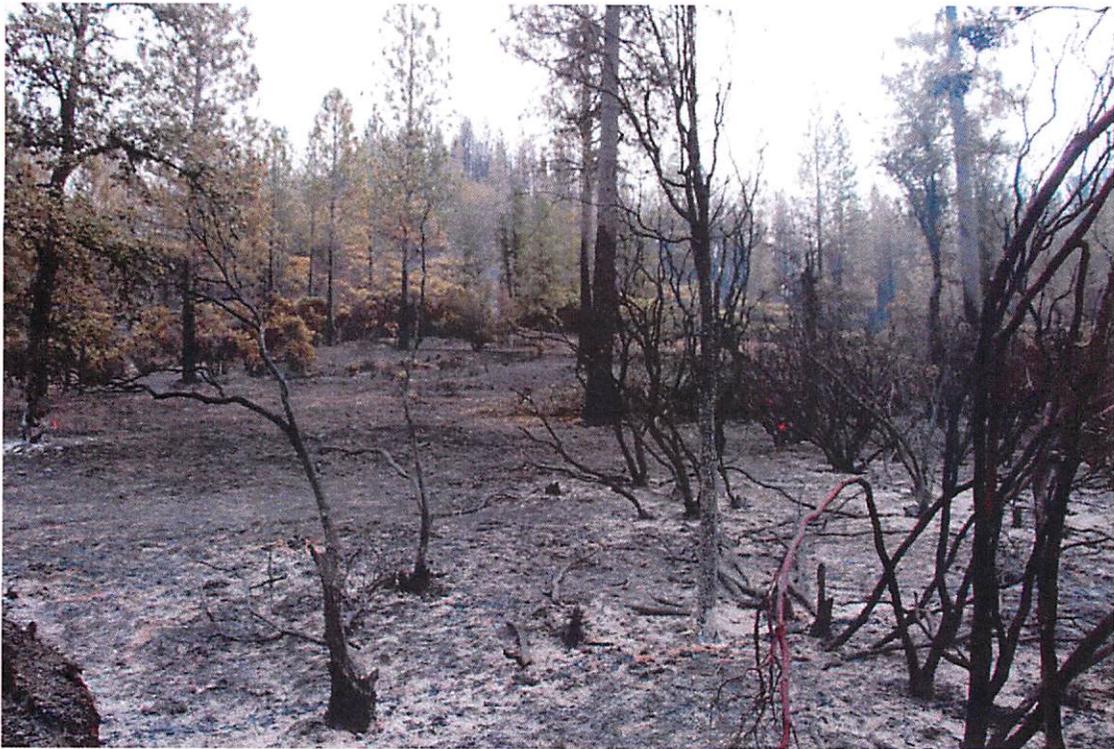
IMG_221 - Looking southeasterly from same location and #220. Indicator flagging in distance.
