IMG_0001 - Cover sheet indicating beginning of photographs.

IMG_0002 - Front of house located at 8015 High Valley Road, Cobb, CA.

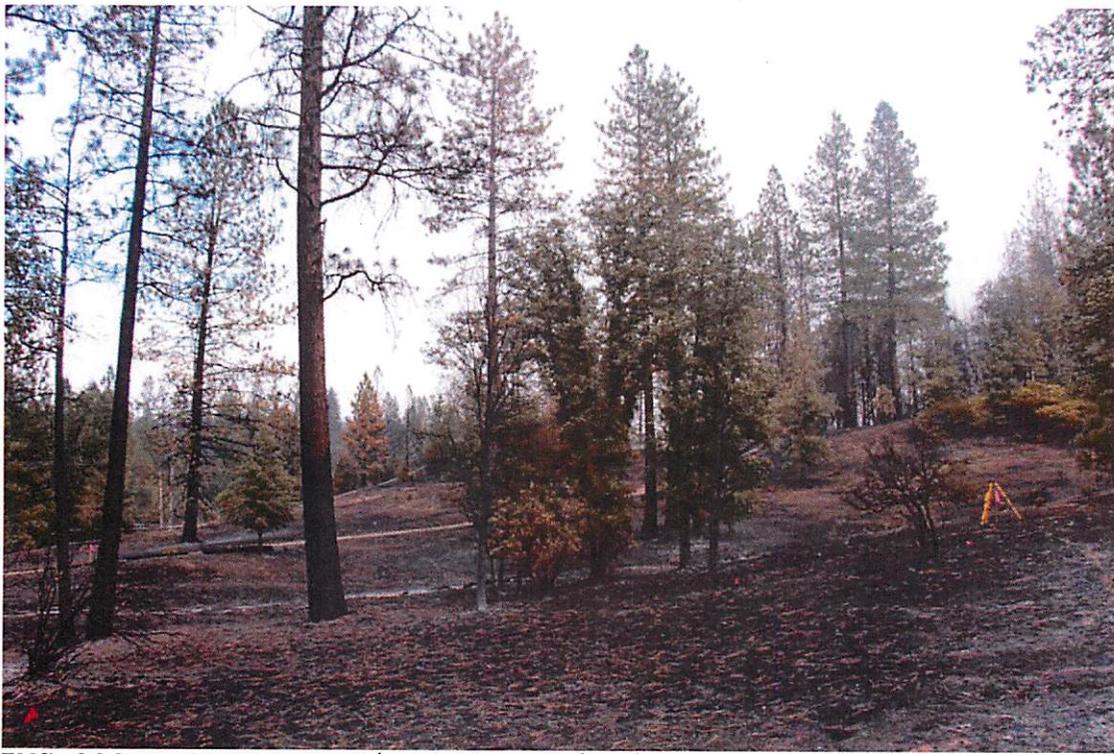
IMG_222 - Survey equipment and indicator flagging, looking southeasterly from location east of fence, northeast of house.

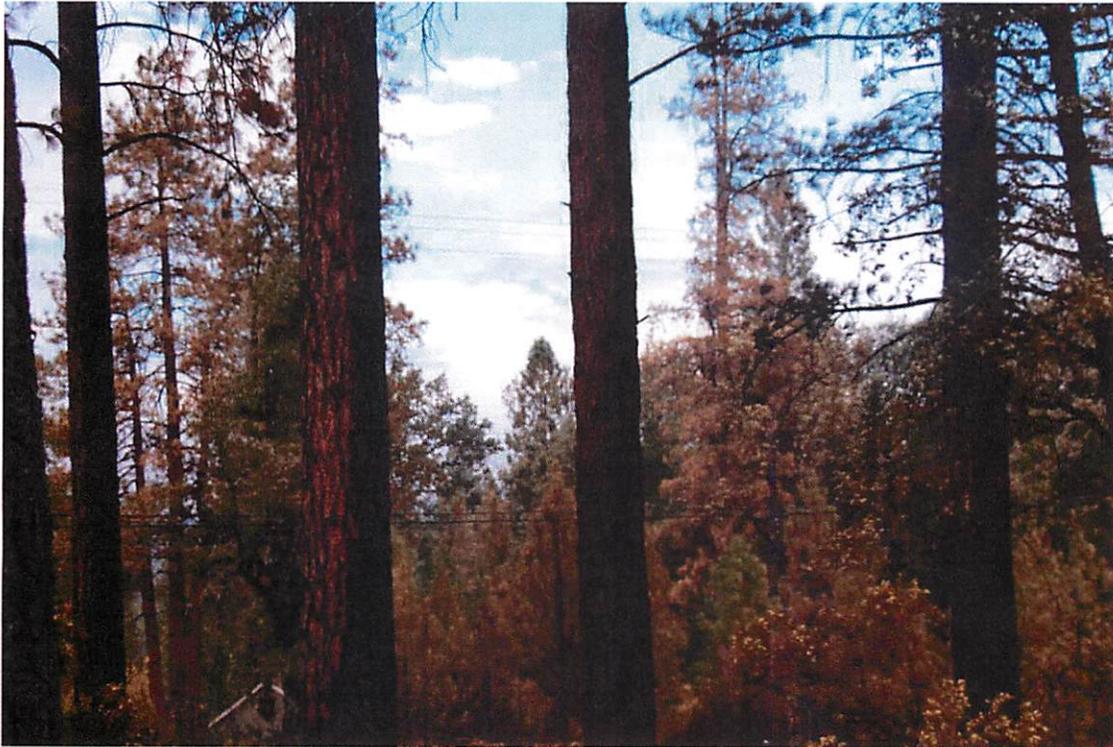
IMG_223 - Angle of char, advancing indicators on north side of property, looking north.

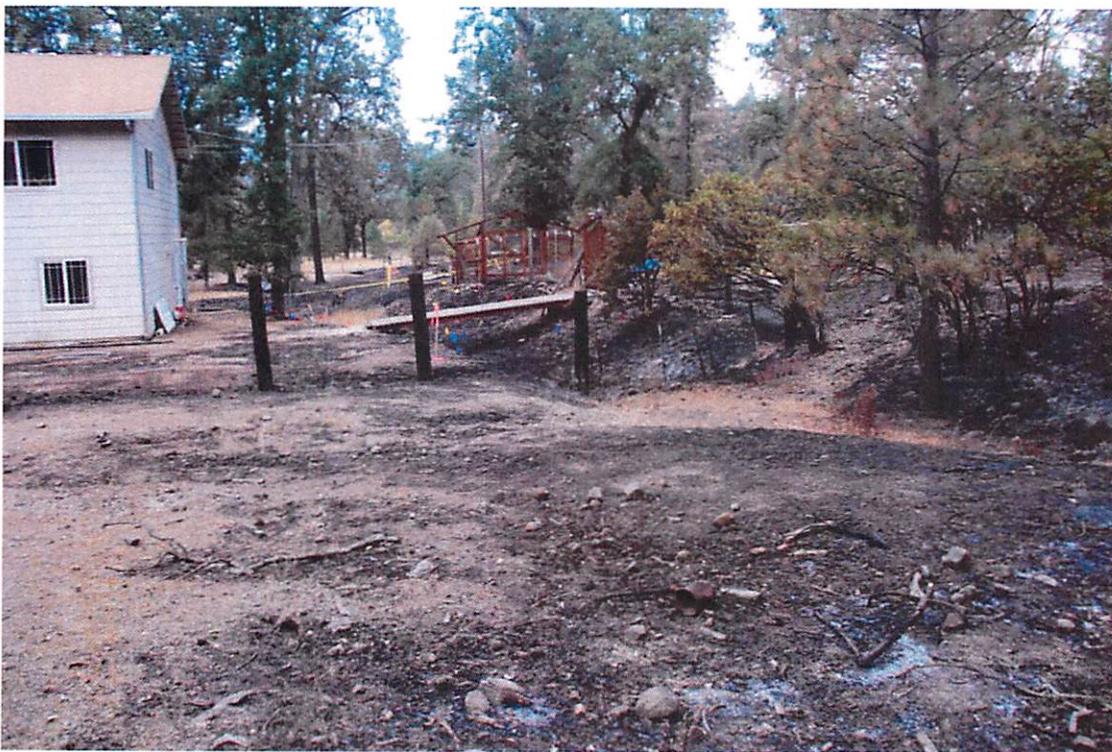
IMG_224 - Looking toward SOA from south of southern fence line.

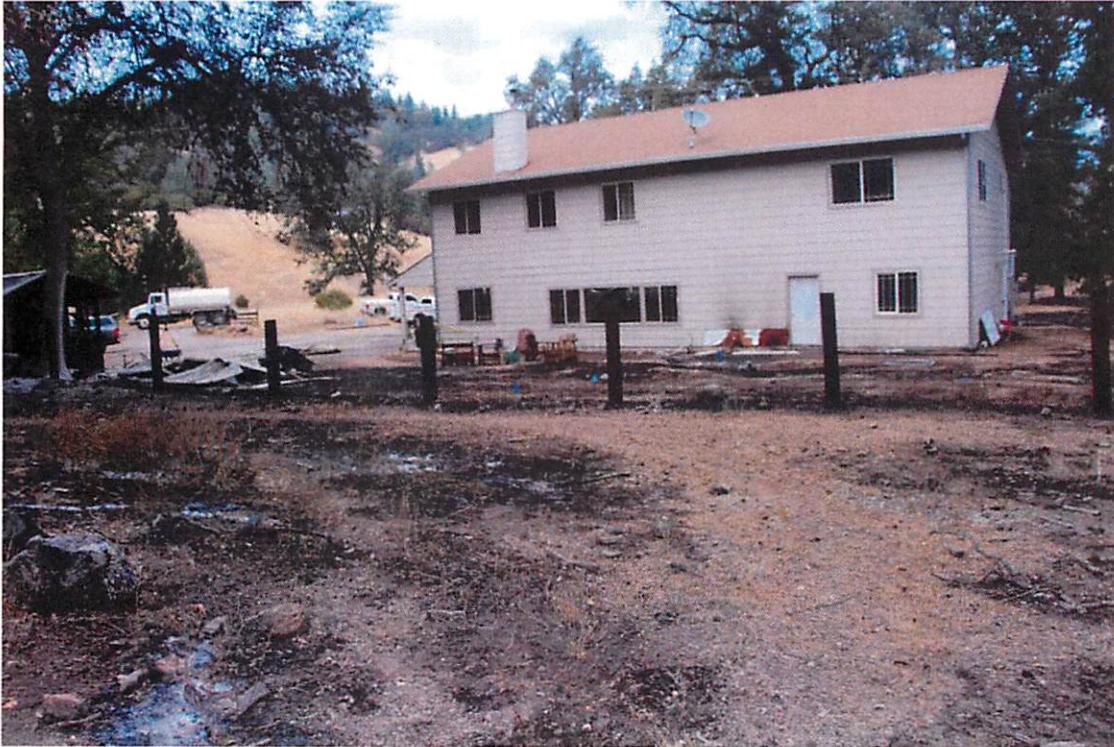
IMG_225 - Looking toward south side of house, destroyed wood shed and damaged tool shed from south of southern fence line. Backing indicator flagging visible north of fence.
