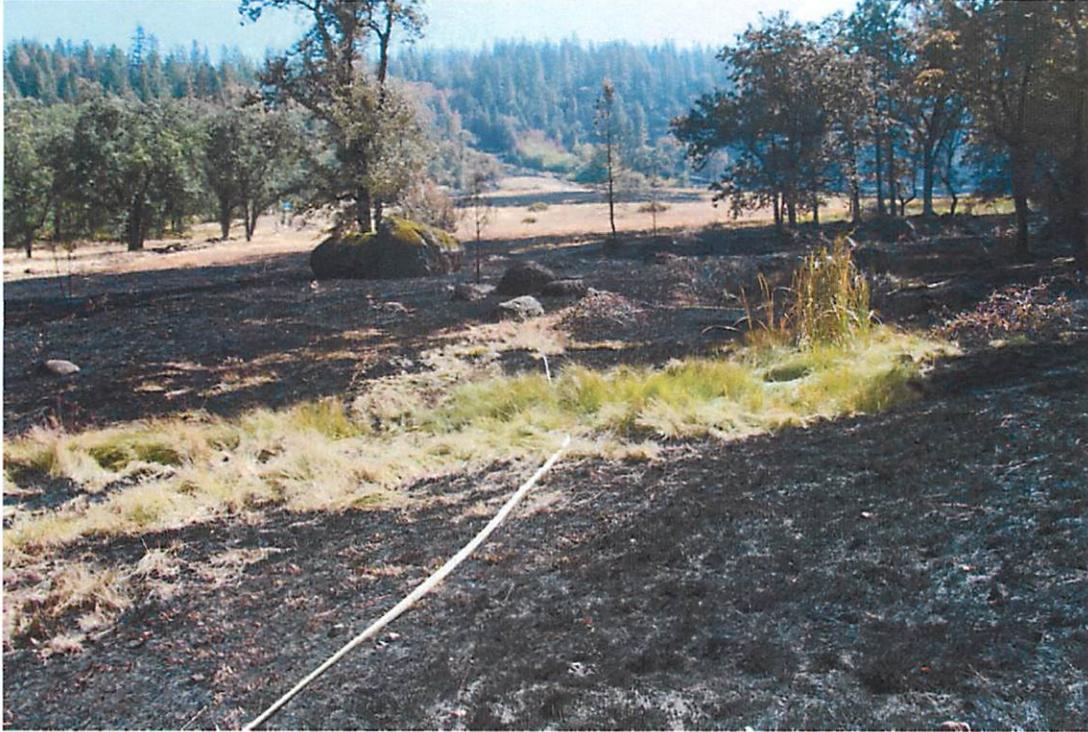
IMG\_0013- Taken from near creek/hose line, looking easterly. Shows what was likely the heel and east flank of the fire when suppression action taken.

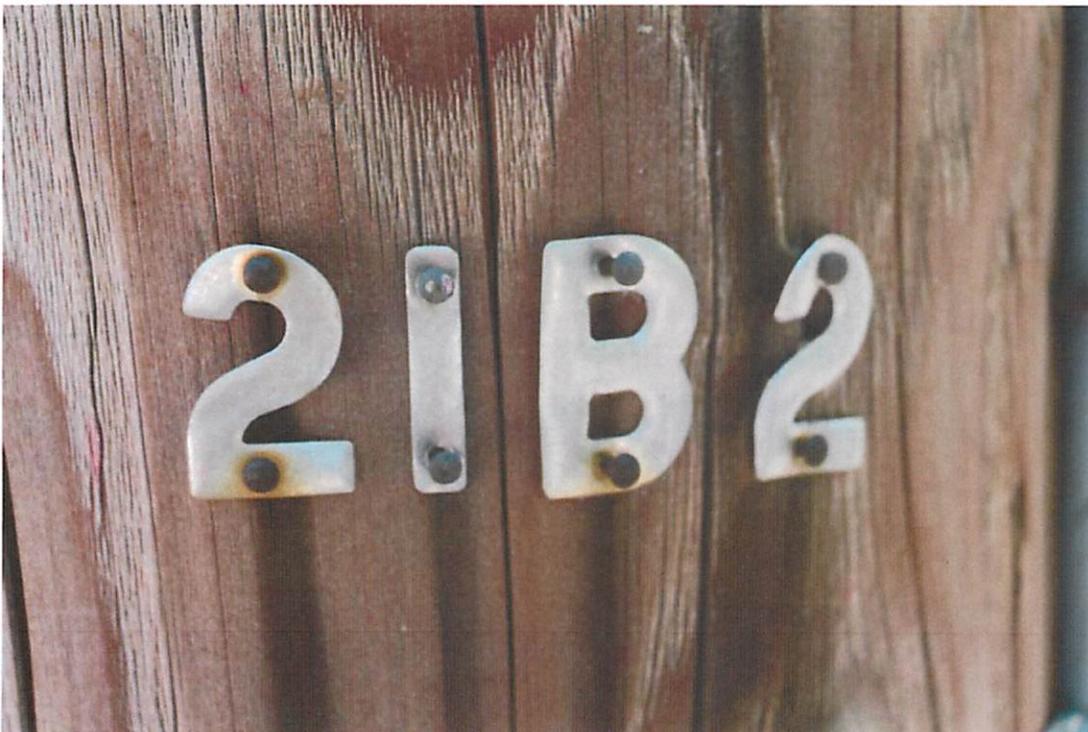
IMG\_0030- Power pole identification number on pole with transformer, located near southwest corner of the destroyed residence.

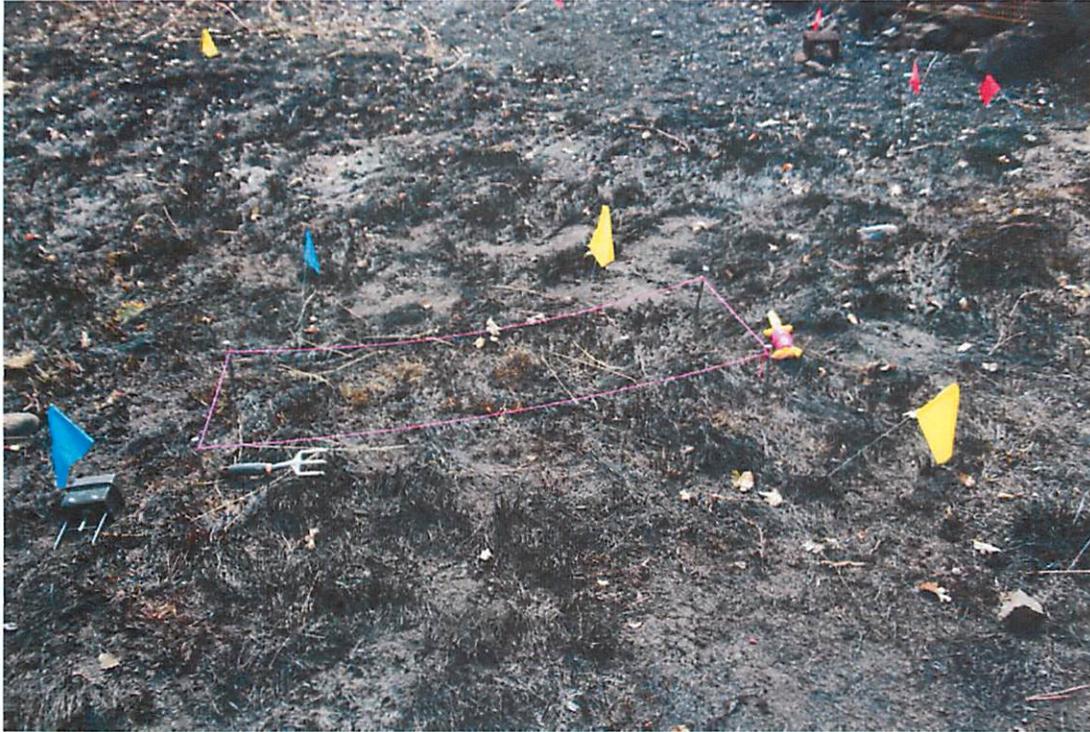
IMG\_0069- First search grid of SOA.

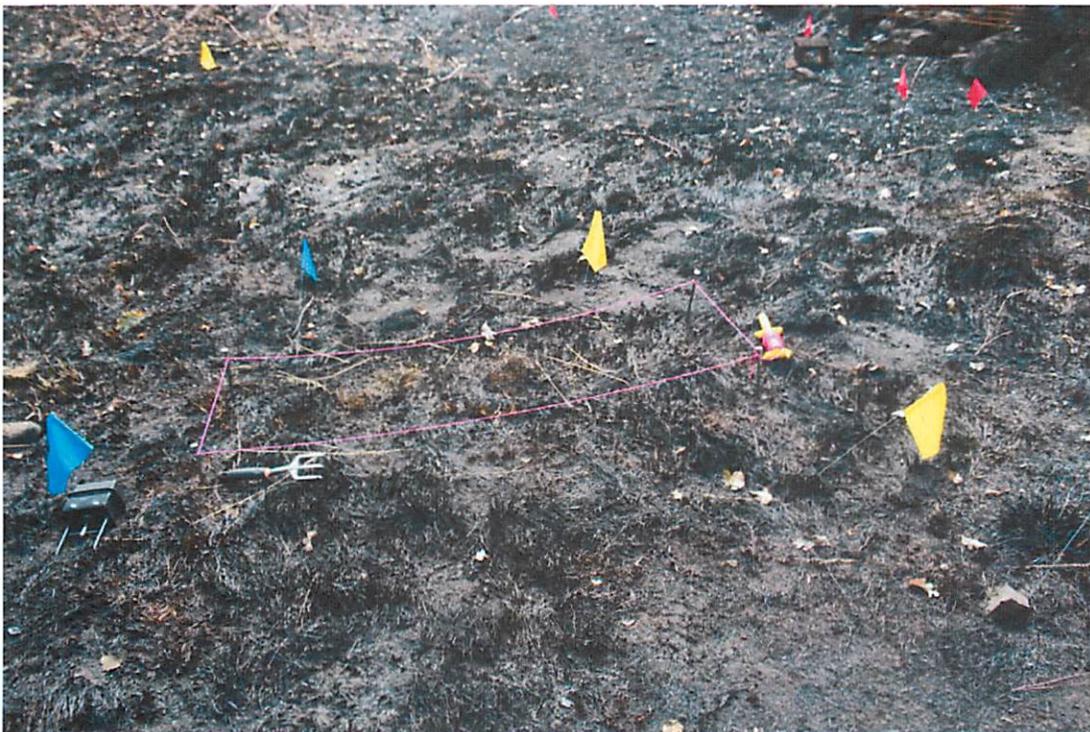
IMG\_0070- First search grid of SOA.

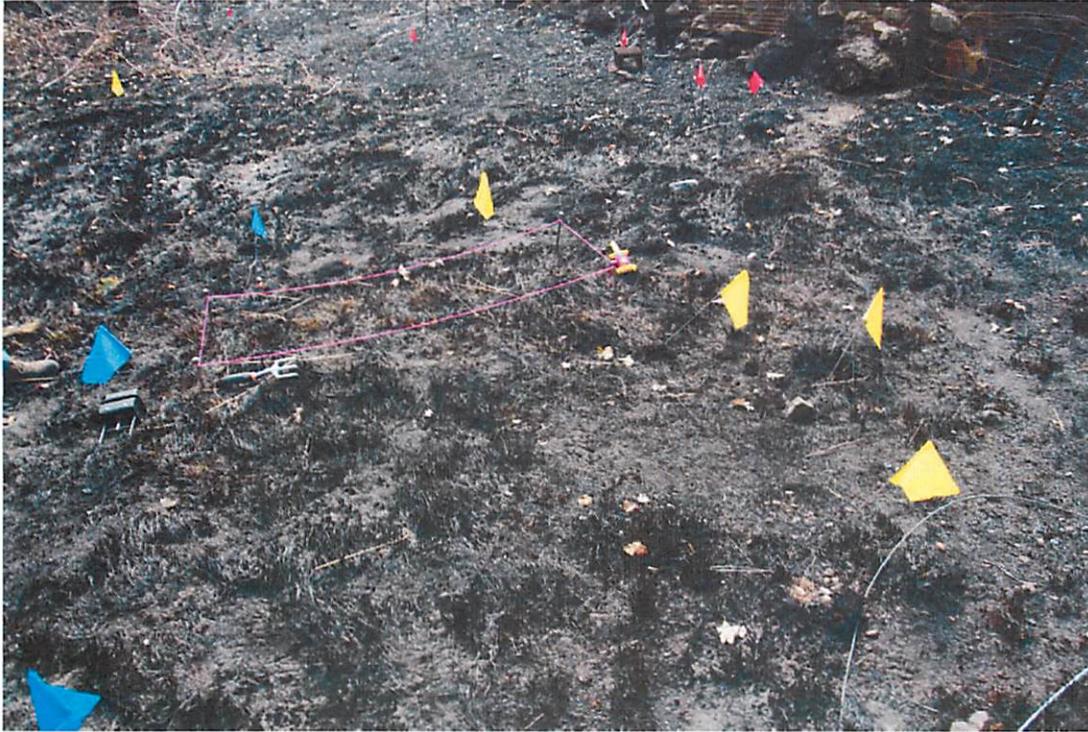
IMG\_0071- First search grid of SOA.

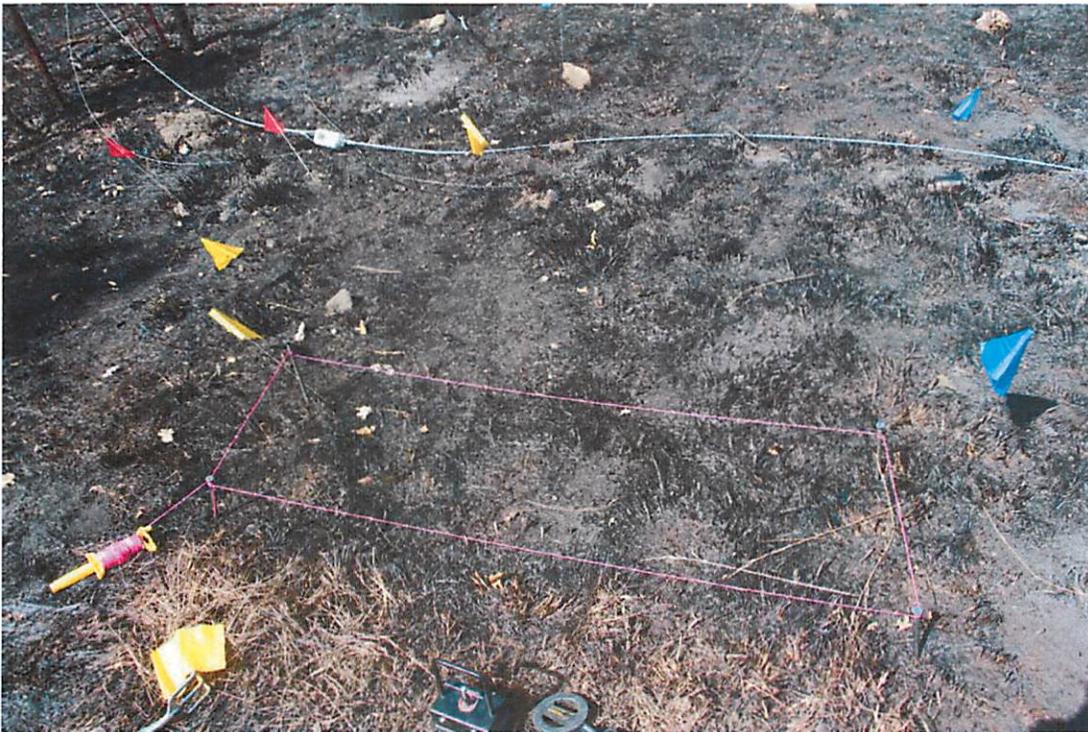
IMG\_0072- Second search grid of SOA.

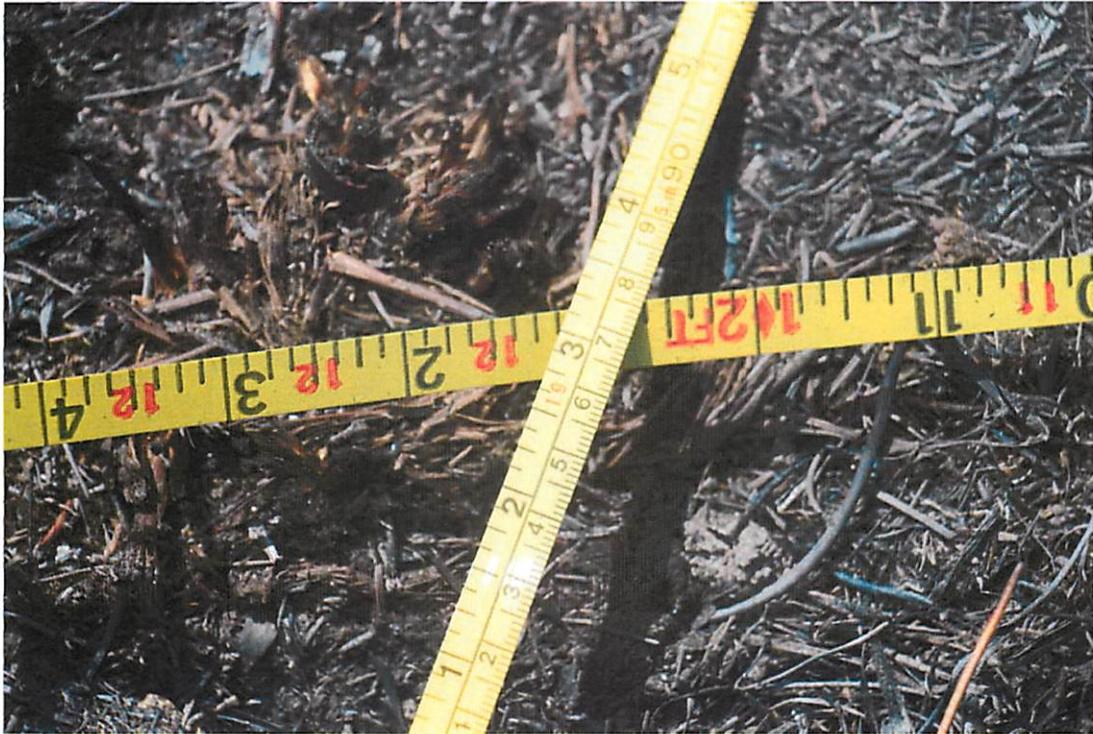
IMG\_0073- Center of SOA.

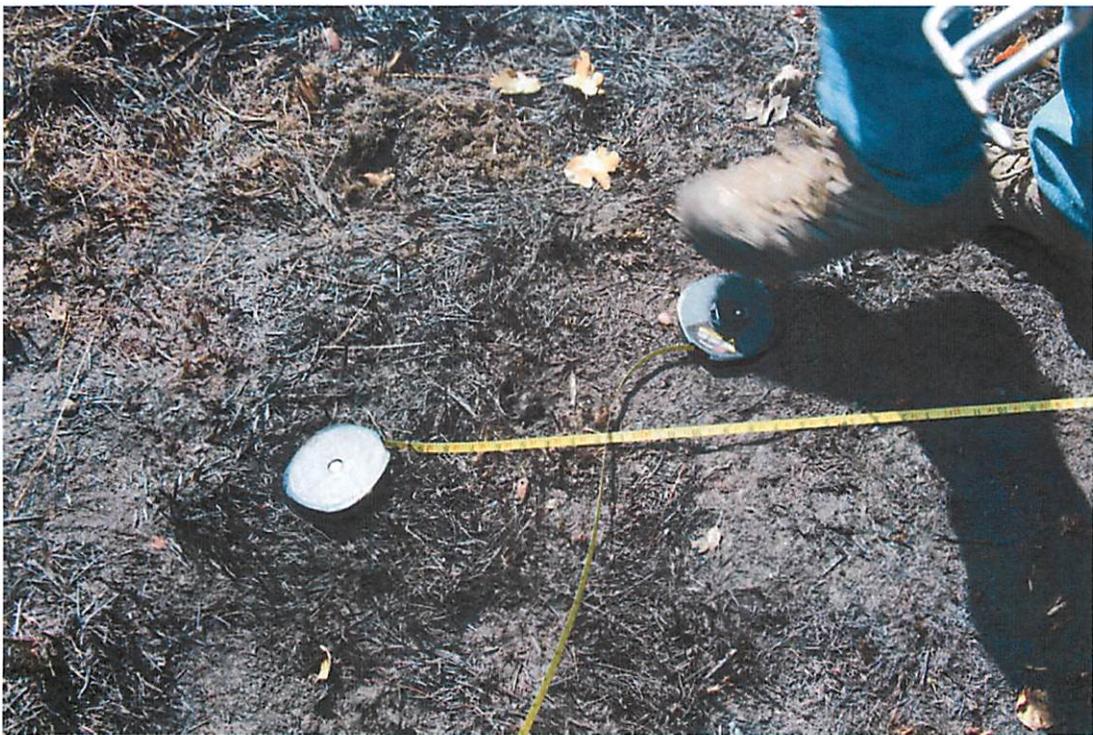
IMG\_0074- Center of SOA.
